## A Type Overdrive, Part IV Final Assembly & Testing

Part III ended with a nearly assembled OD. We pick up here with attaching the OD to the gearbox and finishing the OD assembly. The OD was then tested and several problems were uncovered and solved.

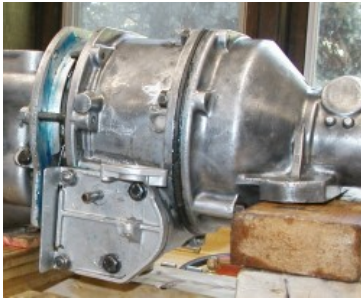
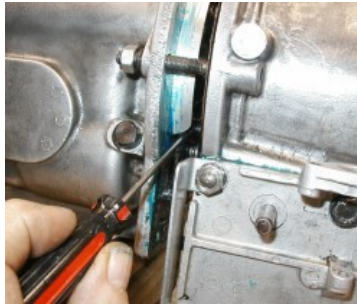
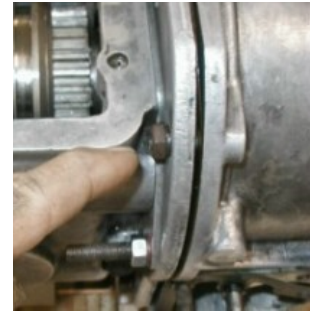
**Mating OD to Gearbox:** The OD was slid over the gearbox mainshaft and the back end was shored up with blocks as shown in the left photo below. The OD was then pushed toward the gearbox (or as the manuals say, offered up) while rotating the mainshaft back & forth till the splines on the mainshaft mated with the planet carrier and then the unidirectional clutch. Lock washers and nuts were put on the two long studs and used to draw the OD to the gearbox. The nuts were tightened alternately a couple turns each while rotating the mainshaft back & forth. When the mainshaft became hard to turn, both nuts were loosened until the shaft turned freely and then the back of the OD was wiggled --- the other studs seem to bind entering the adaptor plate and wiggling the OD freed them. A very minimum torque was used on these nuts. If the nuts are hard to turn, they should be backed off because something is hung up. Once the OD was closed within an inch or so, a screwdriver was used to push the springs forward and over the nipples on the adaptor plate (center photo below). The OD was then drawn further toward the gearbox until enough of the short studs were protruding so that lock washers and nuts can be screwed on. The top nuts must be screwed on before the OD is against the adaptor plate, there will be insufficient gap at that time to slip the nut over the end of the stud --- see right photo below. The wire holding the pump down was clipped and removed when there was about a 0.1 inch gap between the OD and the adaptor plate. The OD was then pulled to the gearbox by tightening the nuts on the two long studs. Once the OD was against the adaptor plate, the other four nuts were tightened. (Tightening the lower two nuts before the the OD is against the gearbox is one way to bend the adaptor plate.)

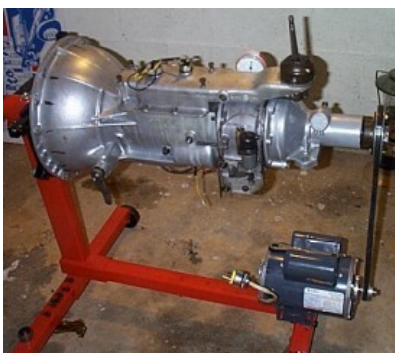
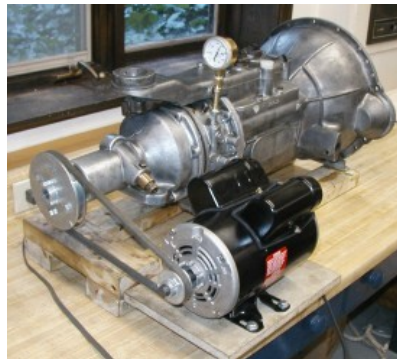
My setup is shown in the center photo below., An inexpensive 5 inch die cast pulley mated well with the OD output flange. I tried to get a 1 3/4 inch pulley for the motor but the smallest size the local stores had was 2 inch. I had a bunch of belts from some previous long forgotten project that were just the right length but too narrow for the pulleys. Used them anyway, worked fine and reduction was 2.7:1 so had ~ 1300 RPM. The board holding the motor is hinged where it attaches to the stand. This was intended to be sort of a clutch ---- lift the motor and let the belt slip to start. Turned out that is was not required since the motor had lots of starting torque, the load was light and the wrong width belt slipped a bit when starting. The motor can be removed when not in use by slipping out the hinge pins.

Ronnie had found a 0 to 800 psi gauge locally (in central Georgia) for less than \$10. After a few telephone calls I found that our welding supply store stocked a similar gauge for ~\$9. The gauge input is a 1/4 inch male pipe thread. (I understood that a liquid filled gauge would be better because it wouldn't vibrate as much; I planned to try to find one later.) The gauge screwed into the adaptor discussed earlier for injecting compressed air. **Caution, operate and release the operating valve using the lever or solenoid a half dozen times to relieve the pressure before removing the operating valve plug.**

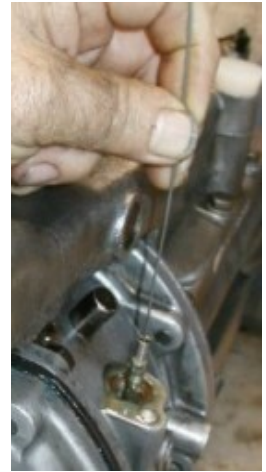
hole in the operating valve spindle was plugged and OD was held engaged. To confirm this I tried to turn the output flange counterclockwise --- wouldn't turn ---- the OD was engaged.

Time to go get a snack while the pressure bled off. Came back a little later ---- no change in pressure. I then loosened the adaptor with gauge carefully. The plan was to loosen it enough so that it would leak and bleed off the pressure that way. It worked and not too much oil escaped, there was still a lot of air mixed in --- the oil was frothy. (The oil was observed to be nearly free of air after more operation indicating that most the air worked out of the fluid). The plug, spring & plunger were then removed. The ball was easily picked out with a magnetic pickup tool. The end of a length of ~19 gauge soft steel wire was bent slightly and then pushed into the end of the valve spindle then pulled up --- the spindle come out easily (photo on right). The top of the spindle was cleaned and blown into --- no air passage. --- it was plugged. A suitable drill bit was slid down the inside of the spindle and turned a few times then removed and wiped on a clean paper towel. Didn't see anything in the fluid but it had a lot of air mixed in it and not sure if I would have been able to see anything anyway. This time when the top was blown into, the passage was clear. (This left an after taste nearly as bad as beets.) The spindle was then cleaned thoroughly and reinstalled: everything worked fine then.

So, where did the dirt come from? It was probably in some of the internal passages in the main casting. Recall that this OD had a major internal failure and it is quite possible part of the debris got in the passages during the cleaning process. It appeared that little made it pass the screen, so if it was exercised a bit, hopefully anything else will work itself through the system, and no problems will be encountered in the future.

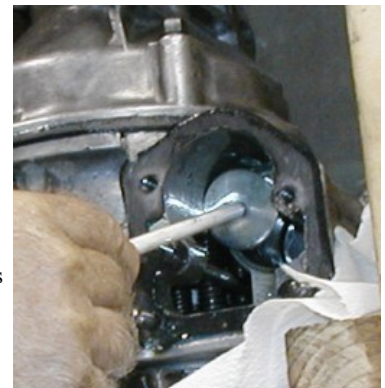
The pressure was at about 310 psi and needed to get to be 450psi, so needed an increase of 140psi. Decided to try two washers behind the spring. Turned the gearbox on the front to let oil drain out of the OD (this is a test that needed to be run anyway to see if front seal leaked -- it didn't - yet). The cover plate was removed (nuts on studs first, then the bolts beside the spring, slackeden together). **Caution, operate and release the operating valve using the lever or solenoid a half dozen times to relieve the pressure before removing the cover plate.** Then put in two washers (photo on right), put it back together and fired it up. Pressure went to about 360 --- about 25 psi increase per washer. The washers were 1/16 inch thick just like the one Ronnie used, but this is a different type accumulator and spring.

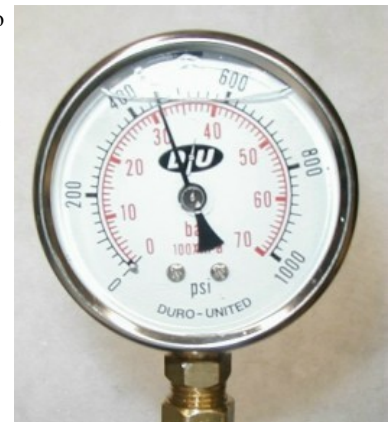
**New Gauge:** Unfortunately, the cheap gauge had become erratic, the no pressure reading had increased to about 40 psi; hours of 50 psi fluctuations 1300 times per minute must have been too hard on it. A liquid (glycerin) filled gauge was found at McMaster Carr via the internet ([www.mcmaster.com/](http://www.mcmaster.com/)). It was ordered at midnight and they sent an email the next morning saying they had shipped it UPS from Cleveland --- less than 200miles away. It arrived the following day. The gauge was what they call Grade A that is calibrated to within 1% around the middle of the scale. A 2 1/2 inch dial, 0 to 1000 psi gauge, part number 49053K79 had been selected. The cost was \$21.34 plus 1.28 sales tax plus \$3.15 shipping, \$25.77 total. This outfit doesn't seem to pad the shipping like some of the others and will get more of my business.

The new gauge is pictured on right. Notice the liquid level. The needle was steady on this one, what a difference!

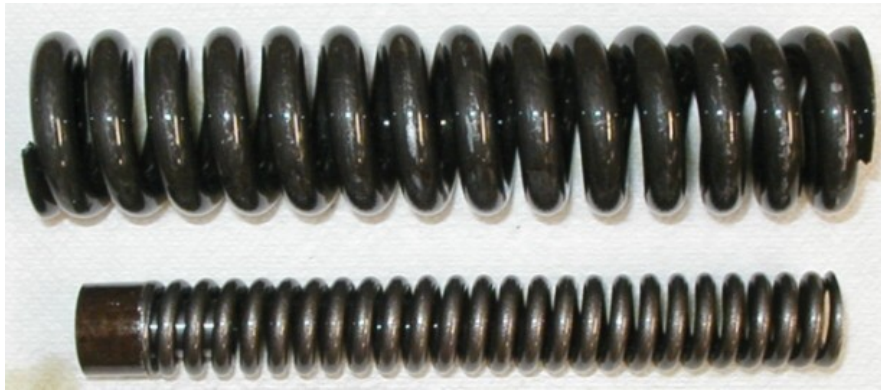
After considerable thought and consultation with a fortune teller, I flipped a coin and decided to make a small plug for the inner spring to compensate for any loss of strength due to old age. I also thought it would give a little margin. This combination is test 11 in the following chart and shown in the photo after the chart.

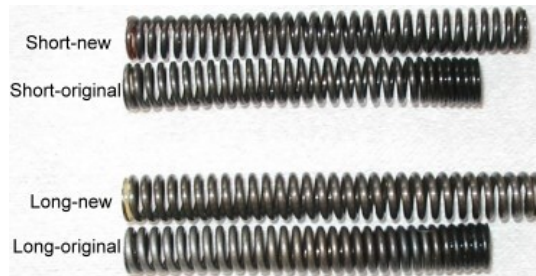
The photo above shows the original and new springs together. The ends of the new springs are painted, red on the short ones and yellow on the long ones. All the springs had about 31.5 turns. Note that the new short springs were wound in the opposite direction from the others --- doubt that the winding direction was part of the original specification. The right 3/4 inch or so of the original springs were clearly collapsed. All of them were that way and they were pretty uniform, so much so that I thought they were manufactured that way. Recall that the release bearing had failed on this unit and these springs pressed the thrust ring into the rotating clutch sliding member. The thrust ring and sliding member got very hot. It was then concluded that the ends of these springs also got very hot, hot enough to remove the temper and allow the springs to collapse. And here I was thinking the PO had substituted the wrong springs. Shame!

Before the new springs were installed the pressure required to operate the clutch using the original springs installed in the correct positions was measured; it took 80 to 85psi. This measurement was repeated using the new springs found to be 140 to 160 psi. This time the OD couldn't be pushed onto the gearbox far enough for the mainshaft splines to engage the planet carrier splines as with the original springs; the nuts on the long studs had to be used to draw it to that position. The mainshaft was rotated back and forth a few degrees each side of the center mark as the OD was drawn onto the gearbox and no difficulty was encountered and a minimal force was required on the long studs. The OD engaged without difficulty and released quickly with the new springs.

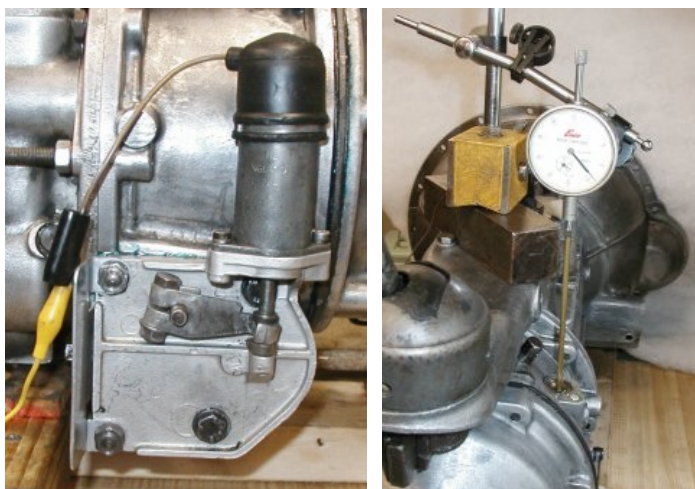
It was decided to use a dial indicator to adjust the valve as shown in the right photo below. The plug and spring were removed and a length of 5/32 inch OD - 1/8 inch ID brass tube (hobby store) was placed over the end of the plunger and the combination then placed between the ball and the dial indicator. The solenoid was not operated without something over the ball --- didn't want to be dodging steel balls --- the solenoid is a very effective ball launcher (bit of experience speaking here). While messing around the lever was turned too far and the end of operating valve spindle (the long thin shaft) dropped past the lever to the bottom of case --- used that bent wire again to retrieve it.

The lift adjustment is made as follows:

1. Loosen pinch bolt
2. Position the plunger with brass rod in the center of the ball and record the dial indicator reading.
3. Push the solenoid plunger up as far as it will go and then operate the solenoid (don't operate the solenoid with valve released --- shock is not good for the indicator).
4. Move the lever on the operating shaft (below operating valve) to the position where the dial indicator reading is different from the reading in Step 2 by the desired lift.

5. While holding the lever in this position, push the actuating lever down against the bottom of the solenoid plunger and tighten the pinch bolt (this takes three hands).
6. Release the solenoid, push the brass rod down and verify the reading is the same as Step 2.
7. Take the operated and released readings several times to verify the lift is set as desired. (Remember to lift the solenoid plunger before operating the solenoid.) If the setting is not as desired, readjust as required.

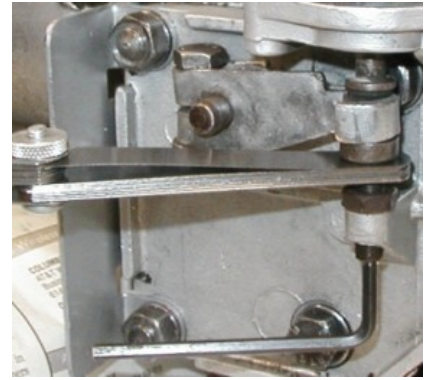
**Actuating Lever Stop:** I noticed that there was no adjustment screw in the stop below the solenoid plunger like on the later A type ODs on my TR250 and TR6. The hole in the stop was not threaded either. One of the catalogues indicated that a rubber stop (NA) was used on the early models. The plunger was pushed down as far as it would go and then the solenoid was powered ---- it wouldn't operate. This must not be allowed to happen The OD will fail to engage and worse, the high operating current will quickly burn up the solenoid winding (~\$100). The hole was drilled and tapped 1/4-28 to match the later models and the 3/4 long set screw and jam nut from a later unit was installed since the hardware store wasn't open at that time of the night. The Haynes TR250-TR6 manual says the gap between the top of the screw and the bottom of the operated plunger should be 0.150 - 0.155 inch, see photo on right. The solenoid then operated reliability. Note that too small a

gap may cause the OD to not disengage when the solenoid releases. Fred Thomas said an insufficient gap caused him to remove the interior of his TR3 eight times this past spring. Fortunately, his OD was not damaged.

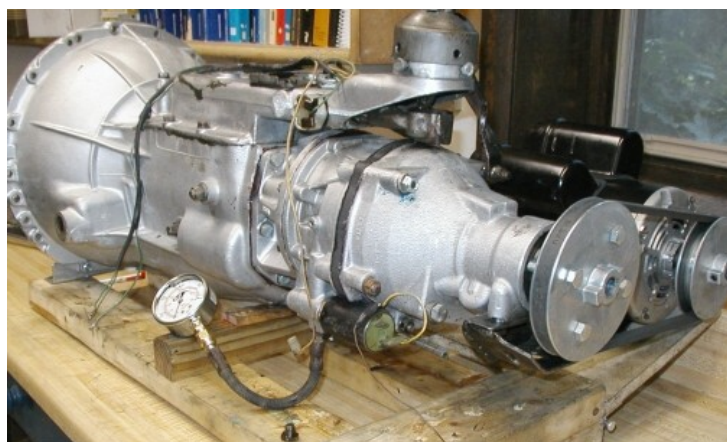
**J Type OD:** The J type OD from my '76TR6 was put in the test stand to find a small leak. Before firing it up, a small leak from the countershaft cover plate in the front was noted, but it hadn't yet made it to the drain hole; the cover plate was bowed so it was reversed. The rear seal was replaced (again) because there was a one drop drip on the bottom. The motor was then run for an hour. There was a stream of oil from one of the studs near the top that hold the front and rear casting on each side of the brake ring. There is a copper washer then lock washer and then nut on the stud. The lock washer had distorted the copper washer,. The fix was to replace the copper washers on the two top studs and then add a flat washer between copper washer and lock washer. Joint sealer was also used around the stud.
