## Chirping GT6 Throw Out Bearing

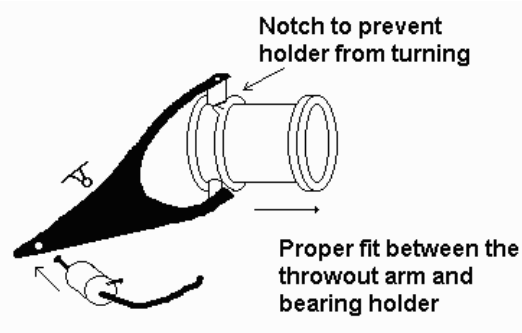
The other possibility is that the TO bearing holder and arm may have become dislodged from each other when I installed the gearbox the first time. The TO bearing is pressed onto a brass holder. Two pins on the TO arm are supposed to fit into a slot between two flanges on the holder. A notch in one of the flanges prevents the mount from turning. If the pins are worn so much that they allow the notch to slip past, the entire mount rather than just the bearing will spin. This was the possibility suggested by Nigel at Spitbits. However when I took mine apart I found little or no wear on the pins. There was no way that the holder could spin more than halfway around.

I still don't know what caused the noise I was hearing. But the lessons are clear. Torque the pressure plate carefully, and don't dislodge the TO arm when installing the gearbox.
