Gearbox Overhaul - Part 1

We describe the disassembly of a TR250-TR6 gearbox in another technical note. The following describes how an amateur mechanic can successfully (we hope) overhaul a gearbox and put it back together. The same parts nomenclature as The Roadster Factory TR6 and TR250 Catalogues is used. These catalogues have excellent diagrams showing how the parts are assembled on the shafts and should be used in conjunction with the following description.

You might recall from the previous article that the object was to overhaul a TR250 gearbox with A Type overdrive. When the gearbox was examined the **constant gear** (the big gear on the front of the countershaft that mates with the gear on the input shaft) was found to have some broken teeth. A spare early TR6 non-overdrive gearbox was also available. It was that spare gearbox that was disassembled in the previous article to get good gears for the overdrive gearbox. The only difference between an overdrive and a non-over drive gearbox is the mainshaft; the overdrive gearbox uses a shorter mainshaft that mates with the overdrive unit that is installed in place of the gearbox rear extension. The plan had been to use all th

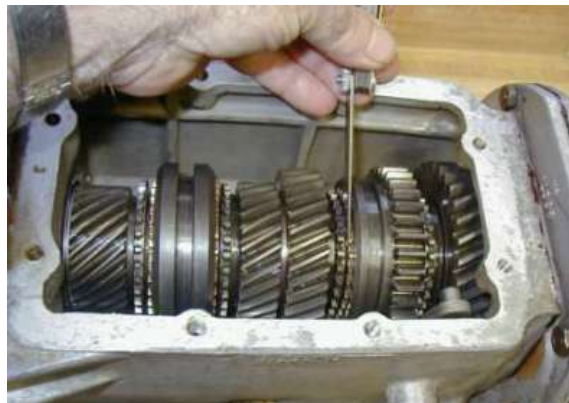
The new synchronizer cups are probably also overkill. One should measure the distance between the cup and the associated gear with feeler gauges (next photo) and if greater than .030 inches, the cup need not be replaced. The cup should be held firmly against the gear when this measurement is taken. This measurement can be taken just as easily when the gears are off the mainshaft. For this project all the synchro cups were well within specs but were replaced anyway since there was a new set in the kit (not sure that this makes sense). The synchro cups are ~ \$80 for a set of four. Next time everything in the kit except the synchro cups and rear bearing will be purchased. I have a whole stack of used cups that are well within specs.

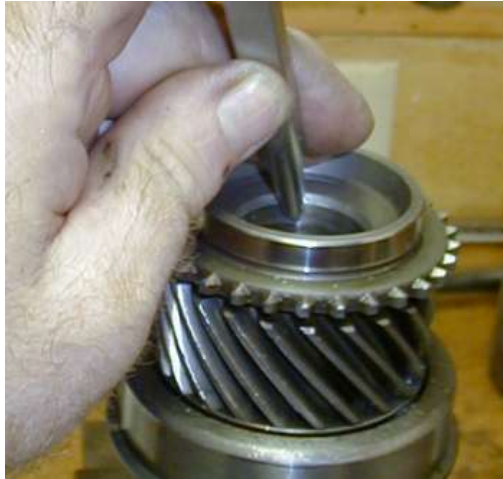
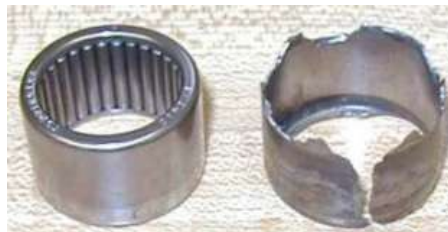
The TRF catalog says that one can identify the early input shaft design because it has a pressed-in, closed-cage bearing which is *hard to remove*. After inspecting the bearing it seemed to be no big deal. A rag was wrapped around the front of the input shaft, which was then mounted in the vise with that difficult bearing facing up. (This shaft is literally irreplaceable; hence it is probably appropriate to wrap the shaft in a heavy bath towel. A bath towel was not available for this job because the spouse was setting between the workshop and the linen closet.)

Next, a tool was designed to catch behind the lower lip of the bearing and pull it up. It didn't work; the lower lip shattered and the needle bearings fell out while the outside race was still firmly pressed into the input shaft.

At this point it was clear that the outside race would have to be removed in pieces. Several chisels were tried with some success at breaking off pieces. It finally became obvious that a channel would have to be broken out the length of the bearing race to relieve the pressure before it could be removed. A center punch was the tool that worked. A new point had to be ground after every few whacks so that it would bite between the hardened thin outer shell of the bearing and the input shaft surface. (You don't need to worry much about scratching the inside of the input shaft; that surface is hardened and the bearing surface is part of the new bearing anyway.) Following photos show working on the bearing and the old outer shell compared to a new bearing.

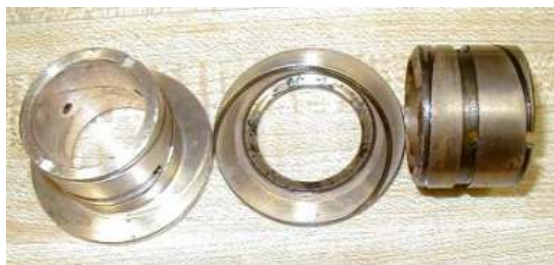
Each part was inspected when taken off the mainshaft and all were OK except for the bush under the second speed gear. The end was broken off this bush that is also called a top hat bush. The following photo shows the broken bush beside the new replacement. This same bush was broken in the same way in both gearboxes disassembled. The TRF catalog indicates that this bush is very failure prone, possibly due to inattention to proper end float. (The later gearboxes were redesigned to use steel bushes instead of these brass bushes.)

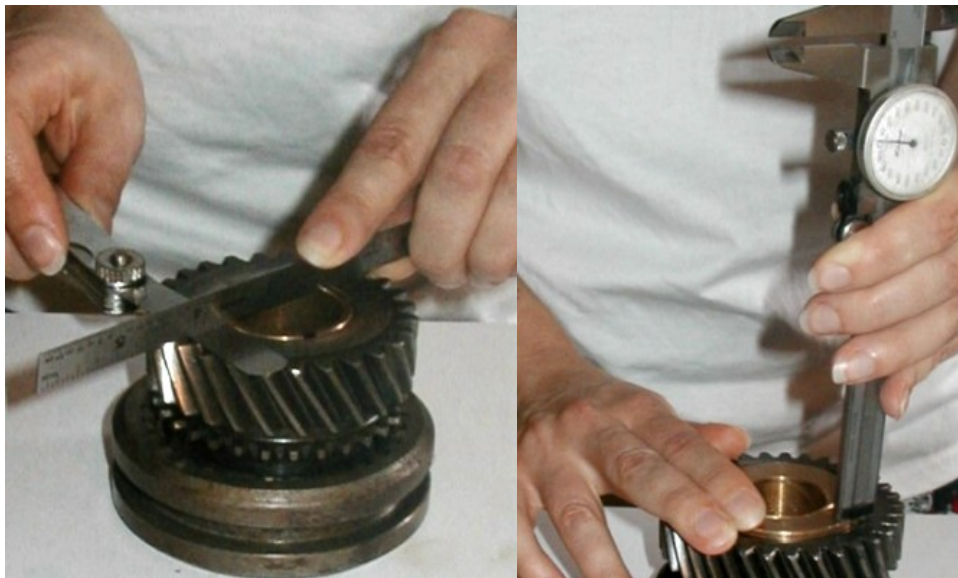
Second gear and the associated bush is also set up on the synchro hub & adjustment washer. However, the top hat brim presents special problems. The float is the gap between the underside of the brim and the gear side. Unfortunately, the side of the gear is recessed so it is difficult to get all except the thinnest of feeler gages to flex enough to get into the recess and under the hat brim. Pete Chadwell had a lot of trouble using the feeler gauges here so he suggested using the dial caliper as a depth gauge to measure the distance from the outside face of the hat brim to the gear side. Then take the gear off the synchro hub and let the bush slide all the way in and take a second

measurement. The difference between the two measurements is the gear float. I tried this and it worked pretty well. I suggest you press down firmly on the bush when taking the measurements. Also, it is suggested that you repeat the measurement several times until you get consistent results. The right photo below shows the engineer with caliper.

I was able to measure the 2nd gear float using feeler gages for the new bush used in this gear box. Just before doing this update I obtained another new bush for a future project. This bush slid freely over second gear except for the last .050 inch or so. Inspection revealed that these was a slight raised edge beside the relief cut adjacent to the hat brim. I removed this edge with a small file and the gear then seated properly and turned freely. Unfortunately, there was no gear end float. The length of the cylindrical part of the bush that fits into the gear is about .006 inch shorter than that of a used bush I measured. I will have to trim the cylinder side of the brim on the lathe to make this bush usable.

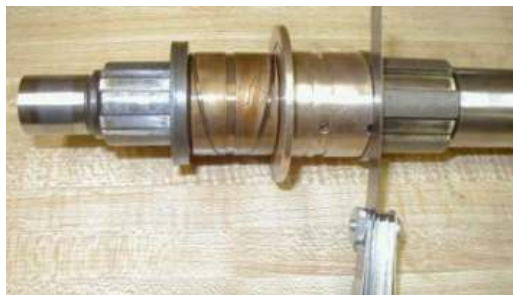
Bush Float: The next job is to assemble the second and third gear bushes together with spacers, washers and clips on the mainshaft and then measure the bush end float. When attempting this using the new top hat bush it was found that the inside diameter was too small --- it would have to be driven onto the shaft. It was then recalled these bushes had to be driven off the mainshaft of both the gearboxes. It seems futile to measure end float when the bushes won't float. This may be why the top hat bushes are prone to break; they are supplied in the wrong size. The bush was mounted in the lathe and the inside honed with 300 grit Emory cloth just enough so that it could be pressed on the mainshaft by hand.

It was then possible to assemble everything and measure the end float as shown in the next photo. The front washer can be reversed and the back edge of the front clip can be slid into the groove for this measurement thus avoiding the difficult task of installing and removing the clip. The specs are for an end float of .003 to .009 inches. The measured end float was .010 inches ----- just a bit too much. The rear washer is an adjustment washer that is available in different sizes to adjust the end float. It looked like a thicker washer would have to be ordered.

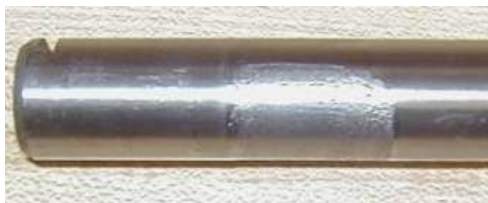
The major wear point on gearboxes is the rear countershaft bearing and the countershaft under that bearing. This is near the first speed gear that must endure the greatest forces, especially if one likes to *peel rubber* to impress the girls.

In the two gearboxes disassembled for this project, one countershaft was good and the other was heavily worn as shown in the next photo. A countershaft with any sign of wear should not be used --- pay the ~\$30 for a new one.
