TR250 & TR6 Brakes Overhauling Handbrake

Overhauling Handbrake

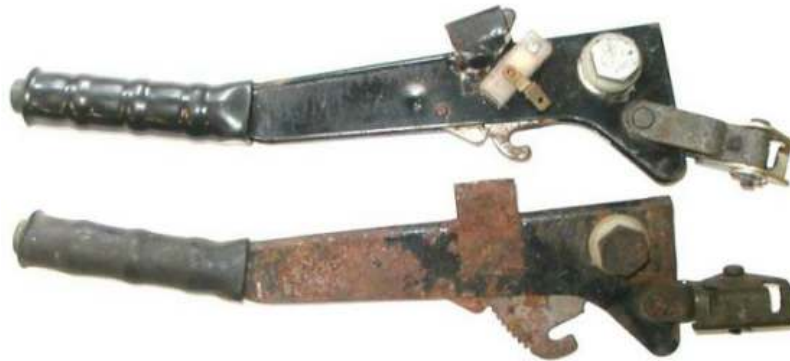
The photo below show a close-up of a lever assembly from a '76 I junked years ago (top) and the lever assembly from the '70 I'm overhauling (bottom). The added switch is clearly visible on the upper lever. The TRF catalog notes that a different grip was specified for the '76 but apparently never used. The Moss catalog shows a grip with a nearly rectangular outer cross section that must be the later version. I've never seen a one of the rectangular grips on any TR6. I assume they used stock of the earlier part and had enough to last through the end of TR6 production.

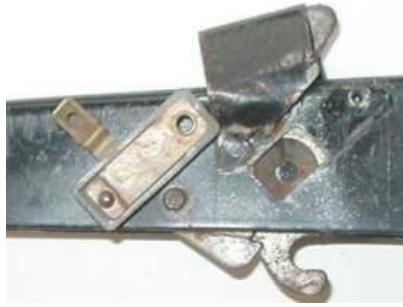
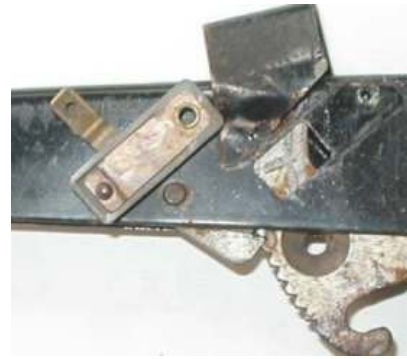
The next photos shown the switch area in more detail. The screw that holds the switch to the handle has been removed and the switch has been turned over. The switch has a metal dimple that sticks down. The left photo shows the ratchet segment in the handbrake released position with a hole under where the the dimple on the switch rests so that no electrical connect is made. The right photo shows the ratchet segment in the handbrake operated position where the switch dimple will be grounded to the ratchet segment (the hole is visible below the handle). Note that a corner of the strap shield over the top of the ratchet segment had to be cut to make room for the switch. Also note that the ratchet segment had to be modified with the hole.

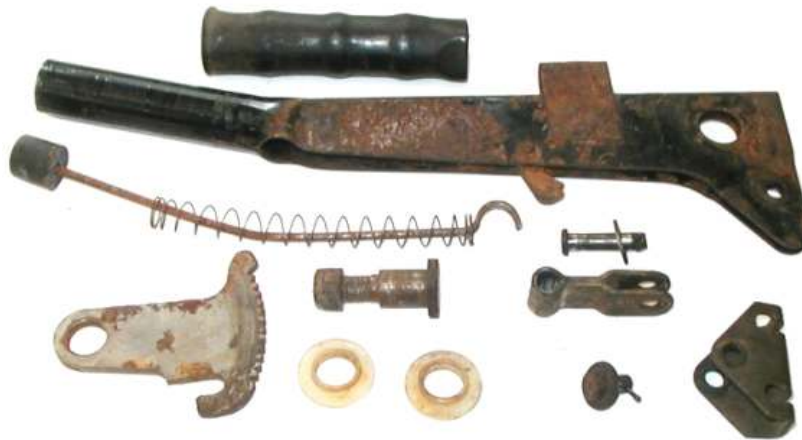
Overhauling the lever Assembly: The next photo shows the disassembled '70 lever assembly.

Some of these parts are obviously in worse shape than those of the '76 handle. For example, the '70 paw release knob has a hole as shown on the right. Won't speculate as to why handbrake was applied with such urgency to make the hole. I decided to use any part from the later lever assembly that was the same as for the early lever assembly and in better shape. (I also have a '76 so wanted to keep the unique '76 parts.)

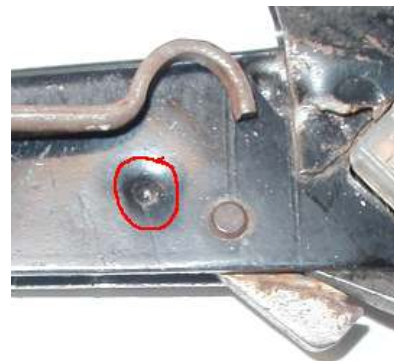
When I tried to remove the Paw release rod from the '76 lever assembly I found it wouldn't come out. It comes right out of the early levers, which is the main reason that I always found it difficult to reinstall the lever. The paw would slid around and let the paw release rod fly out of the handle just when I had it about positioned. The late lever has dimples on each side of the lever to keep the paw from rotating far enough for the paw release rod to escape. The photo on the right shows the dimple in the red circle. The paw release rod from the other lever is setting on top this lever to illustrate the rough position of the rod inside the lever. I decided to modify my early rod so the paw release rod would be retained. Rather than dimples I drilled the lever in the same spot as the dimples on the later lever and threaded one side for an 8-32 stainless steel machine screw to restrict the paw motion. The dimples were drilled out of the later lever so I could get the paw release rod out and move it to the early lever.

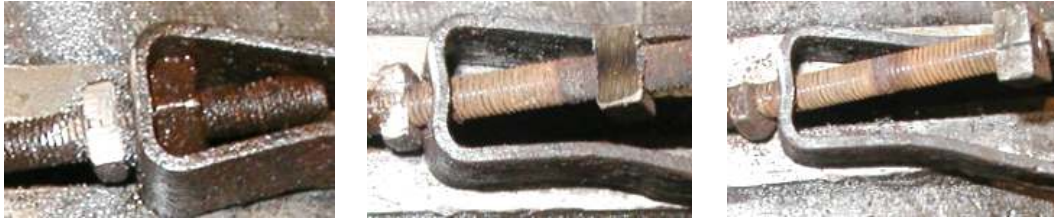
The Cables: I had secured new cables for this project. When I went to find the fork-ends that go between the cable and the rear wheel cylinder lever I found a pretty decent set of cables with the nuts securing the fork-ends rusted solid to the cable. I could have merely sawed off the end of the cable to free the fork end but then I'd have ruined a good set of original cables that I can probably sell on ebay for twice the cost of new cables (they are original). I ended up grinding & filing one side of the jamb nut and then using a sharp chisel to split the nut open. I could then screw the nut all the way on the cable, slide the forked end all the way on the cable and do the same grinning-filing-chiseling to loosen the square adjustment nut. The photos below show the sequence.
