Sticky Clutch

I had a sticky clutch in my TR250 and after I mentioned it to some of the Buckeye Triumphs members I found Murry Mercier had a similar problem. I've also seen a number of references to the problem on the Triumph and 6-PACK email lists.

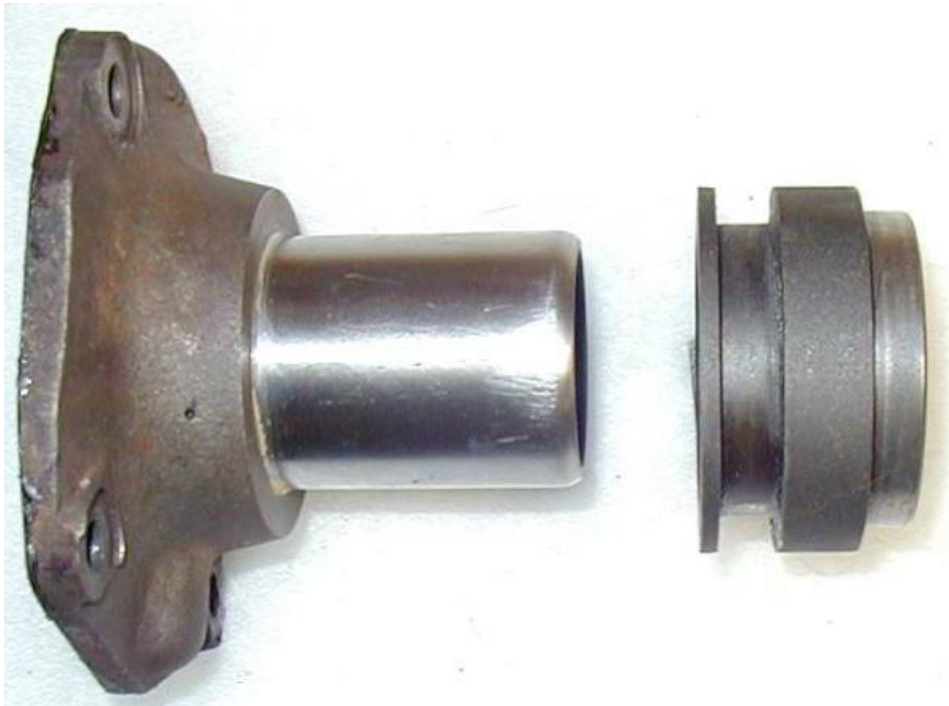
The next photo shows the gearbox front end cover and release-bearing sleeve (with bearing removed) in more detail.

The front end cover outside diameter measured the same as one on another transmission and the same as those we measured last September. The sleeve inside diameter was then measured and the clearance computed to be .008 inches agreeing with similar used sleeves measured last fall. Thus, the problem wasn't a too small sleeve as I had suspected.

Time to Rethink: Next, the two used sleeves and two front end covers were examined. All showed slight wear in the same areas. The sleeves seem to rub against the front edge of the front end covers in one spot (centered around the 7 o'clock position when viewed facing the front of the gearbox) and the rear part of the sleeves rub against the front covers at about the 1 o'clock position (opposite from the front). The second contact area is a little over halfway back on the front end covers. These data indicate that the front of the sleeves are pitched up and to the driver's side slightly (1 o'clock position) when the clutch is operated.

Possible Solution: To minimize the binding it was decided to smooth the contact surfaces and edges. The front cover was placed in the lathe and the entire surface polished. The front edge was smoothed with a file. (The previous two photos were taken after this was done.) Next, the inside edges of both ends of the sleeve were smoothed with a file (in the lathe). If the diagnosis is correct, the rear edge of the sleeve is the most likely point causing the problem. This edge has a 45° bevel but is still fairly sharp.

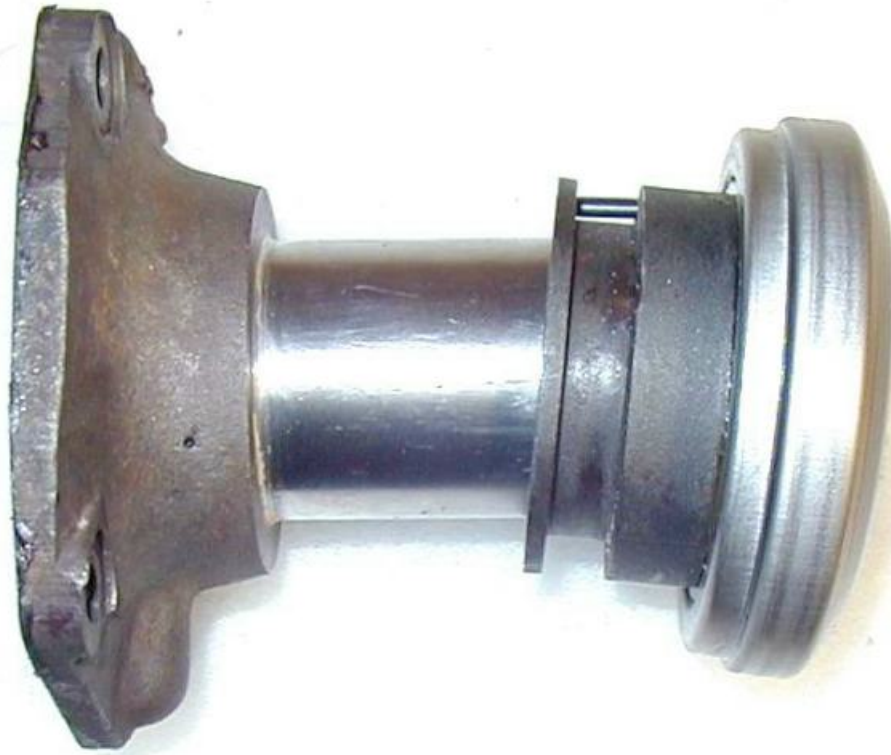
From all these data it was concluded (better make the speculated or guessed) that the clutch hangs because the sleeve pitches up slightly and digs into the front end cover. The next photo shows an exaggerated view of this. The sleeve was pulled toward the front much more than in normal operation to get it to tilt as much as shown. (It was found that the sleeve binds when a large tilting force is applied even when the front end cover is nearly fully inserted in the sleeve.) If this is the cause

of the sticking, then the fact that it first starts to stick after many hours of operation may be attributed to the lubrication thinning at the points of contact. The remaining lubricant may be less effective at elevated temperature causing it to be more prone to hang up when hot.

Some tilting of the sleeve is not surprising since the pins of the clutch fork sweep through the front end cover center line, but are either above or below the centerline during part of the sleeve travel. Also, the pressure plate is probably not aligned perfectly with the front cover. If the bearing aligns with the pressure plate, then the sleeve will be tilted. The fact that the sleeve hangs under the more than 200 lbs clutch pressure plate spring force is however surprising.

The same front end cover, sleeve, clutch-operating shaft and fork were reinstalled my TR250. The same parts were used as a test to try to determine if smoothing the edges and surfaces fixed the problem. The mating surfaces were lubricated with high temperature wheel bearing grease during assembly. [After everything was assembled I remembered the time the clutch disk stuck to the flywheel. Maybe I should have lubricated both sides of the clutch disk too. (That was a feeble attempt at a joke.)]

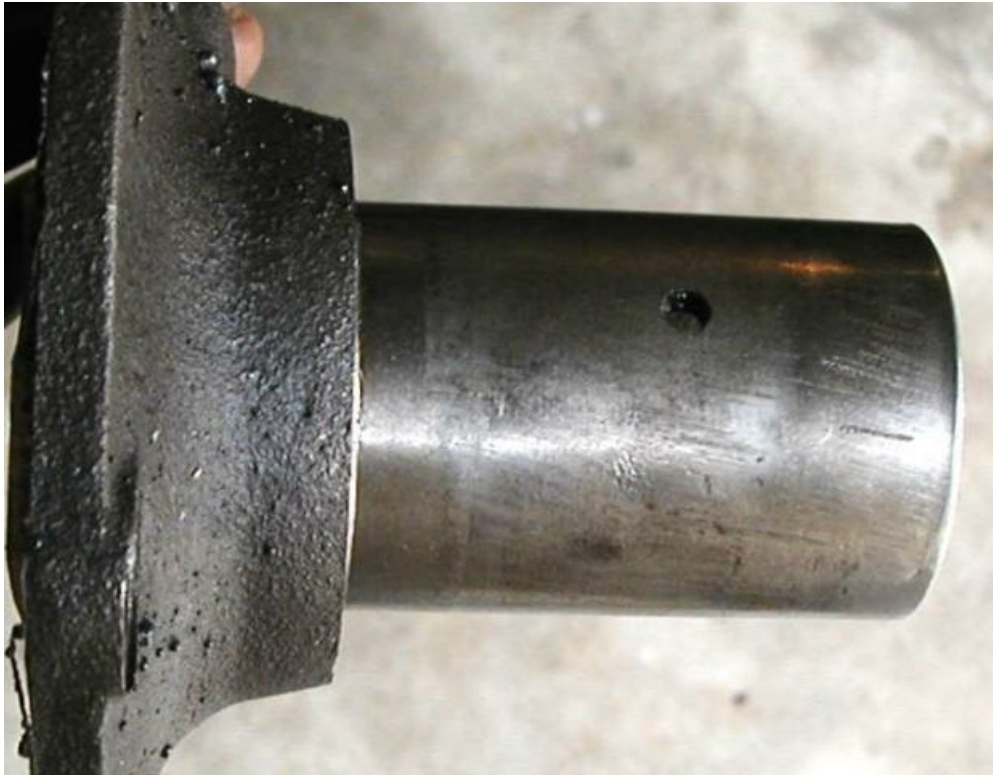
We examined the front cover next and found it had deep scratches. There was also a small lip at the bottom edge of the front cover, as if the front had been driven back or 'peened' over. Some of this is shown in the next photo as viewed from the bottom.

Murry's Fix: We decided to replace the front cover because of the depth of the scratches. We mounted another TR4 front cover in the lathe, cut off 3/8 inch, smoothed and rounded the end and then polished the outer surface.

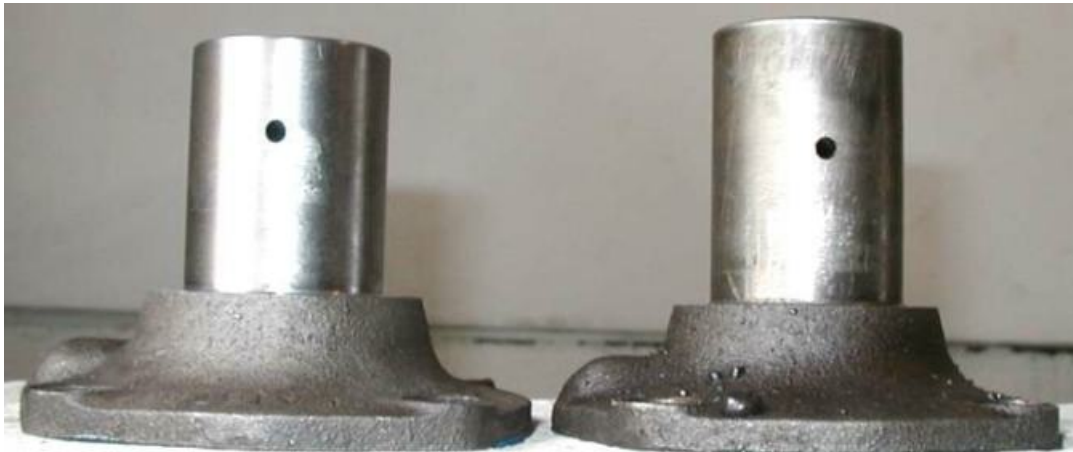
We also found the front cover sleeve length was 3.375 inches typical of the TR4 rather than 2.97 inches required by the TR4A through TR6. The longer sleeve will interfere with some pressure plate spring fingers. The hole in Sachs pressure plate used in the Magic Clutch as well as the standard Borg & Beck pressure is large enough so that there will be no interference. The hole in the earlier Laycock pressure plate is smaller and will likely interfere with the longer front cover. The following photo shows the TR6 front cover (left) with the longer TR4 cover.

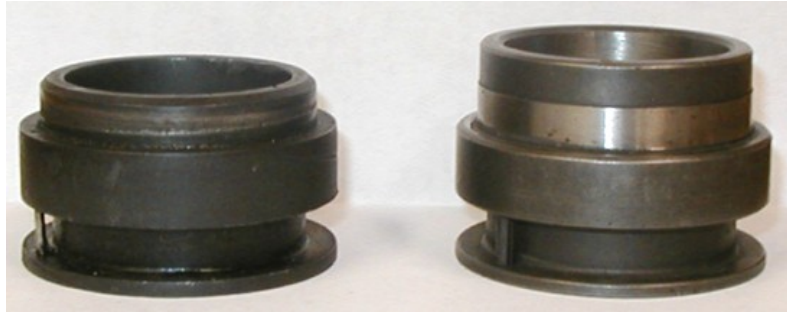
I have a newer sleeve that is longer and thought it was a good idea since the added length would reduce the amount the sleeve can tilt, thus reducing the attack angle of the sharp edge. The next photo shows the longer sleeve beside an old short sleeve. Murry's clutch had one of these longer sleeves. I examined my longer sleeve

more closely and found the edges are really sharp, much more than a used sleeve I have. So there's two possibilities, the longer sleeve sticks because it hangs over the end of the front cover or the longer sleeves have extra sharp edges. One thing seems pretty clear, it's probably foolish to replace a working sleeve with a new sleeve. However, even an old sleeve should be inspected carefully to make sure there are no sharp edges.
