## A Type Overdrive, Part III - Reassembly

### A Type OD Part III

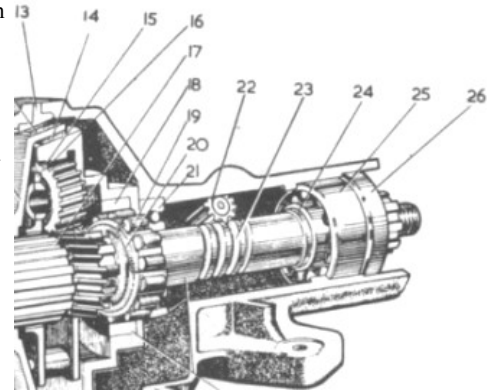
**Annulus End Float Out of Specifications:** The sectional view on the right is part of a diagram in the Service Instruction Manual mentioned in Part I. Component 14 is the Annulus, 21 and 25 are the head and tail bearings, 24 is the adjustment washer and 26 is the rear seal.

New head and tail bearings have some end float between the inner and outer races. I don't have specifications on the bearings but expect it is about .010 inch. Note from the sketch above that the outer races on the two bearings are pressed against shoulders in the rear casting. The inner races are squeezed together by the annulus head and the rear flange. The adjustment washer (24) rests against a shoulder on the shaft and keeps the inner races apart

If everything is perfect, the distance between the two outer races is exactly equal to the distance between the two inner races and the annulus end float will be equal to the lesser of the two bearing end floats. On the other hand, if the distances between the two inner races and the two outer races are different, the end float will be less. In the extreme, if the difference in these two measurements is too large, there will be no annulus end float and the bearings may have a pre load ---- a lateral force applied to the bearings. Pre load will likely lead to early bearing failure.

If there is too little end float, then a different adjustment washer can be used to get the distance between the inner races to match the distance between the outer races. Washers are available (or were available 30 years ago) in .005 inch increments between .146 and .181 inches. Lets say that the end float is .002 inches. The next size washer should bring the end float to .007 inches, in the middle of the specs. Should a thicker or thinner washer be used? You can't tell from these data. If one has a stack of washers, a thicker one and then a thinner one can be tried, etc. There are 8 washer sizes and if one starts with no end float, this can take some time. There is a factory tool that allows one to measure the distance between the inner and out races and compute the correct size washer. I don't happen to have that tool and it looks like too much work to make one to use it once in a lifetime.

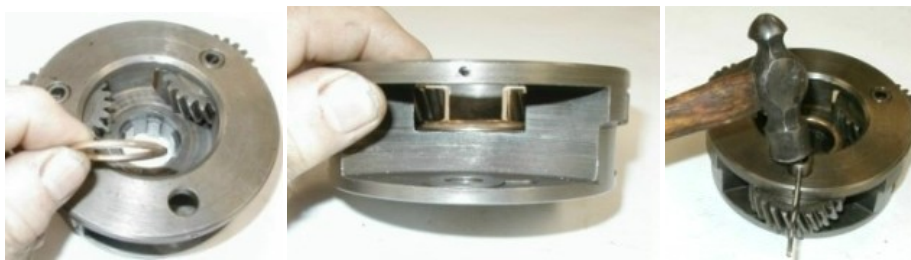
**Planet Carrier:** Each of the planet gears was rotated to make sure the bearings were smooth. Normally there will be no problem and nothing else need be done to the planet carrier. In this case the mainshaft thrust washer retained in the center of the planet carrier was destroyed and the new washer couldn't be installed without removing one of the gears. The photo on the right shows a gear, the little shaft and associated tabbed thrust washer. There is a hole in the top of the shaft. A 3/32 mild steel pin is driven through a matching hole in the carrier and into this hole to retain the shaft. The pin was drilled out using a 5/64 bit.

The shaft was tapped out with a hammer and punch and the gear and washer removed. (If it was necessary to replace the planet gear bearings, this procedure would have been followed to remove the gears. There are two roller bearing cages pressed into the gears. These would be pressed out and new ones pressed in. These bearings weren't removed this time for fear they might be damaged and spares weren't in hand.)

The thrust washer was positioned in the recess in the center of the carrier. The top of the washer is beveled to provide clearance for the planet gear teeth. (If the top of washer isn't beveled, one can try turning it over.) The planet gear thrust washer was then positioned with the tab in the hole, the gear slid into position and the shaft tapped home using a small hammer. The photo on the right shows a drill bit in the hole in the shaft to help keep it visually aligned with the hole in the carrier. A 3/32 steel retaining pin didn't seem tight enough so a 3/4 inch long 3/32 expansion pin was ground down to a length of ~.6 inches and used instead. The expansion pin is tempered and will likely ruin a drill bit if one tries to drill it out. However, if the shaft is pressed out, the pin will shear off and the pieces can then be tapped out with a small punch. (I tried it to make sure it works.)

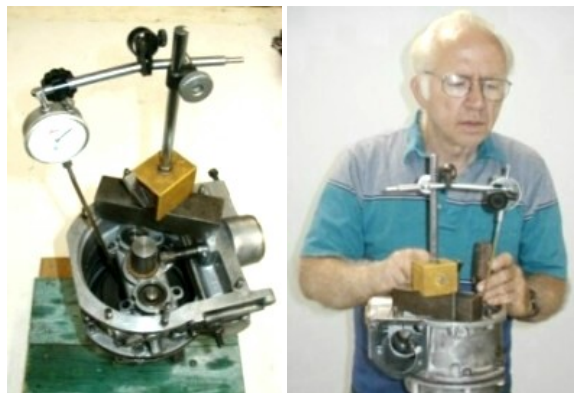
**No End Float!** When the end float was measured with the dial indicator there was none. That was the same result I got using the extra washer method --- but the problems mentioned earlier caused variations of about .010 inch so I didn't know for sure. A problem was suspected because the thrust washer had a groove worn in it. Also, remember that the thrust washer between the sun gear and planet carrier had been destroyed.

Closer examination of the trust washer and sun gear revealed that the bushing pressed into the sun gear was not flush with the top of the gear --- it stuck up at least .010 inches. This bushing has a steel outside and brass or bronze inside. The steel outside part had cut a groove in the thrust washer as shown in photo on right. An attempt was made to press the bushing in further --- wouldn't budge. The protruding part was then filed off smooth. (Photo is after it was filed.) The thrust washer groove was positioned away from the sun gear in the earlier measurements, which explains the lack of end float.

After filing off that ridge, everything was put together to measure the end float again ---- it was about .012 inches this time. Still a little short. There was no hurry this time (I was waiting for a motor to arrive for a test stand --- see next part) so the next size smaller adjustment washer was ordered. A replacement for the damaged thrust washer had been purchased when parts were ordered parts earlier. Unfortunately, I couldn't find the damn thing. Maybe the workshop cats ate it -- or the mice carried it off. The rough edge around the groove in the old washer was filed smooth and the washer was positioned with the groove against the adjustment washer --- should work fine. That new washer was found later and installed when other problems were encountered necessitating disassembly again as discussed Part IV.

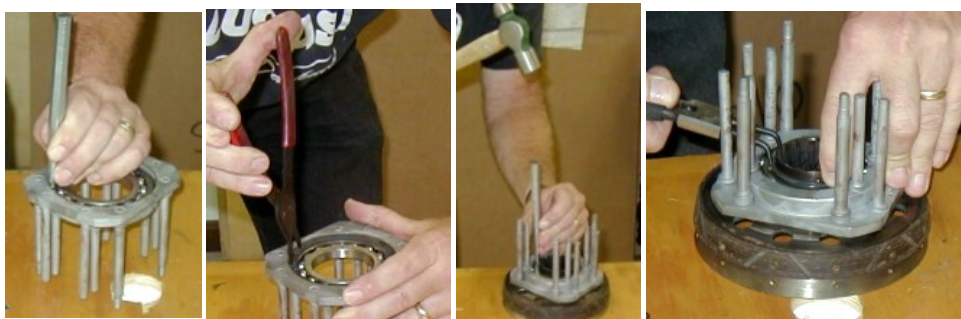
**Assembling the Sliding Clutch:** This job as illustrated in the photos below was fairly straightforward. The outer race was driven into the thrust ring and then the circlip installed. This circlip is a biggie and takes a lot of force to compress to get it into position. We made sure the circlip was fully seated. Next, the thrust ring with bearing was placed over the clutch sliding member and the inner race driven onto the sliding member. The final step was to install the inner race circlip. Fred Thomas (the young man who helped me get started powder coating) had his TR3 OD quit and when disassembled the only problem found was that the circlip had come out. It was reinstalled and the OD tested and found to work fine. Message: **make sure the circlips are seated!**
