A Type Overdrive, Part II - Disassembly

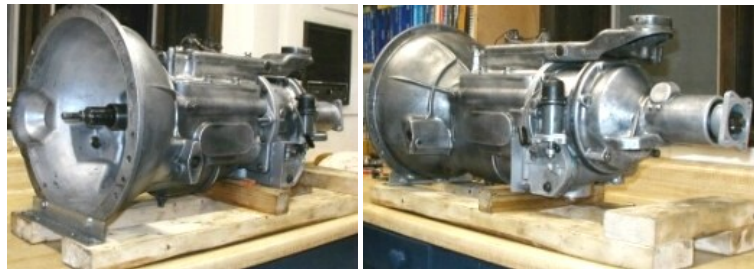
Gearbox Stand: I use a gearbox stand made from scrap pieces of 2X4, 2X2 and a short piece of steel angle as seen in the photos below. The gearbox bolts to the angle at the front. The 2X2 near the rear of the main gearbox casting has a shim tacked to the top to adjust the gearbox so that it is horizontal. The stand took about 30 minutes to make and proved its worth in about 15 minutes of use.

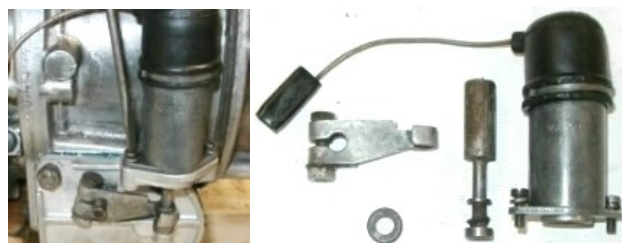
Remove the small parts: It's convenient to remove several small parts from the OD unit before detaching the OD from the gearbox, starting with the solenoid. The solenoid sticks up and makes a nice handle. Unfortunately, using it for a handle nearly always breaks the bracket to which it attaches. At ~\$75 per bracket, an expensive handle. (That small aluminum casting is known both as the solenoid bracket and the cover plate. The term cover plate is used from here on.) It's best to get the solenoid off and in a protected place first thing. The following photos show the solenoid attachment screws being removed (left). The solenoid, plunger, actuating lever and collar are then removed. When new there was a rubber boot around the end of the solenoid to prevent debris from entering the cylinder in which the plunger slides. The boots have long since cracked and fell off on most these old units. Replacement boots are not available so we do without. I've operated several without boots for about 15 years with no problems.

As parts are removed they are thoroughly cleaned and inspected. To keep track of the parts, associated groups of parts are placed in small zip lock plastic bags. For example, the parts in the lower right photo were put in the same bag.

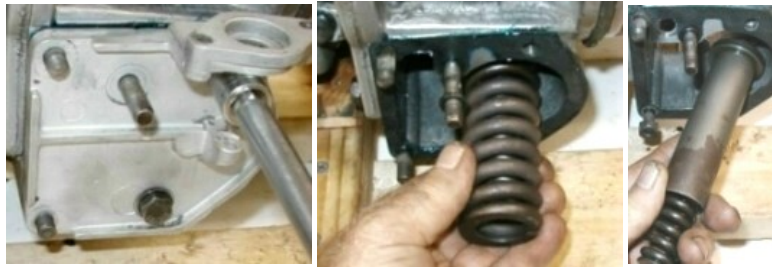
The cover that retains the humongous accumulator spring was removed next. It is secured by two bolts to the rear and two nuts on studs toward the front and must be removed properly so that it is not bent or distorted. **Caution, the operating valve must be operated and released a half dozen**

times using the lever or solenoid to relieve the pressure before removing the operating valve plug or the cover plate. The nuts on the studs on the forward side of the bracket were removed first. Then the two bolts were unscrewed alternately a little at a time such that the plate comes off relatively straight (left photo below). The center photo shows the spring of the early style accumulator being removed. There was a bunch of metal parts in the sump under the accumulator, including several little ball bearings, an ominous sign. The right photo shows the removal of the spring and spring tube from a later style accumulator. (Another OD was setting nearby that is a future project. The accumulator was pulled from it from it to show a comparison. Later on you'll find we borrowed some parts from it.)

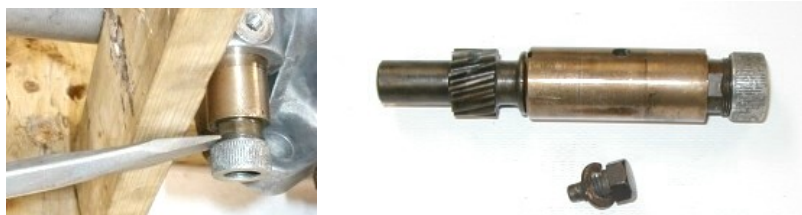
The speedometer bearing & pinion were removed next. This need be removed only if one plans to disassemble the rear casting to replace the two rear bearings. The retaining bolt was removed first, and then the nut from the end of an old speedometer cable was screwed onto the speedometer bearing and a large screwdriver was then used to pry against the lip of the speedometer nut to remove the bearing (left photo below). The parts in right photo were bagged together.

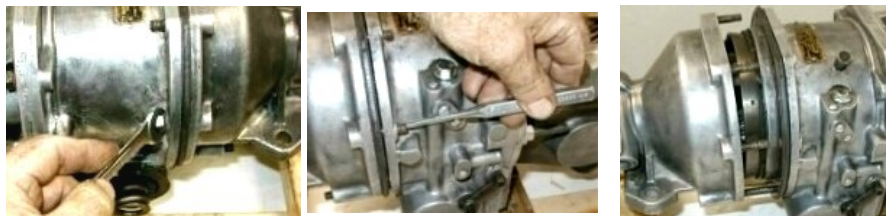
Removing the rear casting: I prefer to separate the rear casting from the main casting while the overdrive is still attached to the gearbox. Six studs hold the two castings together. The eight springs between the gearbox and the OD unit push against the annulus that helps separate the rear casting. This time, the castings didn't come apart when the nuts were removed. The ends of the studs were tapped with a punch to break the seal as shown in the middle photo below. The brake ring also came loose from the main casting so the hammer and punch were used to drive it back into the main casting. The brake ring can't be removed until the bridge pieces are removed from the thrust ring. The right photo shows the rear casting ready to slide off. Once the rear casting was off it was clear that the thrust bearing had failed --- more about that later.

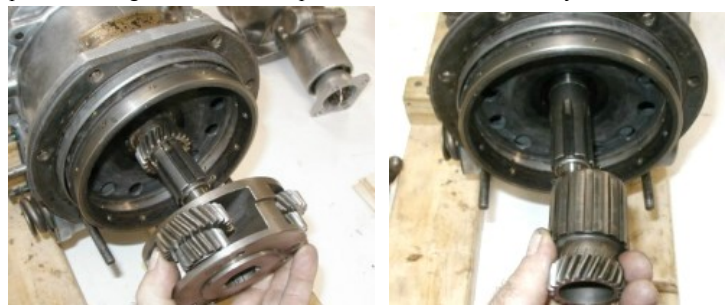
After the rear casting was removed, the planet carrier with planet gears and then the sun gear were removed as shown below. The planet carrier was cleaned and the bearings in each planet gear were tested by rotating the gears. All three gears rotated smoothly and there seemed to be no play in the bearings. It was decided that the planet bearings would not be replaced so it was not necessary to disassemble the planet carrier further.

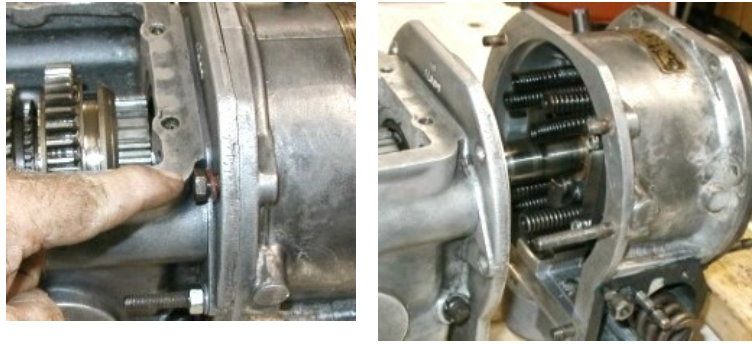
Removing Main Casting: The nuts and lock washers from the two bottom studs were removed first. Next, the nuts on the two top studs were loosened; these nuts can't be removed until the main casting is separated from the OD adaptor plate (left photo below). The nuts on the two long studs were then backed off a quarter inch or so. The casting didn't separate so I tapped it with a hammer and wood block. Once the casting separated, there was sufficient clearance to remove the nuts from the two top studs. The nuts on the two long studs were then backed off together to keep the main casting straight as the springs pushed it toward the rear. After the nuts were removed the casting was slid off. The eight springs were pulled out and bagged.

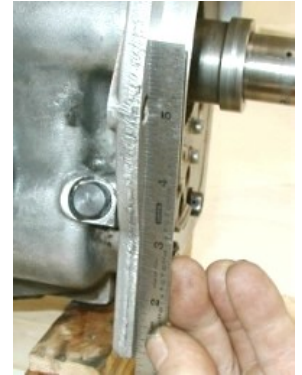
Adaptor: Before leaving the gearbox the adaptor plate surface that mates with the main casting was cleaned and a straightedge used to check to see if it was bent or bowed. If the OD had been previously forced onto the adaptor by tightening the nuts on the studs it is possible that the adaptor is distorted. This will lead to leaks. A severely bent or distorted adaptor can't be used. There have been reports of some success filling minor low spots with epoxy based fillers. The adaptor plate was OK.

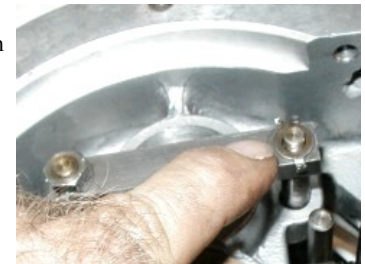
Removing Bridge Pieces: The nuts were removed from the bridge pieces next. These nuts were originally equipped with locking tabs. I prefer to not reuse these because the tabs usually break off after they have been bent once. These tabs are NA so both the tabs and nuts were discarded and replaced with 1/4-28 nyloc nuts. Once the four nuts were removed the bridge pieces were pulled off the thrust ring and the thrust ring was slid out the rear of the main casting. A bronze thrust washer and an adjustment washer were also removed from a recess behind the main shaft bushing in the main casting.

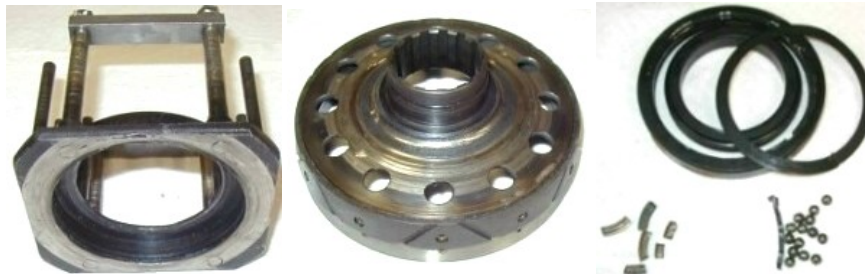
As mentioned earlier, a bit of a disaster was discovered when the OD was dismantled. The thrust bearing, that large bearing between the thrust ring and the clutch sliding member failed --- the balls fell out and the two parts separated. The eight springs then forced the thrust ring (doesn't rotate) into the rotating clutch sliding member. It must have made a hell of a racket. The left photo below shows the back side of the thrust ring where much of the metal has been worn off. The circlip retaining the bearing outer race was also damaged. The center photo shows the front side of the clutch sliding member where again, much of the metal has been worn off. The dark area indicates that it got very hot. The right photo shows the remains of the bearing. The pieces in the lower left hand corner of the right photo are the remains of the thrust washer between the sun gear and the planet carrier. It was decided to reuse the clutch sliding member since the clutch surfaces, the splines and the collar that mates with the bearing inner race were not damaged. The thrust ring was so heavily worn that the lip retaining the bearing outer race circlip was missing in some places. The thrust ring and circlips in addition to the destroyed thrust washer and bearing were replaced. Because some of these metal pieces were floating around the OD it was decided to also replace the two annulus bearings in the rear case.

Because this unit had a failure that ground some parts into unrecognizable bits that were scattered throughout the unit, the unit was completely disassembled except for the planet carrier and everything was inspected. The large bearings were replaced as well as the broken parts.

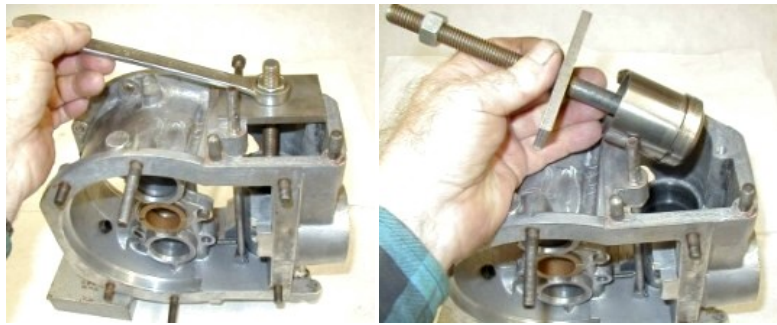
Removing Accumulator Piston: This OD was an early model with the Accumulator cylinder machined into the main casting. The center of the piston has a hole threaded 3/8-24 (this was previously reported as 5/16 -24 - thanks to Dan Shockey for the spotting the error). A puller was made by turning down the end of a 1/2 inch threaded rod (had a stack of these left over from a church project ten years ago) and then threading 3/8-24. A length of 3/8-24 threaded rod would have worked just as well. Not much force was required to remove the piston. The photos below show the puller in action. After the piston was removed, the rings and the cylinder walls were examined for defects. We were lucky; the metal pieces from the bearing failure didn't seem to have made it to the accumulator.

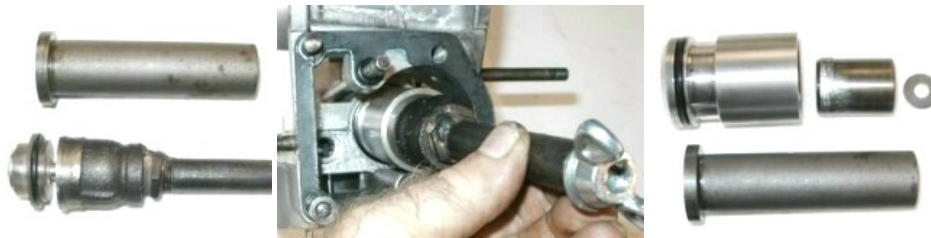
The photos below show removing the later style accumulator. An extraction tool that expands an O ring into the end of the accumulator piston housing where the spring tube fits was fabricated. The tool and spring tube are shown in the left photo below. The O ring and tool outside diameter is 1.5 inches. The inner diameter of the end piece is 1.25 inches, the ID of the O ring. A 3/8 inch bolt extends the length of the tool. Tightening the wing nut pulls the end cap into the main piece and squeezes the O ring out to grasp the accumulator piston housing. Both the tool body and wing nut had to be grasped with pliers to tighten the nut sufficiently to grasp the housing. In the process, the plastic end piece cracked. (Next time I'll make the end piece of steel or aluminum). Once the housing was removed, the piston was easily pressed out the top of the housing. Everything was in order and no problems found. One interesting note, the washer in the right photo is a low quality hardware store type, obviously added well after manufacture. Putting a washer behind the spring is the accepted way to increase the accumulator pressure.

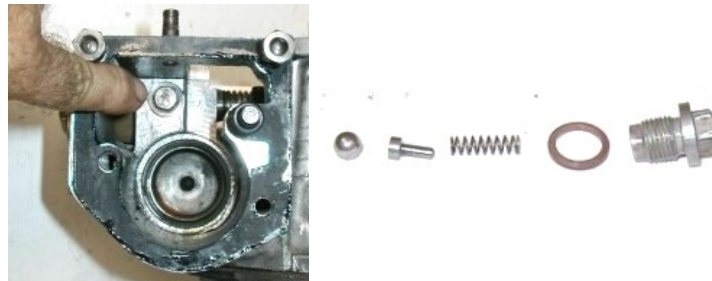
Removing Non-Return Valve: The pump non-return valve is located beside the accumulator cylinder as shown in the left photo below. After the plug was removed the spring, plunger washer, and ball were removed, cleaned, inspected and stored (right photo).

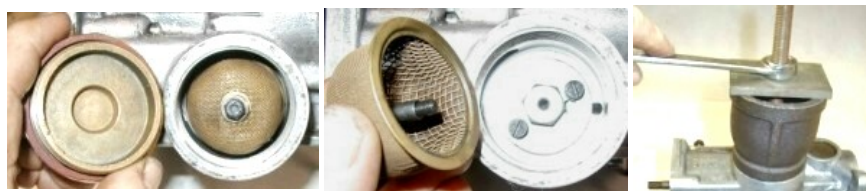
Removing Pump: The drain plug and screen filter must be removed to expose the pump. The photos below were taken after the gearbox had been cleaned up. Much of the oil evaporated from the heat generated when the bearing failed. The outside of the screen was covered by black goo mixed with metal parts. (The later models use a larger plug and the screen is retained by the plug rather than the screw as shown in photos below.)

The pump is pressed into the case and requires quite a bit of force to remove. **Caution - the non-return valve must be removed before the pump body is extracted.** The two screws and plug shown in the middle photo below were removed first. A threaded rod screwed into plug hole was then used to pull the pump body. The threads are 7/16-20. The end of another one of those 1/2 threaded rods was turned down and threaded to make a puller --- right photo below. A length of 7/16-20 threaded rod would have worked just as well. A pipe fitting was used to provide a space to draw the pump into. The pump body came right out as the nut was tightened.

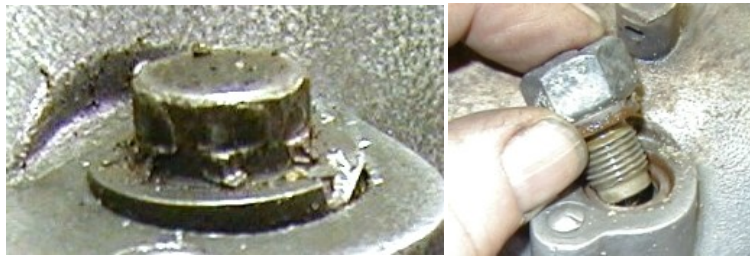
Removing Operating Valve: The last thing removed from the main casting was the operating valve. The valve plug is on the upper right-hand side of the casting. Unfortunately, the corners on the hex head of the plug had been rounded. A six point socket was tried first, and it slipped. There was no room to get another type of wrench on it. A 1/2 inch nut was driven over the top of the plug and welded. The nut and plug were then removed together. The plug with the large nut attached is shown at the right.

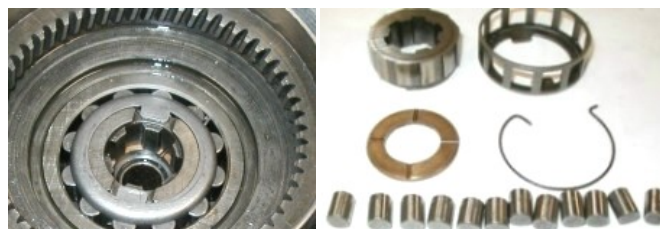
Removing Unidirectional Clutch: The unidirectional clutch sets in a recess in the large end of the annulus in the rear casting (left photo). It is removed by rotating the center part counterclockwise and lifting up. The rollers came out of the cage so then we had a bunch of pieces as shown in photo on right below. The bronze thrust washer is located behind the clutch.

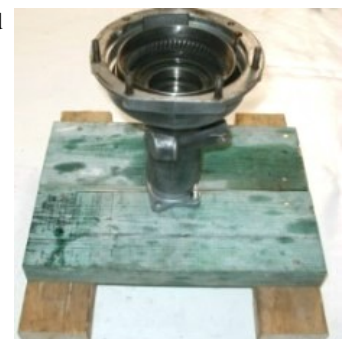
OD Stand: A stable base to hold the OD on end during reassembly is very useful. The old piece of 2X12 used previously had disappeared so the new stand shown on the right was made from scrap lumber. A 1 1/2 inch hole in the center provides clearance for the end of the annulus shaft and nut. Two 3/8 inch holes provide for bolts to hold the rear flange.

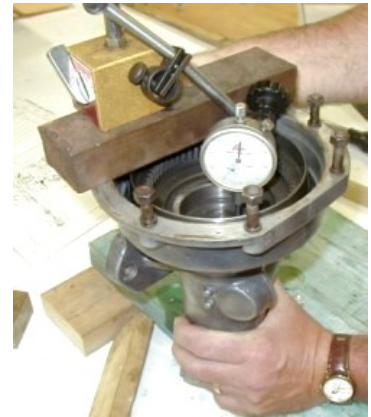
Annulus End Float: The annulus end float was measured before the rear casting was disassembled. The end float is adjusted by changing the adjusting washer between the rear bearing and a shoulder on the annulus shaft. If the end float is within spec before disassembly, then it should be within spec even if new bearings are installed because the bearings are made to a very close tolerance.

The rear casting was secured to the stand and a dial indicator was positioned as shown with the point against the annulus. The casting was then pushed down for the first reading. The second reading is taken after the casting has been pulled up by placing one hand on each side the top of the casting and pulling up while pushing down on thumbs pressing against the outside of the annulus. The required end float is .005 to .010 inches. If the end float is out of spec, refer to the discussion near the beginning of Part III. This end float was right on .005 inches.

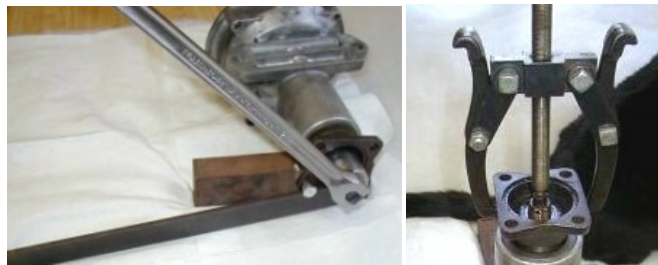
Rear Flange Removal: A "flange removal tool" made from a two foot length of 1/4 inch by 1 1/4 inch steel bar (a 1 inch bar will probably work as well) is used to hold the flange when removing the nut. A 3/8 inch hole is drilled close to the edge near the end for attachment to the rear flange. A second bolt is installed in the flange to rest against the edge of the tool to keep the flange from turning as shown in left photo below. This bar is also a "flange installation" tool. It can also be attached to the flywheel using one of the clutch pressure plate bolts to become a "flywheel removal or installation tool". The cotter pin was removed from the flange nut and then a breaker bar was used with the tool to loosen the nut.

A puller was used to remove the flange as shown in the right photo. The black object is one of the cats that live in the workshop. This is the dumb one; she is so dumb her fur should be blonde.

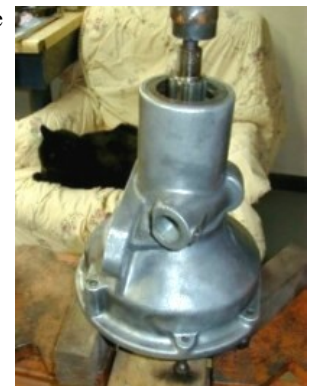
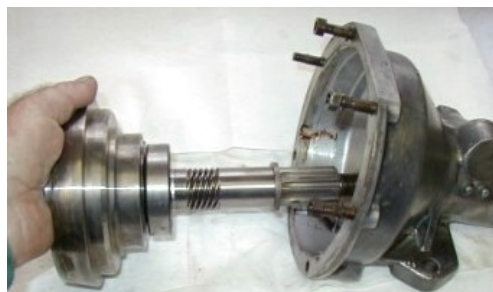
Removing the Annulus: The annulus was pressed out of the rear casting using the hydraulic press as shown on the right. The sides of the casting were blocked up off the press cross members. A scrap piece of 2X4 was placed under the casting to stop the annulus from slamming into the steel press cross member if it came loose with some velocity. This was a well behaved annulus that came out gently with minimum force applied. The annulus is shown in the photo below. The middle bearing must still be removed from the annulus shaft.

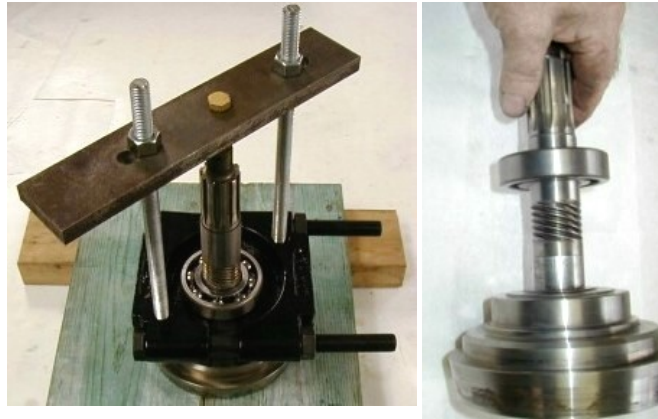
Middle Bearing removal: This bearing is also known as the annulus head bearing. A large bearing separator (available from Harbor Freight, ~\$20) was used to first push the bearing away from the shoulder on the annulus by tightening the two black bolts in the left photo below. Next, the bearing was pulled along the shaft by tightening the nuts on the threaded rods. The right photo shows the bearing nearly off the shaft. The press fit is only on the shiny section very near the shoulder.

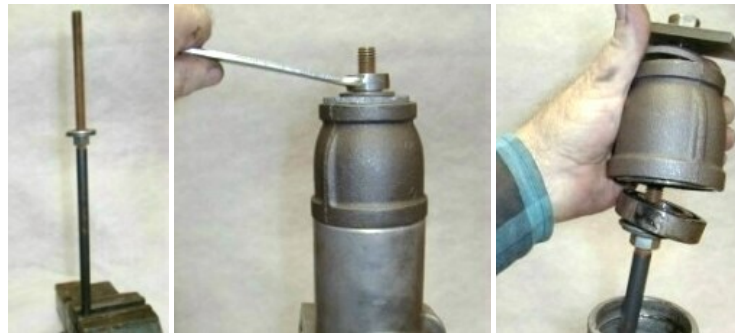
Rear Bearing & Seal Removal: A length of threaded rod, some washers and spacers were used to pull the rear bearing (aka annulus tail bearing) and seal from the rear casting. This is the same stuff used to press rear bearings and seals out of the gearbox extension of non OD gearboxes. The rod was secured in the vise as shown on the left. The rear casing and then a spacer and washer were slid over the rod and a nut threaded on and tightened. The lower washer on the rod pressed against the under side of the rear bearing. As the nut was tightened, the spacer pushed the casting down off the bearing. The freed bearing is shown on the right. The rear seal has been pushed up into the spacer; the bottom edge of the seal is visible.

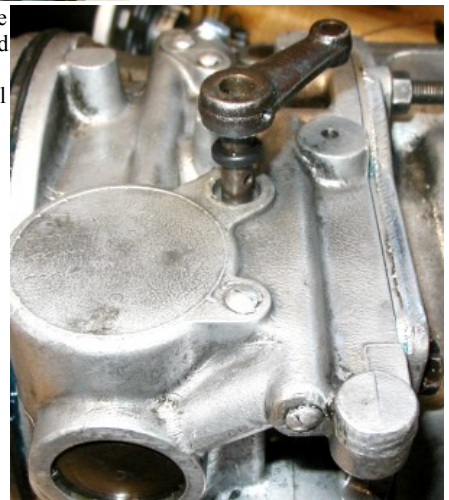
Setting Lever O Ring: There is a small O Ring behind the setting lever on the right hand side of the main casting. The lever must be removed to get at the O Ring. The lever on the later units is secured by what the Brits call a spring dowel (roll, tension or expansion pin in the US) that can be easily driven out with a suitable size punch. The earlier units as that shown on the right have a solid dowel pin. I drilled it out using a sequence of 5/64 - 3/32 - 7/64 drills. The holes are 1/8 inch. The photo shows the lever pulled to the end of the shaft and the O ring pulled out of the recess. I used a sharp scribe to pry the O ring out of the recess. The lever was pulled off, a new O ring slid into position and the lever reinstalled and secured with a 1/8 inch tension pin. The tension pin on the later units seems to be a little smaller, possibly 3/32 inch. I'll update this when I take one of those apart next time. This section was added on 10-9-01 after Mike Kitchener mentioned that these O rings were missing from the parts list. I then realized that hadn't replaced the O ring under the lever on the unit described here. The battery was dead on the hand drill when I first took it apart, so I deferred it and then forgot. I replaced it today on the fully assembled unit --- no problem.

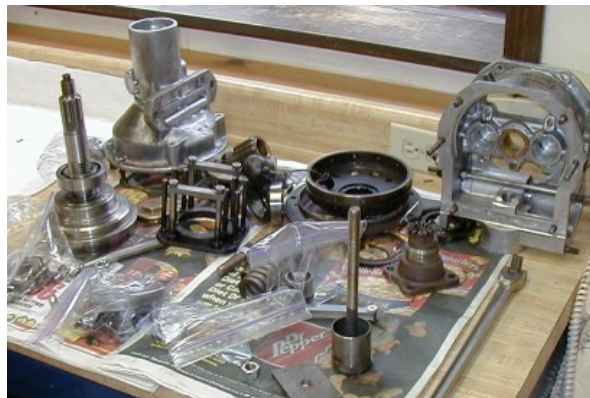
All the parts: The photo below shows all the parts extracted from the OD unit after they had been cleaned up and packed with associated components.
