Gearbox Overhaul - Part 2

Gearbox Overhaul

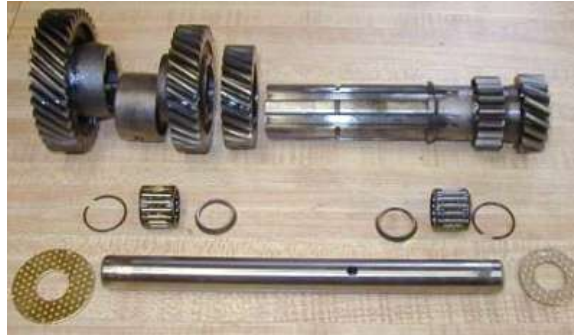
The shafts were checked and reassembled in Part 1. This time everything is put back together. The last thing we did was to install new bearings in the end of the reverse-first speed countershaft gear. The countershaft components are shown in the next photo as a refresher.

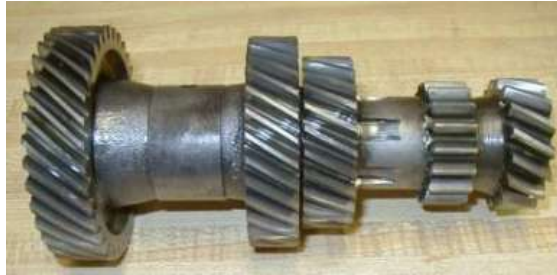
The first thing is to slip the three larger gears and distance piece onto the splines of the reverse-first speed gear. The assembled unit is shown in the next photo.

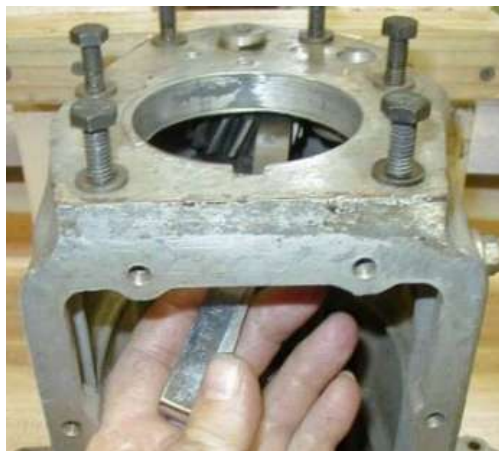
The gears and washer were removed. The surfaces of the case behind the thrust washers were inspected and found to be very rough --- the front one looked like a woodpecker (or in this case an aluminum pecker) had worked on it. It appeared that it had been intentionally roughed up with a sharp punch --- maybe to reduce end float. Both ends were smoothed with a file. The front washer and gears were installed again. This time it was possible to position the rear thrust washer. The countershaft was inserted next and the gears were checked to make sure they turned freely. The end float was then measured between the rear gear and the thrust washer (see photo) and found to be insufficient. The rear thrust washer was then removed and the thickness reduced a few thousandths by first holding the steel back against the side of a grinding wheel and then leveling it off with a file. This brought the end float into specs.

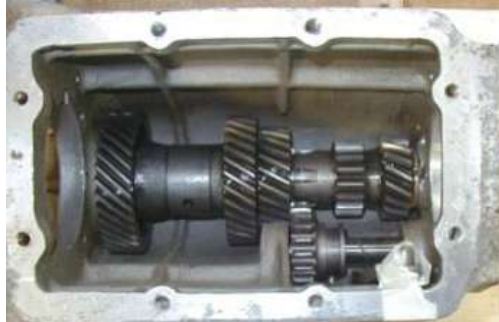
The end of the shaft is wrapped with masking tape to prevent it from moving too far forward during the assembly process. The next photo shows the interior of the gearbox at this point. The masking tape on the reverse operating lever holds the reverse idler gear as far forward as possible to keep it out of the way during the rest of the assembly process. The countershaft is then removed so that the countershaft gears drop to the bottom of the case to provide clearance to install the mainshaft.

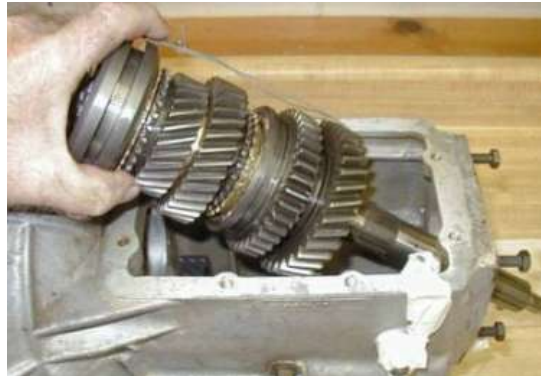
Next, the mainshaft with gears is inserted into the case through the top opening as shown in following photo. The wire is removed after the shaft is in position.

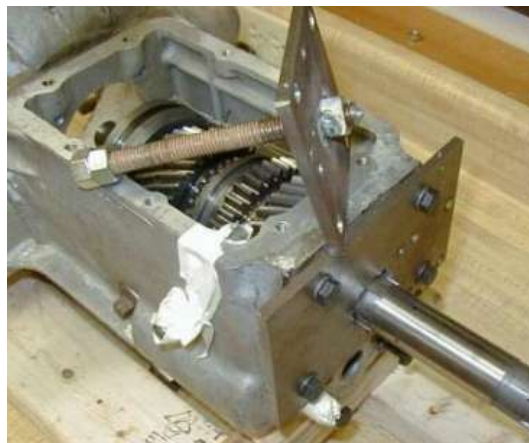
The center mainshaft bearing is now slid onto the mainshaft and driven into the rear of the case. The bearing should move freely on the mainshaft because the mating surface is pulled forward into the case. The bearing is driven into position using a punch on the outer race. Light whacks distributed around the bearing assure that it goes in square. Next, a plate drilled to match the bolts that secure the rear extension and with a hole for the mainshaft is bolted into position to hold the bearing in place. This plate and bolts could be used to press the bearing into case. That is not a good idea ---- a large force should not be exerted on a steel bolt being screwed into an aluminum case ----- it will cause excessive wear on the aluminum. The next photo shows the plate in position at the rear of the case.

The plate with threaded rod (another of those 1/2 inch rods left over from the church project) setting on top the case is used to press the mainshaft into the center bearing. The plate is bolted onto the front of the case using the front cover bolts. The rod is then screwed in so that it engages the center hole in the front of the mainshaft. At this point the first and second speed synchro cups are checked to make sure they are engaging the synchro hub assembly properly. The mainshaft is then pressed into the center bearing by slowly screwing in the threaded rod. The gears should be checked frequently to make sure that they are not in contact with anything and move freely. After the mainshaft is in position, the plates are removed and the washer and circlip to the rear of the bearing are installed. The final step for the mainshaft is to install the tool used to press the mainshaft out of the center bearing (see disassembly article) and press the mainshaft forward slightly so that the bearing rests snugly against the rear washer and circlip. This is necessary to make sure that the rear bushing end float measured previously is still there.

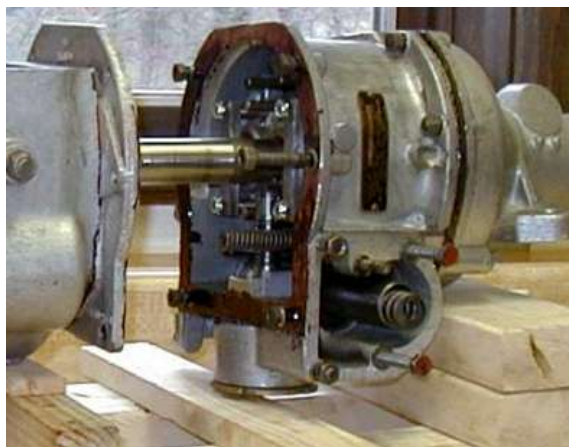
The next photo shows the OD unit in the mating position. Note the use of a gearbox stand to hold everything in position. This stand made the gearbox assembly much easier. The blocks under the OD position it at the correct height to engage the mainshaft. This photo was taken before all springs were placed on the studs in the OD unit. The unit slid into position on the first try. The unit was drawn onto the mainshaft by carefully tightening the nuts on the two longer studs while simultaneously rotating the rear flange back and forth slightly. The mainshaft splines engaged the grooves in the OD unit without difficulty. The whole process including adding nuts and lock washers to the four short studs and tightening all to the proper torque took less than 10 minutes.

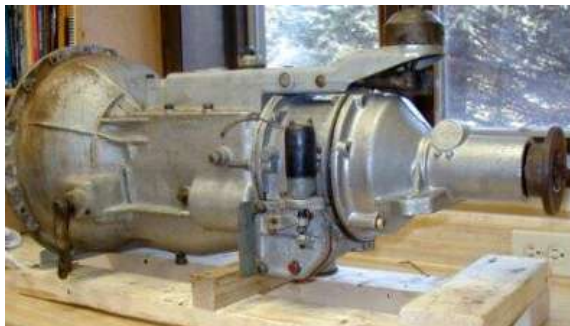
The previous photo shows the assembled gearbox. The only thing missing is a couple switches in the top cover and the wiring harnesses for the backup light and for the OD solenoid. They're around here someplace --- unless the spouse threw them out.

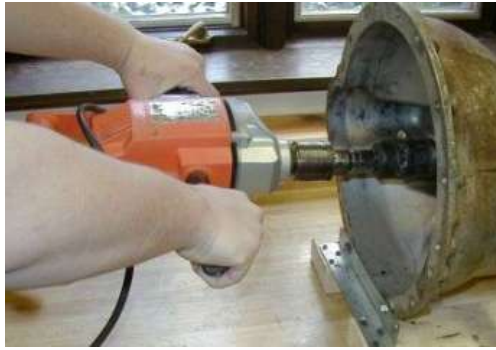
Next, an adapter was fabricated that attaches to the input shaft so that a half-inch drill can be used to spin the gearbox. The next photo shows Ryan winding up the gearbox. The OD was tested to make sure it worked (it did) and to also checked for unusual noises, etc. The final thing to check was the OD solenoid. This required dragging a battery to the workshop. This test was also successful.

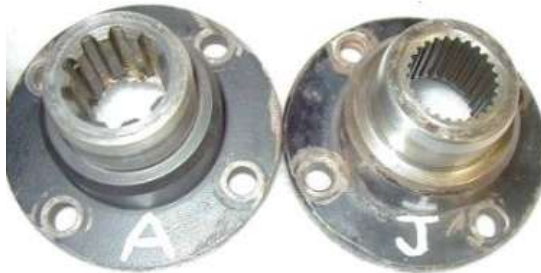
I labeled this flange with a J so I wouldn't mix it up with the flange from the A type OD that I labeled with an A. After looking at them together it was clear that I wouldn't get them reversed – see next photo.

All dimensions of the two flanges were measured and found to be identical except for the inside that mates with the shaft. The parts of the cases that mate with the outside of the seal were also found to be identical. There was a small difference in the distance from the back lip of the case to the backside of the shaft bearing but not enough to make any difference with the seals. The flange off the non-OD gearbox was then examined found it to be identical to the flange from the A type OD.

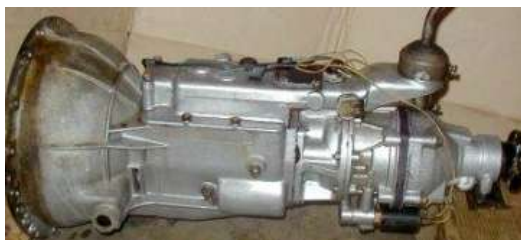
Working on both types of OD units at the same time brought to mind the different mounting arrangements. The non-overdrive gearbox and the A type OD units use the same rear mounting. The design of the J type overdrive is somewhat different. There is a three-inch long adapter attached to the front of the main part of the J type OD. I think this was done so the OD could be self-contained with the 8 springs inside. The OD unit was probably shipped with the adapter installed so the mechanic wouldn't have to fool with the springs and the possibility of springs getting lost. The following photo shows a gearbox with a J type OD that can be compared with earlier photos of the A type OD.

Moving the main part of the OD unit 3 inches to the rear required a different rear mounting arrangement. The change was made in 1973 when the J type was introduced. Different brackets welded to the frame allow a new gearbox mount cross member (#61 in following sketch from Moss catalog) to be mounted in a forward position for a regular gearbox or A type OD and in a rear position for the J type OD. There is a bracket (#60) that is also used with the gearbox mounting adapter (#59) for non OD gearboxes and A type ODs. The gearbox mounting adapter attaches directly to the J type OD and is shown in position just ahead of the rear flange in the previous photo.
