J Type Overdrive (TR6), Part II - Disassembly

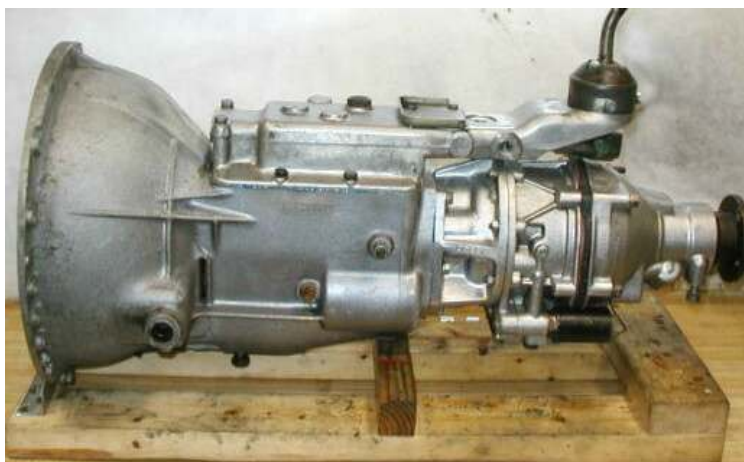
Gearbox Stand: I use a gearbox stand made from scrap pieces of 2X4, 2X2 and a short piece of steel angle as seen in the photos below. The gearbox bolts to the angle at the front. The 2X2 near the rear of the main gearbox casting has a shim tacked to the top to adjust the gearbox so that it is horizontal. The stand took about 30 minutes to make and proved its worth in about 15 minutes of use.

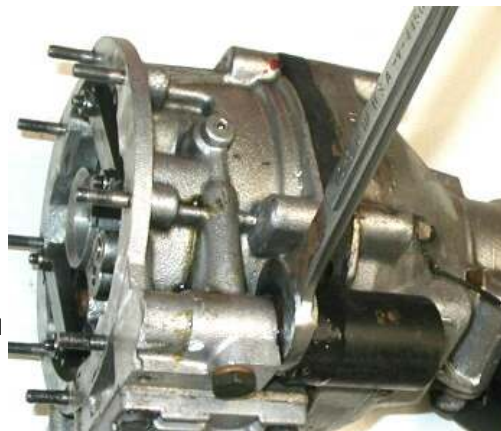
Removing the solenoid: The solenoid with operating valve should be removed before breaking apart the castings. This requires a thin 1 inch open end wrench. I had neither a thin nor a 1-inch wrench. I did however have a 22 mm wrench with no know application. A little work on the grinder and the 22 mm became a 1- inch opening and after a little more work, it was the exact thickness to just slide into position. The photo on right shows the wrench in action.

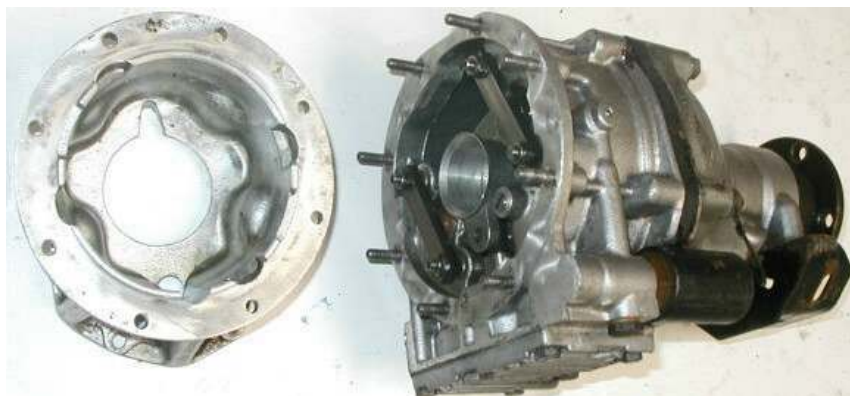
Adaptor Casting: The adaptor casting that goes between the OD and the gearbox had been removed when I brought the parts home -- the adaptor is on the left in the photo below.

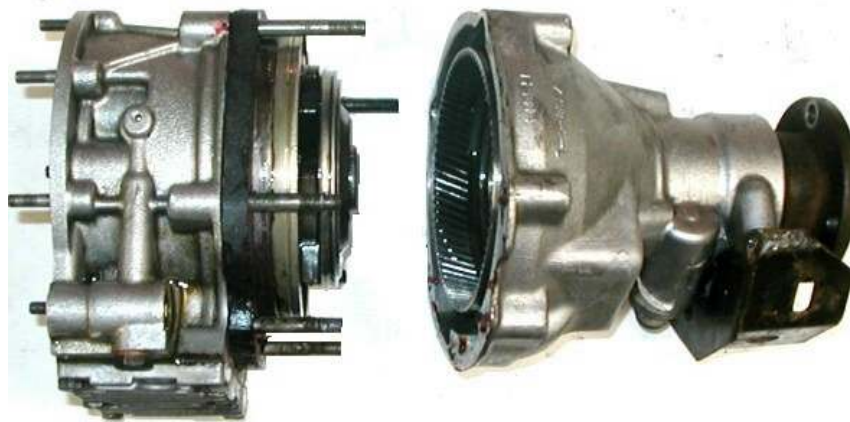
Splitting the castings: The next step was to spilt the rear and main casting. The 8 nuts were removed from the studs. A wood block was then placed against the lower part of the main casting and tapped with a hammer to loosen the seal. The black colored brake ring between the castings must come off with the main casting because it won't slide over the sliding clutch. In this case, the brake ring wanted to stay attached to the rear casting. There are little notches in the brake ring casting in the same area as the solenoid (already removed) that a punch can be positioned against. A couple taps with a hammer on a punch freed the brake ring from the rear casting.

The photo above shows the separated castings. The planet carrier with planet gears came off with the main casting and sun gear. It was held there by friction between the sun gear and planet gear teeth. In some cases it might stay in the annulus. Care should be taken that it not fall off the bench

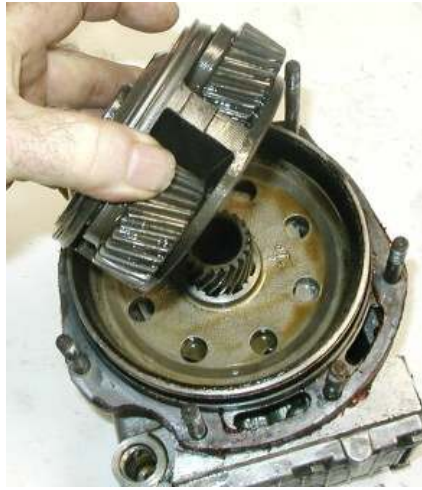
and break a few (gear) teeth or a few toes (on your foot). The photo on the right shows removing the planet carrier from the sun gear. The sun gear is retained in the sliding clutch with a circlip. The clutch is held to the thrust ring by the thrust bearing. The thrust ring is held to the main casting by the bridge pieces. Both the main casting and planet carrier were set aside for later attention.

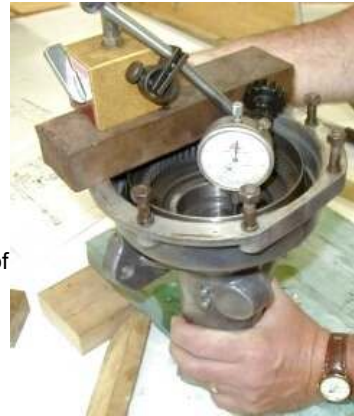
Before taking the rear casting apart I did a couple tests on the bearings. First, I checked the end float using the same technique used on the A type OD where the end float must be adjusted using various size washers. End float adjustment is not required here because the parts (especially the rear casting) are machined to closer tolerances. The end float test in this case was to see if the bearings were worn and loose. The photo on the right shows the setup to test annulus end float on an A type OD; the setup for the J type is the same. The dial indicator rests on the lips of the rear casting with the point near the center of the annulus. The case is then grasped on each side with the hands and lifting while using thumbs to pushing down on the annulus. In this case an end float of 0.006" was measured. I don't have specs for the end float but guess that 0.005" to 0.010" specified for the A type is OK here. Less end float indicates that there is something wrong with the bearing position and shims may be required. See the A OD notes Part III for more information on adjusting this end float. An end float greater than 0.010" indicates bearing slop and the bearings should be replaced.

I tested the bearings carefully and found everything seemed smooth and no unusual sounds were heard. This together with the good end float measurement indicated to me that the annulus bearings were good.

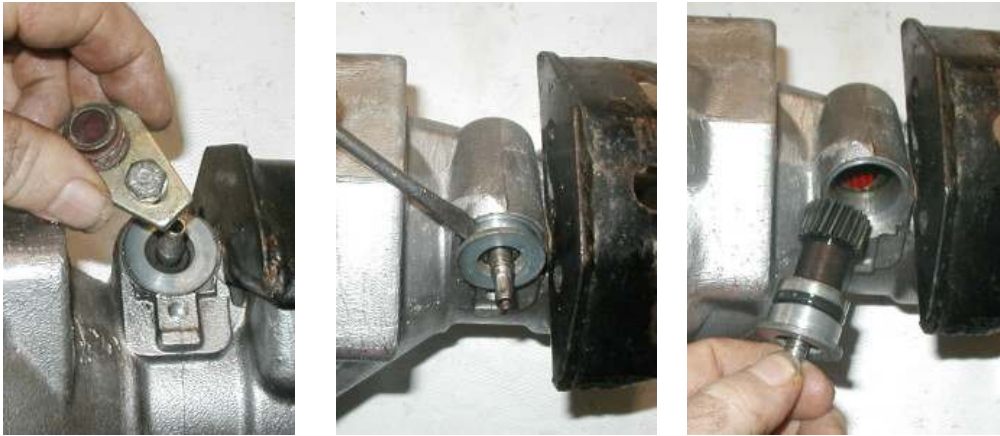
Speedometer gear: After the screw securing the speedometer cable connector was removed, the connector, bushing and driven gear were removed as shown in the following photos. As parts were removed they were thoroughly cleaned and inspected. To keep track of the parts, associated groups of parts were placed in small zip lock plastic bags.

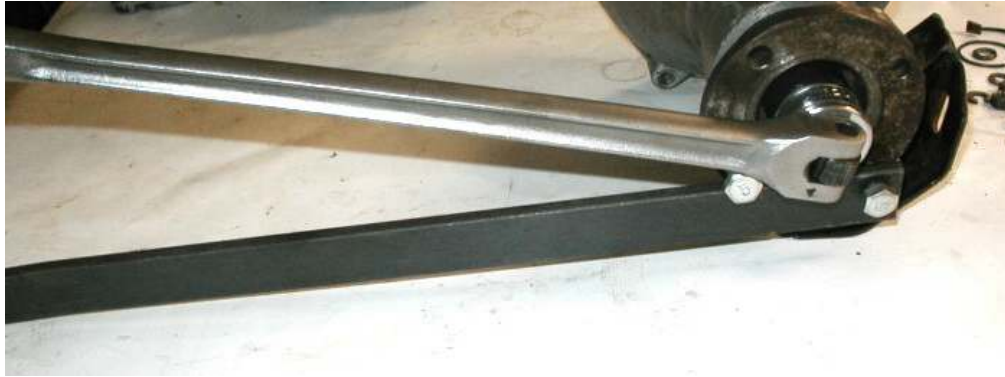
Rear Flange: The instructions say use a RG 421 tool to retain the flange. Looked in the toolbox and couldn't find anything labeled RG 421. I did however have a long flat steel bar with a 5/16 hole drilled in the end --- just the ticket. After the nut was removed, the flange slid right off.

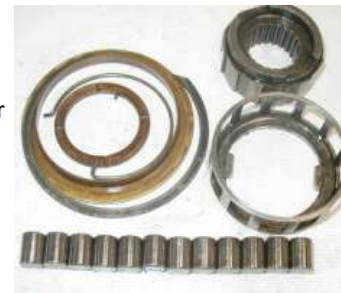
Unidirectional Clutch: The circlip retaining the unidirectional clutch was lifted out with a screwdriver. The unidirectional clutch parts are shown in the right photo. The small brass washer in the middle is a thrust washer that fits behind the unidirectional clutch. There is a small mainshaft support bushing pressed into the hole in the annulus behind the unidirectional clutch. The bushing was in good shape so it wasn't removed.

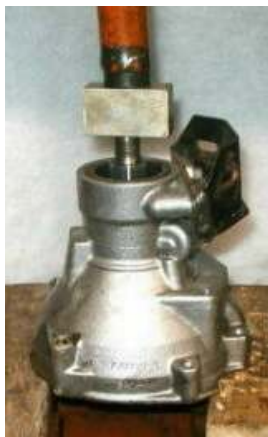
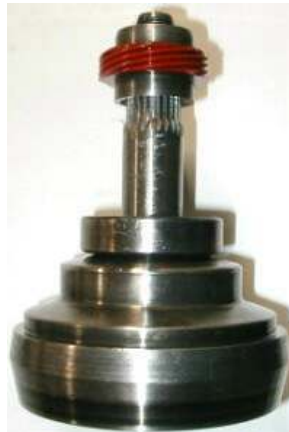
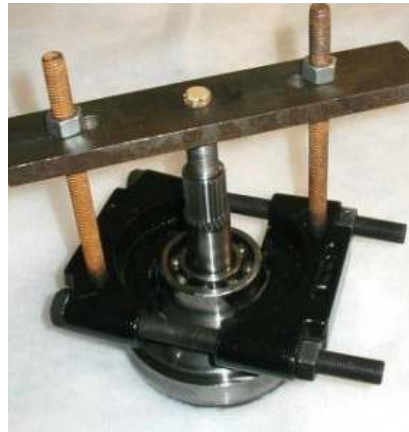
Annulus: The annulus is easily pressed out using a hydraulic press (left photo). The center photo shows the speedometer drive gear. The plastic gear is fastened to the steel sleeve that also serves as a spacer between the inner races of the two annulus bearings. The front annulus bearing was removed using a bearing separator (~\$15 @ Harbor Freight) and part of a puller fabricated to remove the gearbox rear casting --- see gearbox overhaul notes.

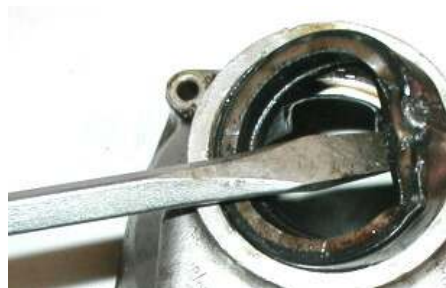
Rear Seal: I don't know an easy way to pull the rear oil seal. The best way I've found is to use a hammer and chisel to deform the seal enough so that it can be pried out with a screwdriver as shown on the right. The rear annulus bearing left in the casting when the annulus was pressed out can be removed after the rear seal is out. I tapped the bearing out from the inside of the case using a long pin punch on the outer race.

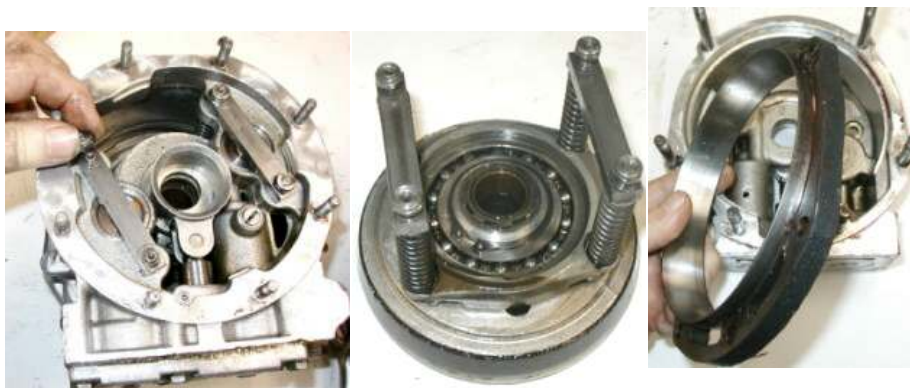
Bridges, Thrust Ring with Clutch & Brake Ring: The four nuts retaining the bridge pieces were removed (left photo below) and then bridge pieces were pulled off. The sliding clutch with thrust ring and release springs was then drawn out the rear of the casting. I put the bridge pieces and nuts back on the thrust ring so that the parts aren't separated (center photo). The brake ring was then pulled off the back of the main casting.

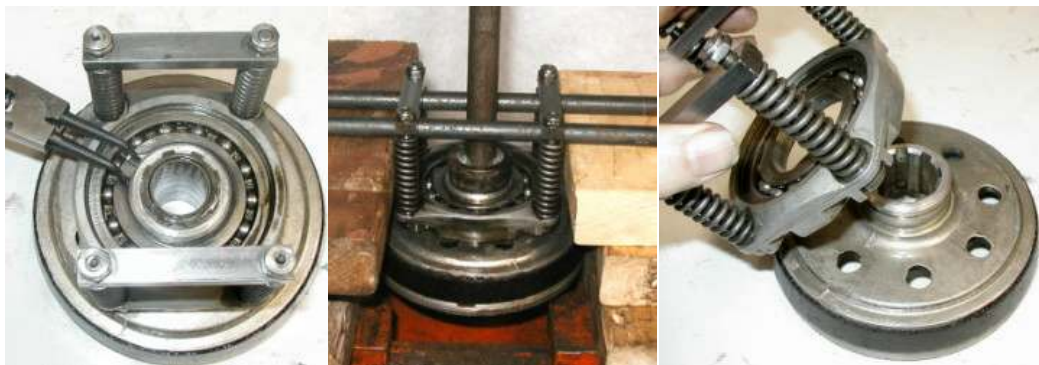
Separating Clutch from Thrust Ring: The sliding clutch should be removed from the thrust ring only if the thrust bearing and/or sliding clutch is being replaced. I tested the bearing before taking it apart. The bearing was first tested for looseness; no problem, the bearing turned smooth and no slack was detected. I decided to take the bearing out anyway so that I could show how it is done.

The sliding clutch is pressed into the thrust bearing and retained by a circlip. The circlip was removed first (left photo). Next, the clutch must be separated from the thrust bearing. I tried the large bearing separator used on the annulus bearing earlier. It is about 20% too small and I didn't have ready access to a larger one. I then supported the bridge pieces with 1/2-inch rods on 2X4 blocks in the hydraulic press and used it to press out the clutch. This worked --- see center photo. The separated parts are shown in the right photo.

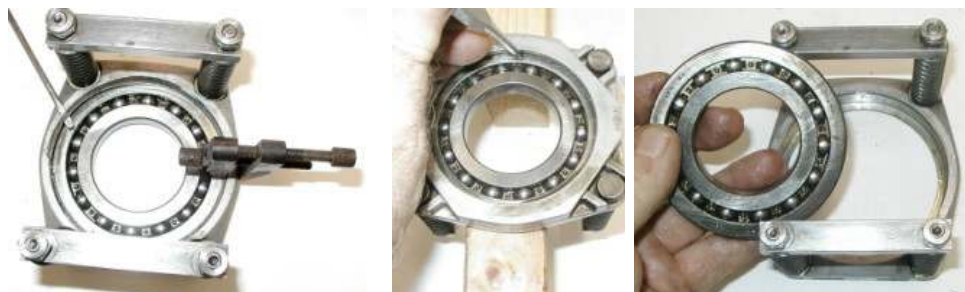
Removing Thrust Bearing: The thrust bearing is removed from the thrust ring only if it is to be replaced. The first task is to remove the circlip retaining the bearing. First attempts at this task drew a few choice words. The end of the clip is beveled so that one can slip a screwdriver under the point of the bevel and pry the clip out. Unfortunately, when just enough force is applied to lift the end of the circlip, it slides around the groove and off the end of the screwdriver. A third hand was needed. Considered asking the wife, but she'd expect me to reciprocate with a small job for her, like shoveling the snow off the driveway. (Should have asked for her help; had to clean the driveway anyway.) The solution was to secure the ring with a small machinist clamp; it was then easy to lift one end of the clip and slide a small screwdriver under the clip (left photo below). The next task was to remove the bearing from the thrust ring. I set the outer edge of the thrust ring on two 2X4 scraps that were positioned on edge and then used a pin punch against the outer race to drive out the bearing (center photo). The separated parts are shown in right photo. These parts were cleaned up and set aside.

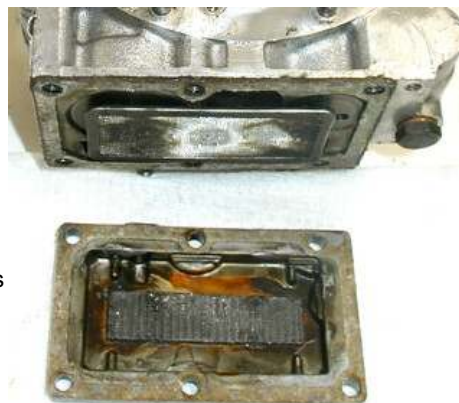
Sump Cover & Suction Filter: Next, the eight bolts retaining the sump cover to the main casting were removed and the sump cover pried off. The suction filter was then slipped out of the pump input channel. The filter and magnetic strip affixed to the bottom of the sump cover were inspected for signs of metal. There were just some small particles, not the chips I found in my OD that had been driven for many miles after the rear countershaft bearing in the gearbox had failed. The gasket material was cleaned off the cover and both the cover and filter were cleaned thoroughly. There was quite a bit of thick sludge on the magnetic strip. These parts were then set aside.

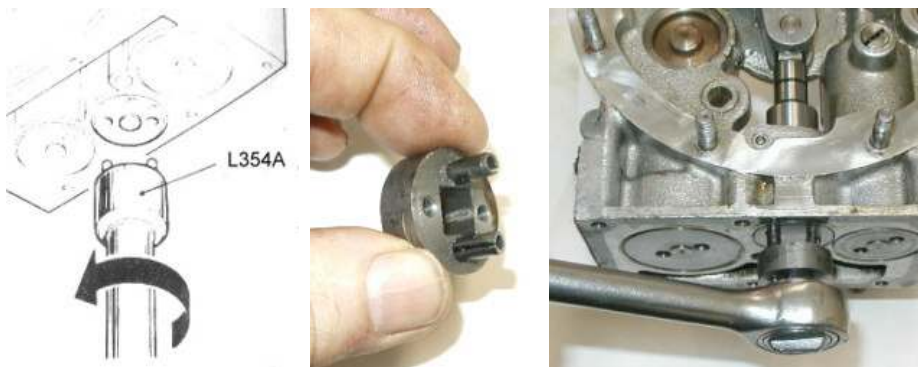
L354ATool: The next step was to remove the hydraulic components from the bottom of the main casting that are secured with plugs. The plugs have two holes that mate with two prongs on tool L354A. The plugs are unscrewed by rotating the L354A as shown in the left photo below. I didn't happen to have a L354A so I made the substitute shown in the middle photo below. I used roll pins for the prongs. The extra holes were an error --- forgot to measure twice and drill once so I measured once and drilled once, then measured again and drilled again. Didn't have any drills that made square holes, no broaches either, so it was round hole and file. The hole mates with a 3/8" drive ratchet as shown in the right photo.

Pump: The right photo above shows removing the pump plug. This plug was much tighter than the other two plugs. The casting had to be held securely to break the plug loose. The piston and cam combination was removed after the plug was removed (it can be removed before too). I pushed the pump body out from the top with a finger as shown on the left below.

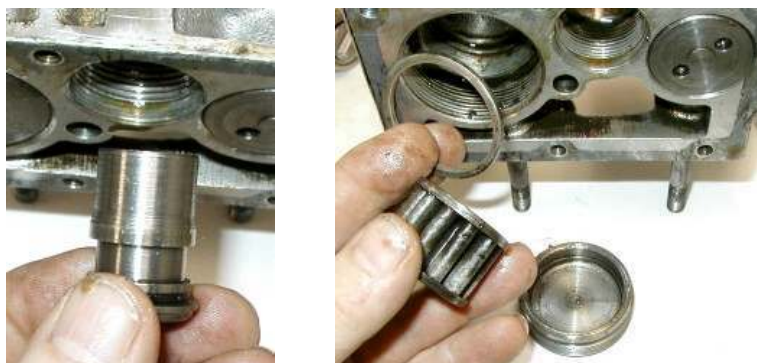
High Pressure Filter: The high pressure filter with washer drop out after the large plug is removed -- right photo below.

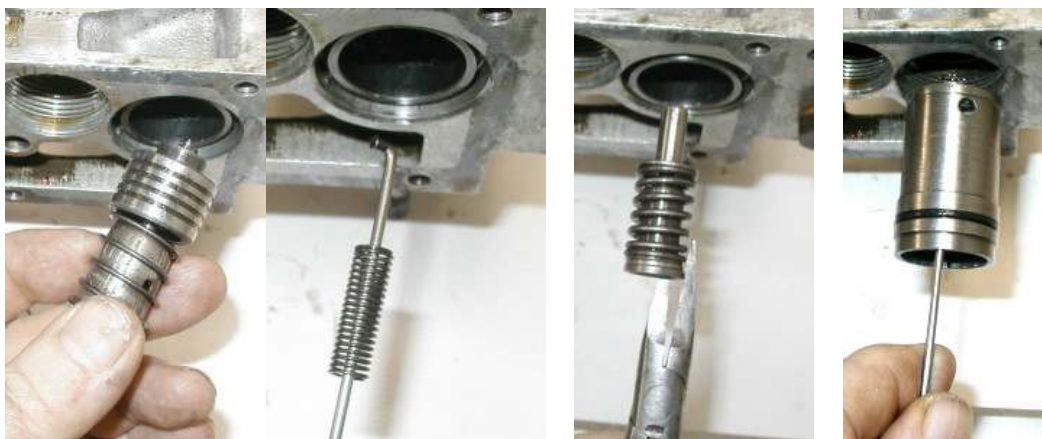
Relief Valve: The dashpot piston slides out easily after the valve plug as been removed, left photo above. The center photos above show removing the residual spring with a hooked wire and the valve with pliers. The dashpot sleeve is removed by slipping the hook at the end of the wire through the little hole.

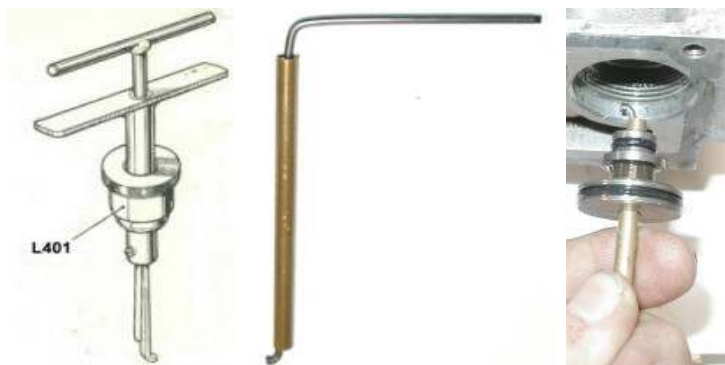
Tool L401 is designed to remove the valve body at the very bottom of the valve chamber. I didn't have a L401 so I made an extracting tool using a piece of 1/4" OD brass tube and 3/32" stiff wire, both available from hobby stores, center photo below. The wire is the same one used to remove the residual spring and sleeve above. The valve body slides out rather easily as long it as is straight. If it tilts it binds and can't be withdrawn. The brass tube slides into the hole in the valve body to keep it straight. The hook at the end of the wire goes over the top lip of the valve body. Care must be taken to keep the hook from scratching the inside of the valve body. After the tool was in position, I grasped the end of the tube with one hand and pushed the end of the wire toward the casting. That forced the hooked end to the side of the tube and securely hooked it over the valve body lip. The tube was then withdraw, bringing the valve body with it as shown in right photo below.

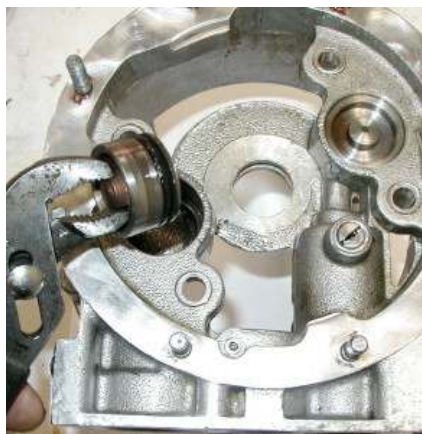
Pistons: The pistons were pulled out easily using pliers as shown on the right.
