## J Type Overdrive, Part III - Reassembly

Everything was disassembled and cleaned and the parts needed for the rebuild were determined in Part II. The reassembly is described in this part. The annulus was installed in the rear casting first. The clutches and epicyclic gears were dealt with next. The final steps were to reassemble the hydraulic components in the main casting and then mate the main casting to the rear casting.

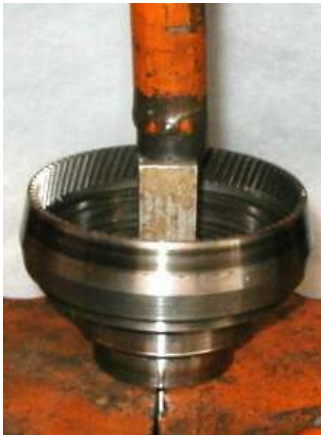
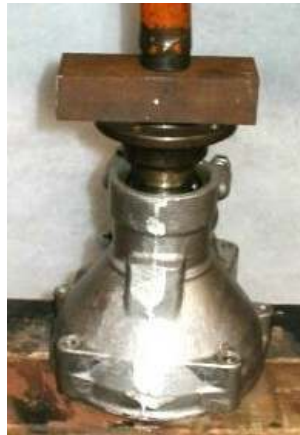
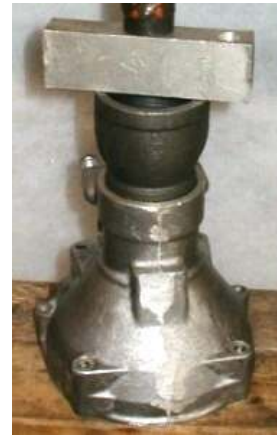
**Installing Annulus:** The first step was to press the annulus head bearing onto the annulus shaft as shown in the left photo below. I used a plastic block and then an aluminum block to avoid damaging the inside of the annulus. Next, the annulus with head bearing and speedometer drive gear were slid into the rear casting. I spread a little grease on the casting where the bearings fit to ease the next step. The annulus was positioned in the casting and then placed in the press. A couple 2X4 blocks were positioned under the annulus to avoid the damaging the front edge during the pressing operation. The tail bearing was then slid over the tail end of the annulus and into the casting. A punch was used to tap the outer race of the bearing into the casting. Once everything was positioned the rear flange was used to simultaneously press the head bearing into the casting and the annulus into the tail bearing as shown in the center photo. Next, the front edge of the rear seal was greased and pressed home using a pipe fitting as shown in the right photo. Those of you that have had to deal with the A type OD annulus end float measurements and adjustments will appreciate that we're now done with the annulus bearing. What an improvement!

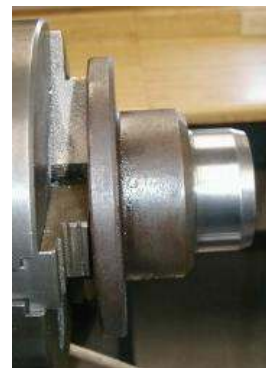
The area of the rear flange that mates with the rear seal was polished with 400 grit Emory cloth and oil. This can be done on the workbench. I spun the flange in the lathe as shown in the photo on the right. That made the polishing job go fast. The flange was then slid onto the annulus shaft. A little Hylomar sealer was smeared on the underside of the rear flange washer and then the nut was screwed on and tightened to a torque of 80 to 130 ft pounds. The same steel bar used to hold the flange when removing the nut was used to hold the flange here.

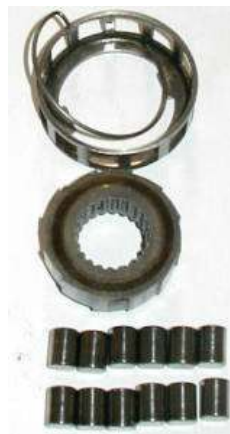
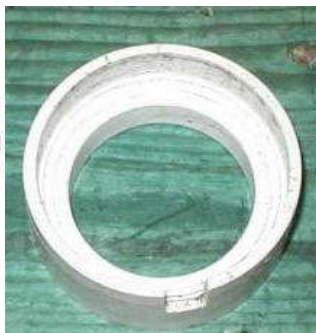
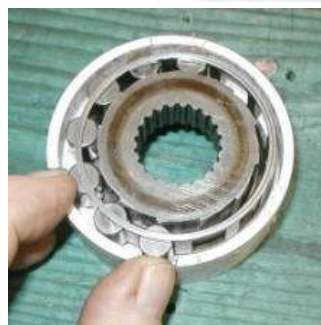
**Tool L178:** Another way is to use L178 as shown in left photo below. I made a similar tool from plastic pipe fittings for use on the A type ODs and it works fine here (center photo below). The tool is shown in use in the right photo below. The cage is rotated clockwise after each roller is inserted

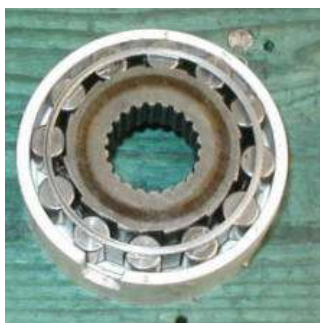
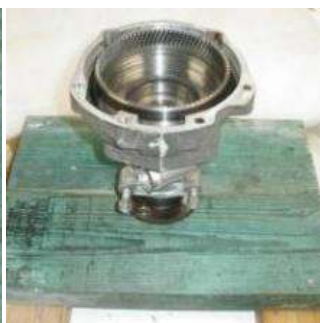
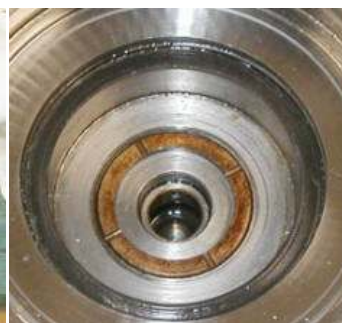
The tool with the fully assembled uni-directional clutch is shown in the left photo below. Before proceeding I secured the rear casting to the OD stand I made for working on the A type ODs. The stand, shown in the center photo below, is made from scrap 2X4s and 2X6s. The OD is secured with a couple 3/8" bolts through the rear flange. If the small mainshaft support bushing had been removed, it must be inserted before proceeding past this point. The uni-directional clutch thrust washer was positional as shown in right photo below.

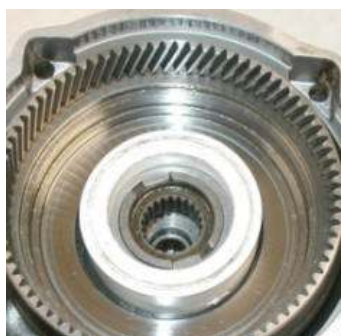
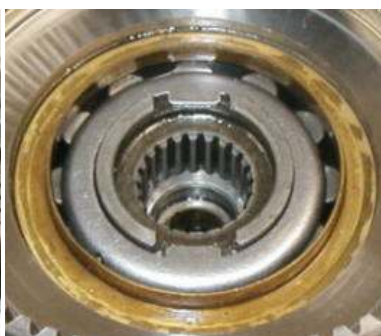
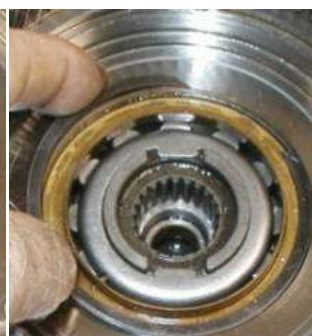
The L178 tool wanabe with uni-directional clutch inside was positioned open side down over the thrust washer and the clutch was then pushed out into the recess in the annulus, left photo below. The process works the same if the rollers were secured by rubber bands and the rubber bands should slide off as the clutch is slid into position. The brass oil thrower was positioned next. If everything is correct, the clutch should look like the middle photo below. It should be possible to rotate the clutch counter clockwise. However, if clockwise rotation is attempted, the clutch should engage to prevent rotation. If the clutch fails to move counterclockwise and to lock clockwise, it has been assembled incorrectly and must be removed and reassemble correctly. The final step after everything checks out is to install the circlip as shown in right photo below.

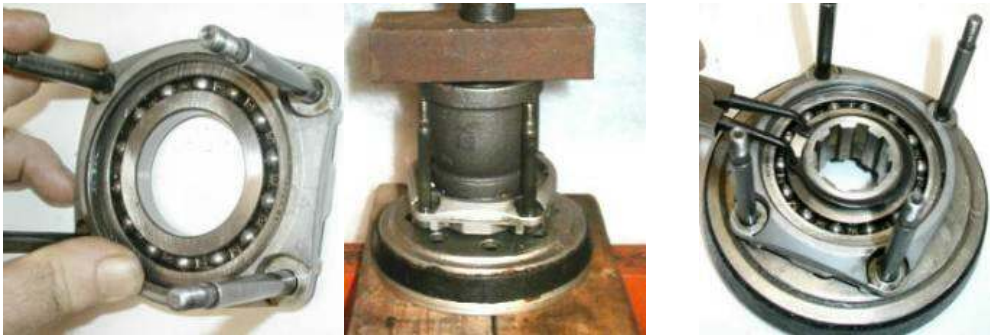
**Thrust Bearing & Clutch:** This process can be skipped if the bearing wasn't removed. The first step was to inset the bearing into the thrust ring. I used a pin punch around the outer race to seat the bearing. The punch should be moved from side to side to keep the bearing straight as it goes into the thrust ring. The bearing with thrust ring was then inserted into the bearing (left photo below). The bearing with thrust ring was then pressed onto the clutch as shown in the center photo below. The pipe fitting concentrates the pressure on the bearing inner race. The circlip was then installed as shown on the right. Care should be taken to assure that the circlips are seated properly; a friend had his OD fail after several 10K miles when one of these clips worked loose and the bearing came out. Fortunately, no damage was done but it's 8 hours plus to remove and reinstall the gearbox.

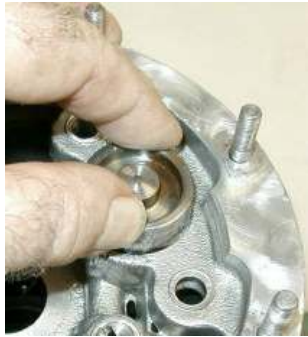
**Operating Pistons:** The operating pistons were merely pushed into their cylinders (left photo). These received a thick coat of petroleum jelly to make sure they moved freely without damaging the O-Rings

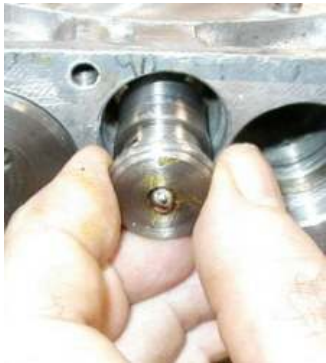
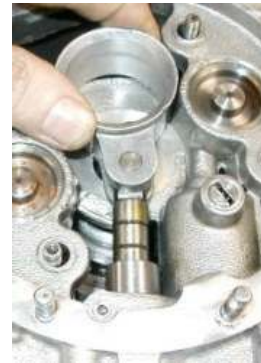
**Pump:** A little petroleum was smeared bottom of the pump body and the non-return valve ball and the pieces are pushed together. The jelly holds everything together. These parts were then inserted into the main casting as shown in the left photo below. I pulled on the top with one hand and pushed on the bottom with a finger. After the pump body was seated, the non-return valve ball was verified to still be in position and then the plug with non-return valve spring inside was screwed in (center photo) The pump piston with cam follower attached was slid into the pump body (right photo). The plug was then tightened to 16 lbf ft (192 lbf in). The repair manual says to tighten all three of the plugs to 16 lbf ft. The pump plug was considerably tighter than the other two when disassembled so I gave it a little extra twist after it reached 16 lbf ft.

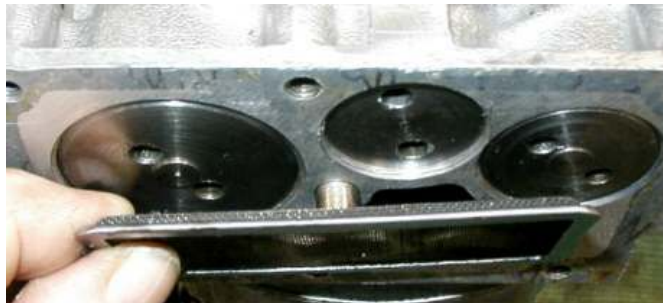
**Suction Filter:** The suction filter was then positioned with the tube in the pump input channel as shown below.

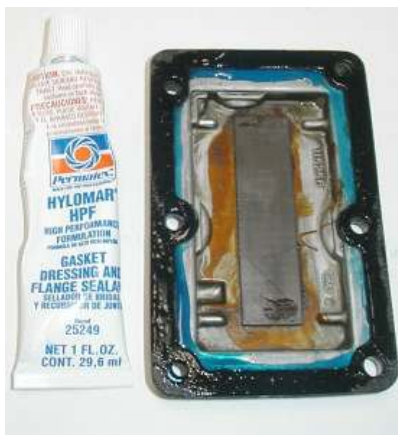
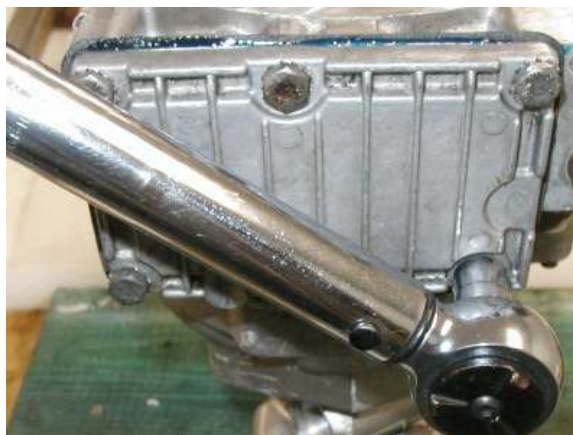
**Sump:** Both sides of the sump gasket were coated with Hylomar sealer and the sump cover was then installed. See photos below. The six bolts were tightened to 6 lbf ft (72 lbf in). (I don't know the origin of the rust colored stain on the bottom of the sump cover --- maybe rusty water had laid in it for a while.)

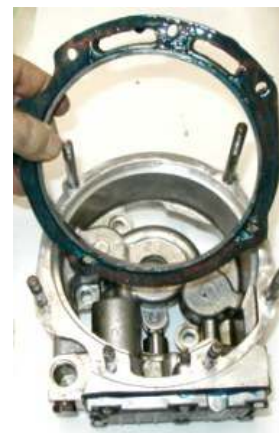
**Brake Ring:** The gaskets on the two sides of the brake ring are different. The correct position of the brake ring is with the cone pointing into the main casting. Both sides of the gasket between the brake ring and main casting were coated with Hylomar sealer and then the gasket was slipped onto the brake ring. The photo on right shows the brake ring with gasket and Hylomar sealer. The brake ring was flipped over and then slipped on the studs and lowered onto the main casting and driven home with a hammer on a block of wood.

The gasket between the brake ring and the rear casting was then coated both sides with Hylomar sealer and the gasket slipped over the studs onto the brake ring.

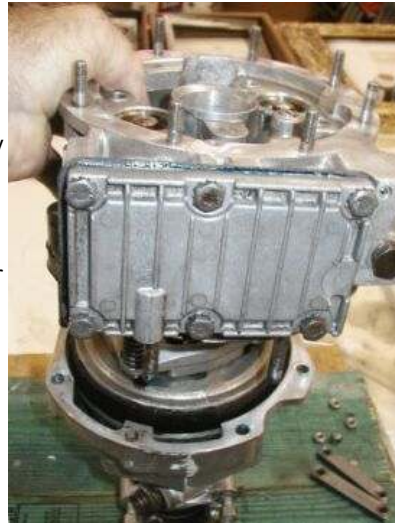
**Mating the two castings:** The release springs were installed on the thrust ring bolts and the main casting was lowered onto the rear casting that was still bolted to the stand. The thrust ring bolts were positioned as the casting was lowered so that the bolts went through the holes on each side on the main casting. The two upper studs use copper washers. The J type OD in my '76 TR6 leaked around these copper washers because the lock washers distorted the copper washers. I purchased copper washers from Lowe's that were a little thicker than the standard. I used internal tooth lock washers over the copper washers hoping that they are less prone to distorting the copper washer. Hylomar sealer was applied to the copper washers before installation. The other four studs use only lock washers. The release springs kept the two castings apart so that it was difficult to install both the nuts and lock washers. One of the studs that uses a copper washer is extra long so no trouble there. I temporarily screwed one of the nuts on the short stud opposite the long stud and tightened both nuts enough to compress the springs so that the other nuts with lock washers could be started. I then tightened the nuts a little, removed the nut without the lock washer and installed lock washer. The six nuts were then tightened progressively drawing the brake ring into the rear casting and compressing the release springs. The nuts were tightened to 15 lbf ft (180 lbf in).

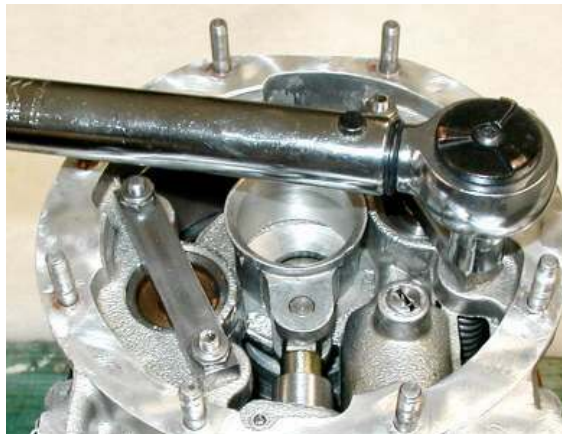
**Bridge Pieces:** The bridge pieces were slipped over the thrust ring bolts and secured with the four self locking nuts. The part of the bolt just under the head is knurled to keep the bolt from turning when the nut is tightened. If the knurled part slips out of the thrust ring, the bolt might turn when the nut is tightened, especially when the nut is threaded on to the point where it becomes hard to turn because of the self locking feature. A screwdriver blade can be placed under the nut and used to pry the nut up as it is tightened. This will cause the knurled part of the bolt to enter the thrust ring far enough to stop the turning. The four nuts were tightened 6 to 8 lbf ft (72 to 96 lbf in).

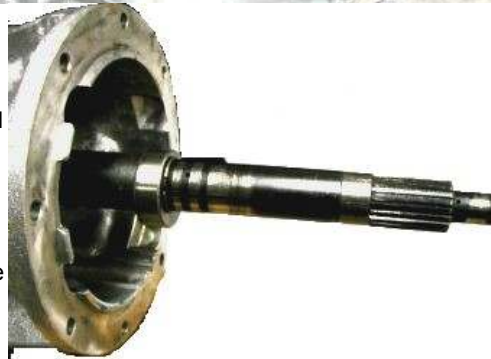
**Attaching OD to Gearbox:** The OD adaptor casting was reattached to the gearbox using a gasket and Hylomar sealer between the gearbox and adaptor. The pump cam key was inserted in the slot in the mainshaft and the cam slid into position and secured with the wire circlip. The top photo on the right shows the mainshaft with cam.

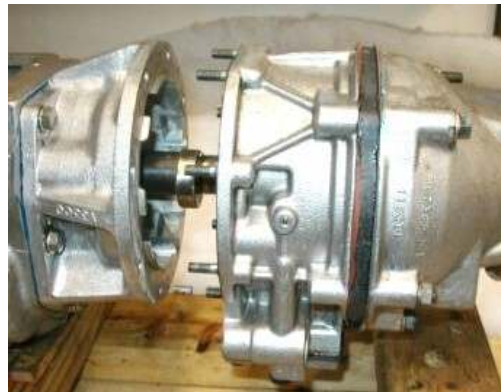
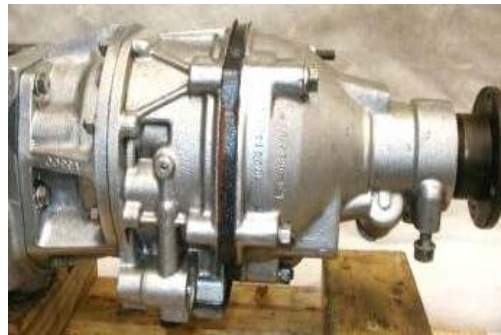
A gasket with Hylomar sealer was slipped over the studs on the OD unit. Next, a screwdriver and flashlight were used to align the splines on the inside of the planet carrier and the unidirectional clutch. The planet carrier is locked to annulus by the sliding clutch so it can't move relative to the annulus. The rear set of splines are in the unidirectional clutch and can be rotated counterclockwise as required to achieve alignment.

The mainshaft was positioned with the lobe down and the pump piston pushed to the down position in preparation to mating the OD to the gearbox. The OD was then slid over the mainshaft and pushed toward (offered up to) the gearbox. The mainshaft was rotated slightly to engage the splines. On the first attempt the OD wouldn't go in the last half inch or so indicating the splines were misaligned. The OD was pulled back off and the splines aligned again. The OD slipped into place on the second attempt. The OD was then secured to the adaptor casting with the 8 nuts and lock washers.

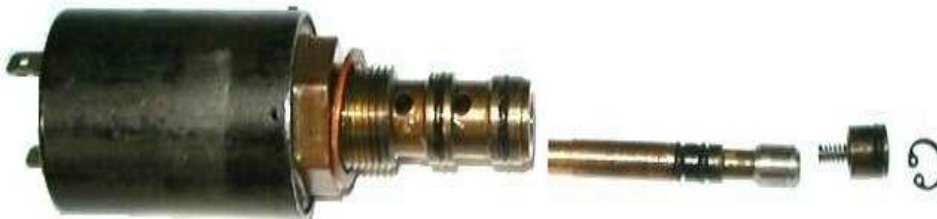
**Solenoid:** New O rings were installed the end of the solenoid, the valve stem and the valve end. The valve stem was then slipped into the solenoid followed by the end cap with spring. The end cap was then secured with the circlip. The photo below shows the solenoid and valve components.

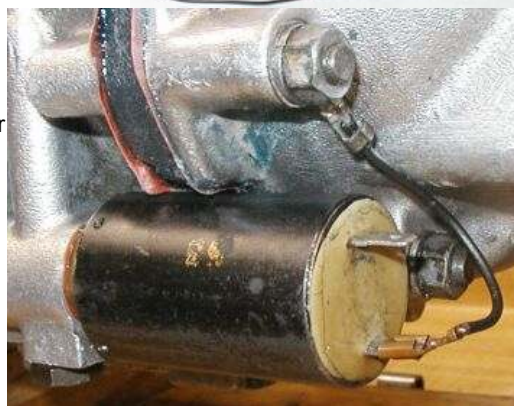
The solenoid was then screwed into the main casting and tightened with the modified wrench discussed earlier and the ground wire installed as shown on the right. The OD wiring consisting of a wire between solenoid and the 3rd/4th gear isolator switch and a second wire between the isolator switch and a bullet connect just outside the gearbox cover were missing so clip leads were used in subsequent tests.
