Adding OD Isolator Switches to Gearbox Top Cover

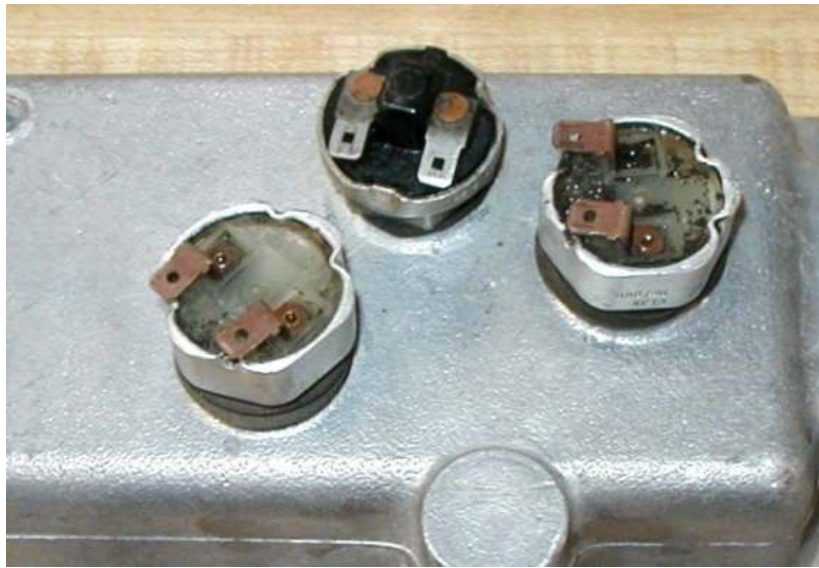
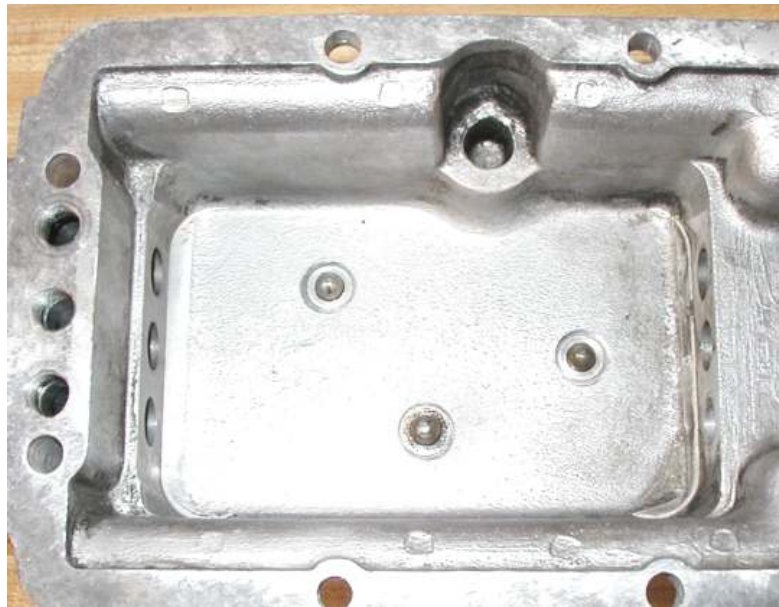
The next two photos show the top and under side of the top cover with the switches installed. The switches are the same as used for the reverse lamp and also the seat belt alarm/neutral safety switches on the later models. We were able to salvage a pair of switches from spare covers.

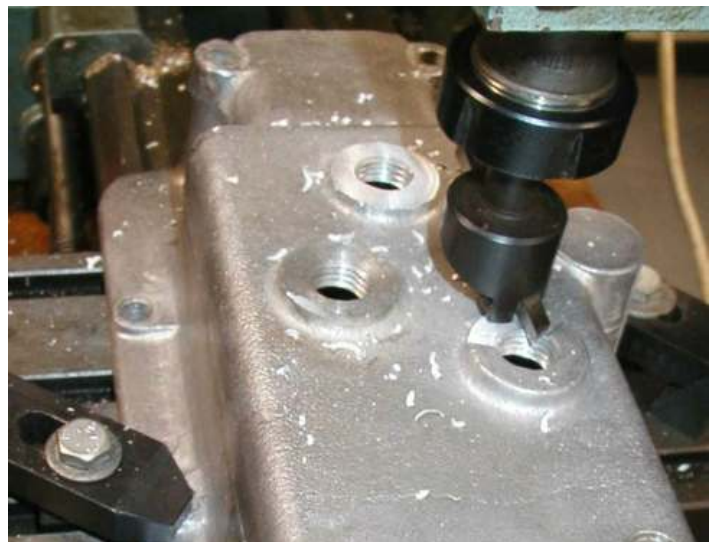
Not so fast: If you look at the above photo You might notice that the plunger on the lower switch (that's the reverse lamp switch) is sticking out a little further than the others; in fact it's sticking out about 0.050" further. Then I remembered that the top of the boss holding the reverse switch was machined smooth --- see first photo. This is an ideal job for a fly cutter in the mill as shown on the right. I adjusted the cutter so that the top of the two bosses for the OD isolator switches was machined to the same height as for the reverse lamp switch.

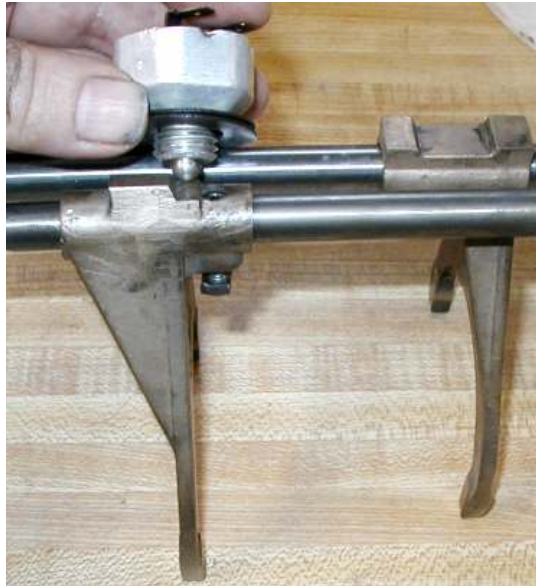
The next photo shows how the switches interface with the shifter forks. I'm holding the switch in the neutral position over the 1st/2nd fork. The shifter fork moves forward (to the right) when shifted into second gear and the raised part of the top of the fork will slide under the switch and push the switch plunger into the switch thus operating the switch. Note that there is no raised part on the forward part of the selector so when the selector

is slid to the rear (left) when engaging 1st gear, the switch is not operated (and it should not be operated). The other selector on the right for 3rd/4th gear has a notch where the switch plunger rides in neutral with raised parts in the front (right) for 4th gear and to the rear (left) for 3rd gear.

Note the two dark washers on the bottom of the switch. These I think serve the dual purposes of providing some switch height adjustment through using more or fewer washers and also as an oil seal. I prefer to use a little silicon based gasket sealer on the threads to minimize oil leaks (I never say prevent oil leaks when speaking of a TR).

One of the of the concerns I had was whether I got the switches in exactly the right spot relative to the selector forks so that the switches would operate only when the gearbox was in the desired gears. I checked out a cover with factory drilled holes (before I drilled my holes) and as far as I could tell the holes were in the center of the bosses

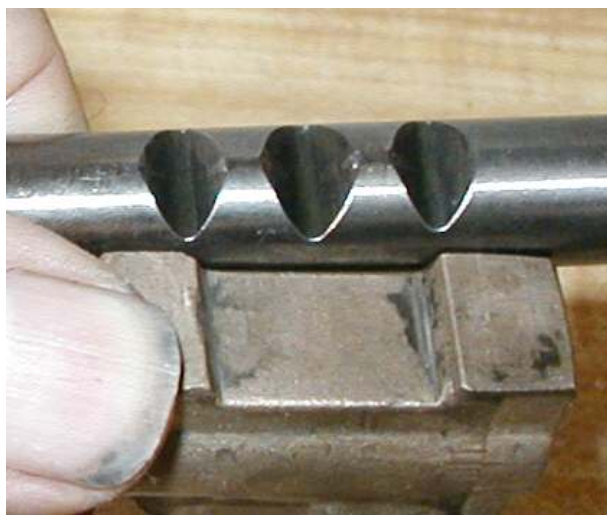
That was not the case with 3rd/4th. It appeared that the switch would barely operate in either gear. Next I took apart the shaft and fork and compared the length of the recess in the top of the fork with the distance between the slots for the 3rd and 4th gear detents in the selector shaft. The next photo shows this comparison. It's pretty clear that there is little margin for error in the position of the switch. If the switch is positioned exactly in the middle of the notch in the top of the fork when the fork is in neutral, then there will be just barely enough motion to operate the switch in either direction. If the switch is off center in neutral, it's likely that it'll operate only in only 3rd or 4th, not both. So --- why so little margin? My guess is that way back when, someone should have checked the drawing a couple more times before making the pattern for the casting. And what about wear in the top of the fork? I've heard of people having trouble. Maybe that's why they moved the switch to the rear and operated it from a notch in the shifter shaft --- they were having problems with the switch operating from the fork.

I think building up the top of the fork is the best solution for us users if we get the hole for the switch slightly off center or the switch becomes erratic due to wear. One could probably add some material through brazing then file it to the desired shape. The easiest solution that comes to mind for me is to use the head of a screw ---- drill and tap as hole maybe 6-32 exactly under the path of the switch plunger. I'd install the screw with thread lock and if necessary, file off part of the head toward the center of the slot.

I guess we were lucky that we got the hole just right --- at least for now.
