TR250 & TR6 Brakes Overhauling Brake Servo

This section describes how I overhauled the brake servo for my '70 TR6. As mentioned earlier, the car is completely disassembled and I was able to take the servo to the workshop to do the work (it's February, cold in the garage but nice and warm in the basement workshop). As we see later, it is very difficult for the home mechanic to get the servo apart and many repair parts are available only to professionals. However, this exercise did provide an opportunity to really understand how the servo works.

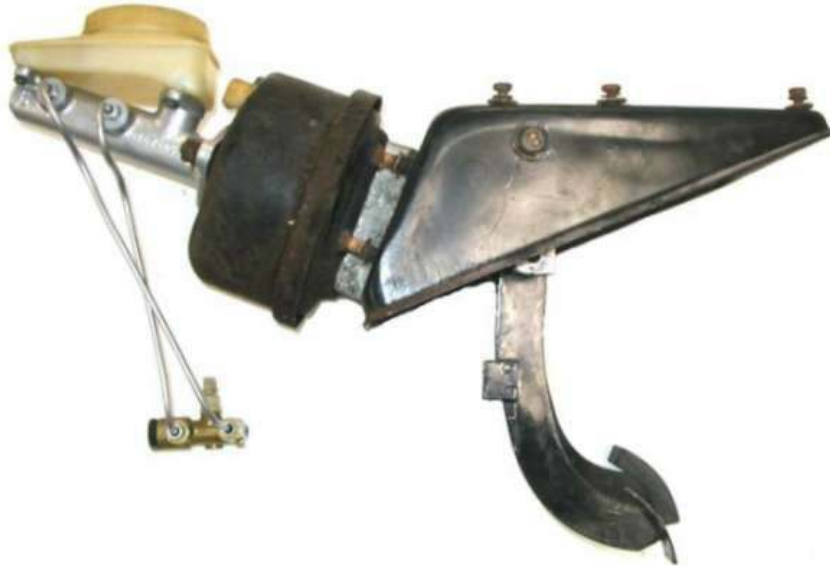
We start by looking where the servo fits -- between the pedal assembly and the master cylinder unit as shown above. Note that the master cylinder and PDWA are all clean and freshly painted. Also note that the servo is mounted at an angle --- the correct angle is where the top of the MC reservoir is horizontal. One might ask, why are you tearing apart a servo that is working? Good question. First, it looks terrible, no way am I going to put that thing on a freshly rebuild car. So, I want to clean it up and paint it ---- powder coat of course. Since it has rubber and plastic parts inside, it must be disassembled to remove those parts to prevent damage from the 350-degree powder coating curing temperature. And the main reason, I wanted to play with it.

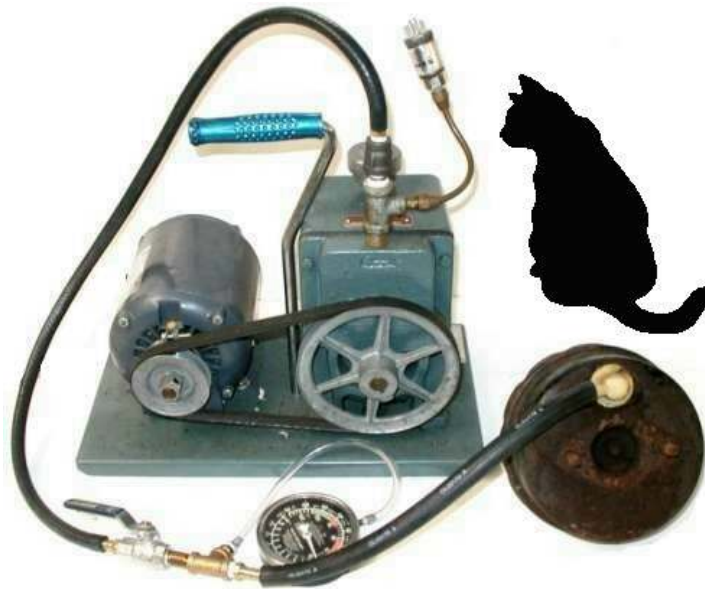
Test Setup: The photo shows the setup I used to test the servo. The pump is a two-stage unit used to evacuate air conditioning systems that I borrowed from a friend. When I first brought it home I set it on the workbench, turned it on and went to find the vacuum gauge. The workshop cat was nearby checking it out. I cautioned her about tails, pulleys and belts. When I came back a few minutes later she was gone. I was really concerned that she was sucked into the pump. I shut off the motor and listed for a meow from the pump. Nothing. A

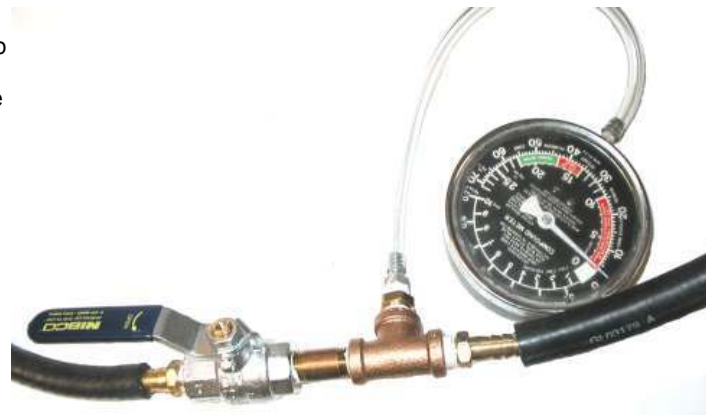
This shows the plumbing in more detail. The valve is between the pump and the servo. This allows the hose to the pump to be sealed and the rate of depression loss observed. The gauge is a compound gauge that reads both pressure and depression. Another setup will be to supply compressed air at a low pressure, close the valve and observe the rate of loss of pressure as an indicator of the non-return valve health.

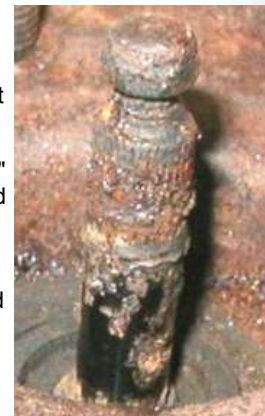
Bench Test: The first thing I did was to plug the hose and determine the maximum depression I could create --- 21" Hg. I then closed the valve to determine how long it could hold it ---- slowly bled down (or I should say up) to half the starting depression in 2 minutes. After checking around I figured out that one of the pipe fittings was leaking slightly. Fixed that and it held the depression

I next hooked up to the old servo and found the best the pump could pull was 19" HG. When I closed the valve it bled down to half in ~ 18 seconds. Next I pushed the pedal side rod in and the output rod moved, but the depression dropped to about 5" Hg and that was the best it would hold. Notice the scabs on the extended MC side push rod in photo on right. I think I understand why the seals leaked. Next, I put about 10 psi pressure in the input hose, closed the valve and watched pressure decay to half in about 20 seconds --- the non-return valve leaked too.

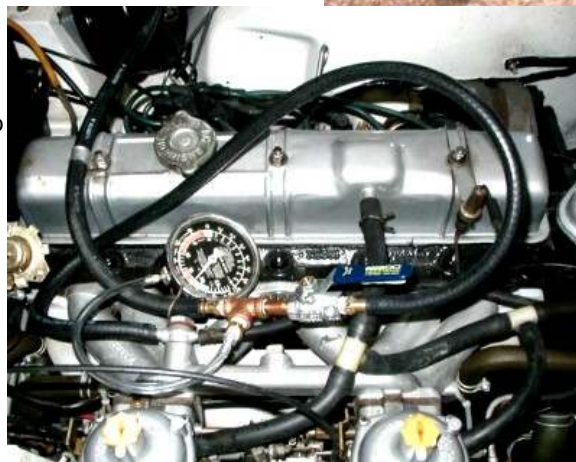
Test in Car: I next moved the valve, gauge, etc to the garage and put it in series with the hose from the manifold to the servo on my '76 TR6 as show on right. This worked just as well as the pump in the workshop. At idle I read 18.5" Hg with valve to servo open or closed. Closed the valve and observed that the system bled down to half in about 5 minutes. I then pressurized the system and observed that the non-return valve bled down to half in about 5 minutes too.

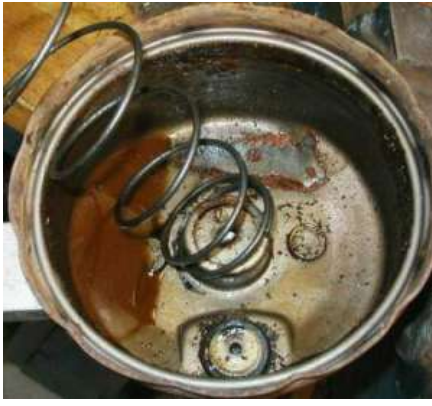
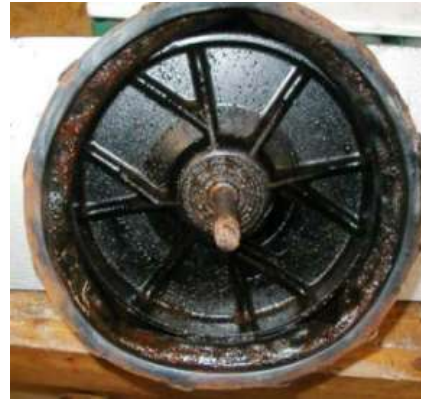
After everyone left I put some long (> four feet) handles on the tools and then tried to open another servo. The seal proved stronger than the handles. In frustration I locked the vise really tight and tried the big hammer again. It worked at once, but only a little movement with each whack. So, with perseverance, got another this one open and found it a little low, but not out of brake fluid as shown in photos below. (This one belongs to friend Ryan who obviously left it here by mistake.)

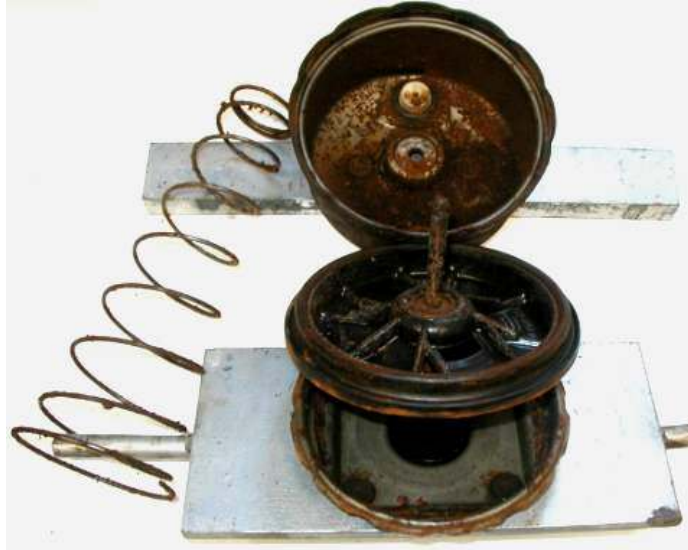
Disassembling the Front Half-Shell: The left photo below shows the inside of front (MC side) half-shell. This servo came off a '73 I junked a number of years ago. The upper photo on the right shows the removed MC push rod seal (tapped out from the inside) and the non-return valve. When the non-return valve was pressed out it came apart. It seems to snap back together with no problem. The little pile of debris fell out of the valve, which probably explains why it leaked a little. It looked like foam rubber. When I disassembled the pedal side a little later I realized that the air filter was missing. Further inspection revealed that apparently the filter disintegrated and was sucked through the system and into the engine. After blasting the half-shell I found a little hole in the bottom. Apparently if had water or water logged brake fluid set in it at some time. I had another servo that I got with a piece of TR250 years ago (that red one pictured in the theory section). I considered it junk since the no-return valve was broken. It was the first servo I'd taken apart and I broke the diaphragm plate in the process. The half-shell looked good so I decided to use that half-shell and switch the non-return valves.

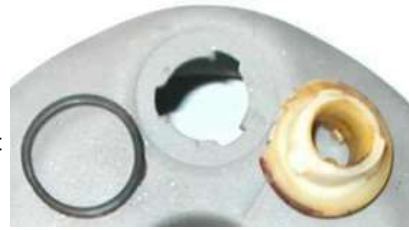
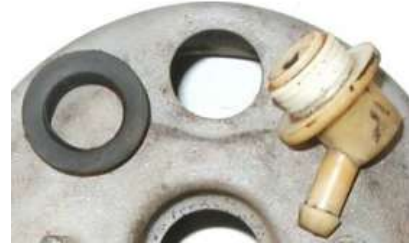
Non-return valve variations: Not so fast on the swapping the non-return valve. The original servos had a bayonet style retainer (push & turn) as shown in upper right photo. Apparently servos for the later TR6s and replacement servos came with a push-in valve that is locked with serrations on the side like pictured above and in lower right photo. Further, one of the folks brought a replacement servo with a smaller push-in non-return valve, so there are at least 3 variations. It looks like the hole for the

bayonet style can be enlarged to fit the larger of the push-in valve. Moss lists both type valves. The seal on the push-in valve shown is not in very good shape so I decided to get a replacement valve. The bayonet style is very hard to get out (that's how the one sample of the bayonet style got broke). However, the seal is a readily available O-Ring and Moss lists that seal separately. The push-in style seal is a custom job, comes with the new valve and is not listed separately. Several of the other guys have servos with missing push-in type valves but good seals who might be able to use my spare valve, so I ordered a new bayonet style valve with seal from a Moss reseller to match the upper half-shell that hasn't rusted through.

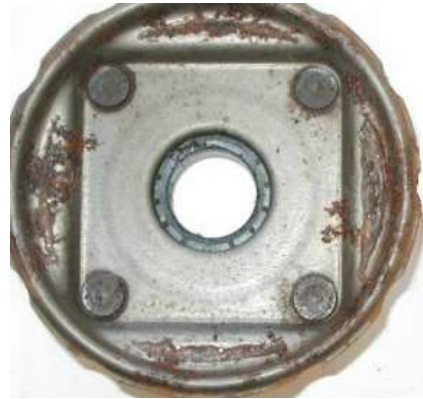
Disassembling the Rear Half-Shell: The inside of the rear (pedal side) half shell is shown on the right. This half-shell also had some rust but cleaned up quite nicely with no holes. The parts below were removed before the blasting. The dust cover stretches over a collar on the pedal side of the half-shell. The retainer, then washer and seal were pried out of the center cylinder without difficulty.

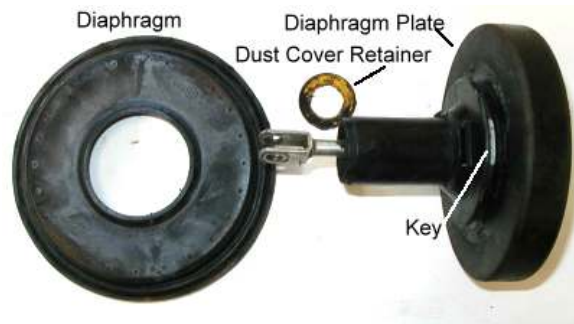
Removing the valve: The inside of the diaphragm stretches over a groove in the back side of the diaphragm plate as shown on the right. It comes off with just a little tugging and stretching. The dust cover retainer also slides out over the pedal pushrod. One thing is clear, the dust cover retainer has nothing to do with retaining the dust cover, which fits over it. The filter fits behind that retainer so maybe whoever typed the list up some decades ago skipped a line or two. It's probably really the filter retainer. One might ask why worry about retaining that filter, the air movement is always into the servo through the filter and valve assembly. This is true, however, as shown previously, the fluid drains out this hole to reach the operator's shoes.

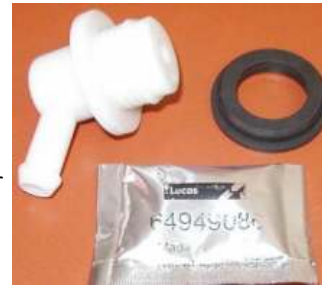
Replacement Non-Return Valve: I mentioned earlier that I ordered the bayonet type replacement valve from a Moss reseller. The actual valve I received is shown on the right, clearly the push-in style. I reconsidered my plan and decided to keep this valve since it is easier to remove and replace without opening the servo. I enlarged the hole for the valve in the half-shell to the 1.075-inch diameter required for the push-in valve.

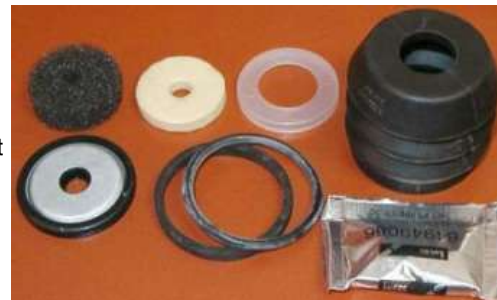
Minor Rebuild Kit: The parts in the minor rebuild kit are shown on the right. The top row is the air filter and boot that go around the pedal pushrod. The master cylinder push rod seal is on the lower left. The two rings are seals for between the servo and master cylinder and are not used in the TR250/TR6 application. The little packet contains grease to be used on the seal. The same grease that was packed with the non-return valve pictured above. Note that all these parts can be replaced without opening the canister.

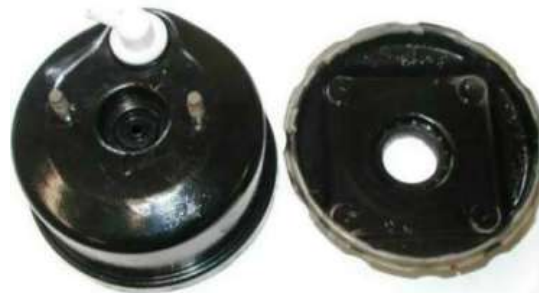
Reassembly: The two powder coated half shells are shown below. I first installed the check valve by applying some of the grease packed with it on the seal, pushing the seal in the hole and then putting some grease on the valve and pushing it position. When the valve is seated it makes a very tight joint with the seal and half-shell. The seal around the master cylinder push rod was then coated with grease and pushed into position with metal plate towards the inside. The large seal that goes in the rear half-shell was covered with grease and inserted into the half-shell followed by the washer and retainer clip.

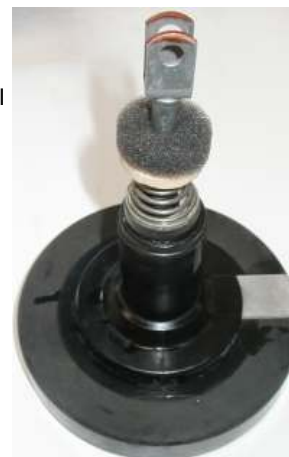
The next step was to install the poppet valve assembly. I had purchased a new poppet valve assembly that looked like it had been on the shelf a while. Part of the metal end that forms the valve to the outside air was corroded as shown on the right. I installed the foam filters on the pushrod as shown on the right. I then coated all the rubber surfaces with grease, pushed it into position and inserted the retaining key. The diaphragm was then stretched over the inner lip on the rear side on the diaphragm plate.

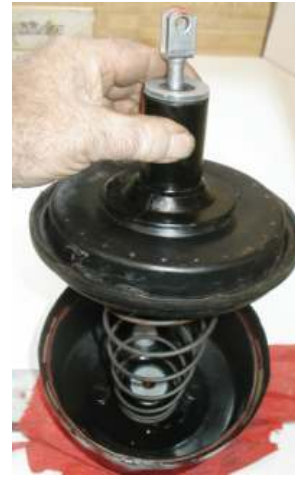
The photo on the right shows how the unit goes together with the big spring then the diaphragm plate, the rear half shell (not shown) goes on the top. The other holding tool was attached to the rear half shell, using several

folds of cloth between to prevent scratching the new paint. The lips of both half shells that retain the outer edge of the diaphragm as well as the mating edge of the diaphragm were all coated with the red rubber grease. As mentioned previously, these lips were not painted to ease reassembly. The grease serves to minimize corrosion of the unpainted surfaces as well as easing the job of turning the shell to lock them into place. The area under my hand in the photo was also coated with the grease that came in the rebuild kit.

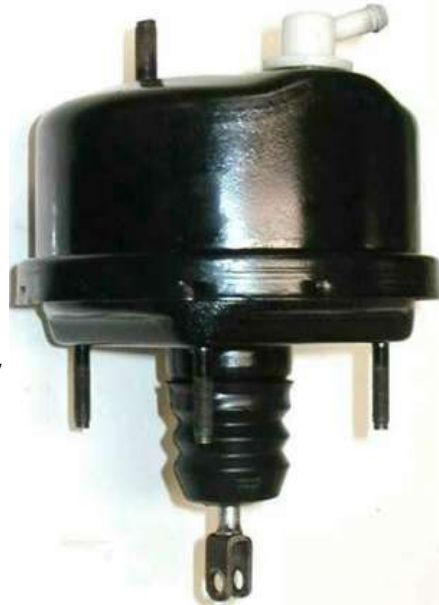
The next step was to connect it make sure it held a depression; the pump was run until the depression pressure stabilized and about 20" of Hg and the valve was then closed. There was a small leak. Rats! I fiddled around with the input push rod and finally rotated it couple turns and the leaking stopped. For some reason the valve between the rear chamber and the atmosphere had been leaking. Next I tested the operation at various pedal positions. It worked fine but there seemed to be a leak when the input was pushed. What I did was push the input about halfway in, waited until the depression stabilized and then closed the valve. The depression bled away in a few seconds. There was clearly a leak between the two chambers. The diaphragm was known to be good so it must be the valve. Well, have to take it apart again. Less than five minutes and had it apart. Decided to try the old valve. Reassembly at this point was a snap.

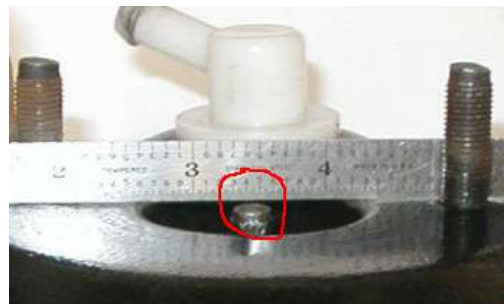
Push Rod Adjustment: The end the push rod that drives the master cylinder primary piston is adjustable. I laid a ruler across the front of the servo and measured the gap between the end of the pushrod and the ruler (see red circle on the adjacent photo). The gap on the servo I had just overhauled measured ~0.035". I hadn't changed the adjustment during the overhaul since the adjustment screw was frozen (rusted solid). Another servo I had measured zero gap. The piston in the master cylinder I just overhauled sticks beyond the face of the servo by about 0.040", so this servo will hold the piston slightly off the stop provided by the end of the tipping valve.

While I don't have specifications for the push rod adjustment I can make some guesses. We don't want it too short to avoiding introducing slack into the system. We don't want it too long because it might prevent the primary piston from returning far enough to open the tipping valve. The 0.035" gap that moves the primary piston about 0.005" off the stop seems to be reasonable.
