TR250/TR6 Clutch Release Bearing Woes

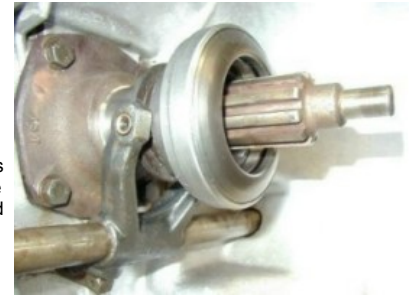
The Original Design: The original equipment release system is shown in the adjacent photos. The upper photo shows the front of the gearbox as viewed from the left side. The splined shaft is the gearbox input shaft. The splines fit into the clutch disk that drives the shaft. The thick disk in the center is the release bearing. The shaft across the bottom is the clutch operating shaft. When the clutch pedal is pressed, the shaft rotates such that the forked shaped casting, called the clutch fork, rotates and pushes the release bearing towards the front of the gearbox against the clutch pressure plate, not shown.

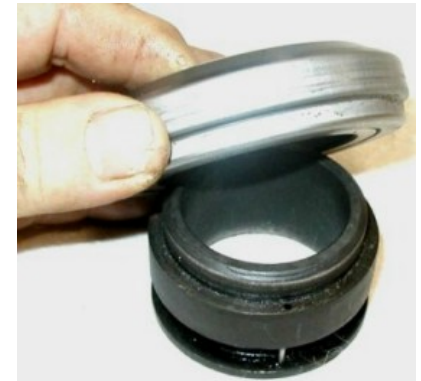
The next photo shows the standard (RHP) release bearing and the release bearing sleeve.

The sleeve slides over the gearbox front cover. The little pin in the groove at the bottom on the sleeve in the photo rests against one of the pins on the clutch fork and keeps the sleeve from rotating. The front of the bearing, at the top in the photo rotates with the clutch pressure plate. The inside of the bearing is pressed onto sleeve that doesn't rotate.

The act of pressing the bearing on the sleeve I think can damage the bearing. I use a two-pronged approach. First, I cool the sleeve in the freezer to shrink the sleeve outside diameter and heat the bearing in a ~ 200 degree oven to increase the bearing inside diameter. Next I use a tool sold by TRF that rotates the bearing as it is pressed on the sleeve. See photo on right.

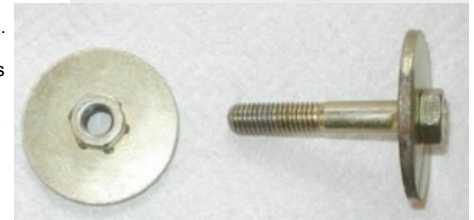
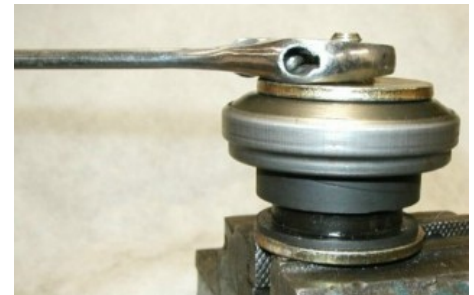
The head of the bolt is secured in a vice, the (cold) sleeve and then the (hot) release bearing are placed over the bolt and the nut with washer screwed down. Since the large washer is welded to the nut, the bearing is forced to rotate as it is pressed on the sleeve, thus distributing the force over the bearing surfaces. Note, I much prefer to press the bearing onto the sleeve myself rather than buying the combined unit since I have no idea how the bearing was pressed on the sleeve. Also, I smooth and polish the sleeve as describe in the "Sticky Clutch" note before pressing on the bearing.

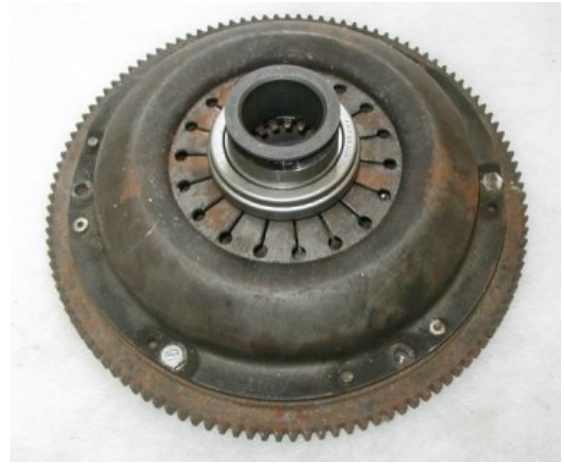
The photo shows a clutch pressure plate mounted to a flywheel. A release bearing is positioned against the pressure plate spring fingers, as it would be in normal operation. The pressure plate is a Laycock brand used as original equipment in the later TR6s.

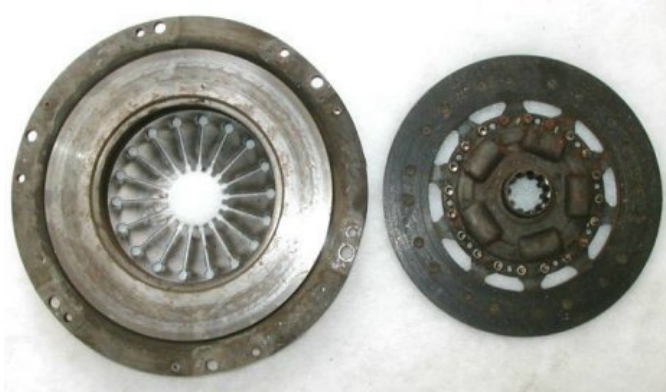
The next photo shows the under side of the Laycock pressure plate on the left and the clutch disk on the right. The clutch disk is sandwiched between the pressure plate and the flywheel. There is stiff diaphragm spring in the pressure plate that normally holds the disk tightly against the flywheel so that the disk turns with the flywheel. As mentioned earlier, the splines on the disk mate with the splines on the gearbox input shaft hence coupling the flywheel to the gearbox. Applying force to the pressure plate spring fingers via the release bearing lifts the pressure plate away from the clutch disk allowing the disk to rotate independent of the flywheel --- in other words, disengage the clutch.

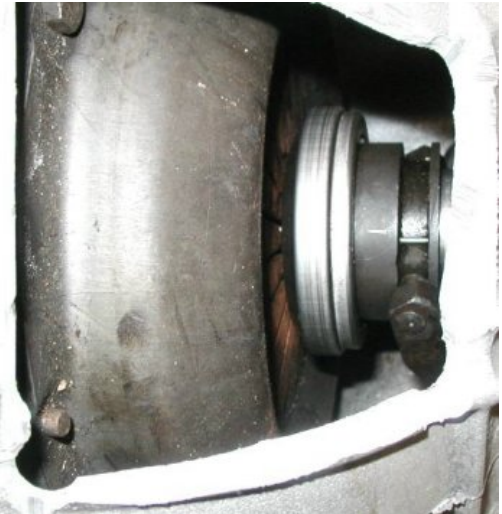
The release bearing and clutch pressure plate as viewed through a hole cut in the top left side of the gearbox bell housing is shown on the right. In normal operation with the clutch engaged, the release bearing is next to or against the pressure plate spring fingers and in some cases the bearing turns with the flywheel.

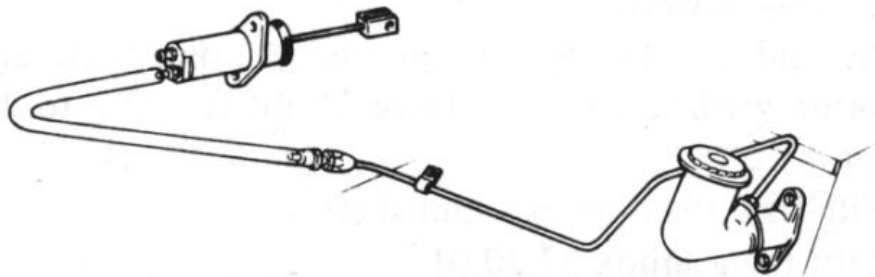
The clutch pedal is connected to the release system via the hydraulics shown in the sketch below. The unit on the right side is the master cylinder. The clutch pedal (not shown) is linked to the piston in the master cylinder. The slave cylinder is on the left side. The rod extending from the slave cylinder is connected to an arm that turns the clutch operating shaft. The operation is as follows; when the clutch pedal is pressed, the piston in the master cylinder is pushed into the cylinder forcing hydraulic fluid out of the master cylinder through the tube and then hose into the slave cylinder. The additional fluid in the slave cylinder forces the slave cylinder piston towards the rear in turn pushing the push rod.

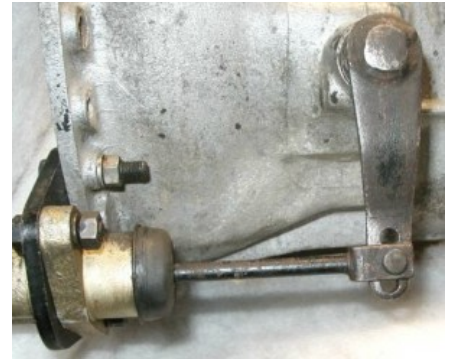
The push rod forces the lever on the clutch operating shaft towards the rear, in turn rotating the operating shaft and via the clutch fork forces the release bearing to press against the spring fingers on the pressure plate. The slave cylinder, push rod and operating shaft lever are shown in the next photo. (This is a bench setup. In a working system, the engine rear plate is sandwiched between the plate holding the slave cylinder and the gearbox. I didn't want to go dig out one of those greasy old plates just for the photo.) More information on the hydraulic system is contained in the "Clutch Hydraulics Overhaul" article.

The operating shaft arm length to the center hole is 3.36 inches and the fork length to the center of the pins is 2.44 inches. Therefore, the clevis pin in the center hole of the operating shaft arm moves 3.36/2.44 or 137% of the distance that the sleeve and release bearing moves. Since the release bearing must move about 1/4 of an inch to release the clutch, the clevis pin must move about 3/8 inch. The maximum movement available for a new system is about 0.6 inches for the 0.75 inch master cylinder system, about 0.5 inches for the later 0.70 inch master cylinder system. As wear (especially in the linkage between the clutch pedal and the master cylinder) introduces slack into the system, there is little if any margin in the system.

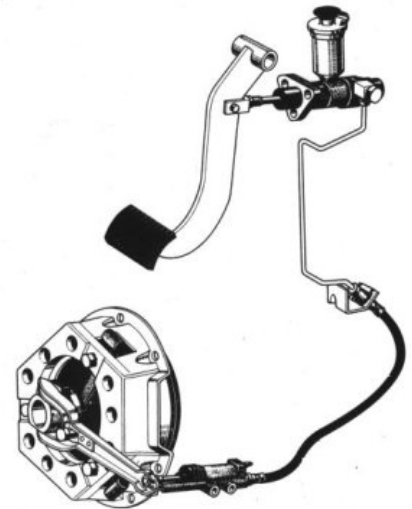
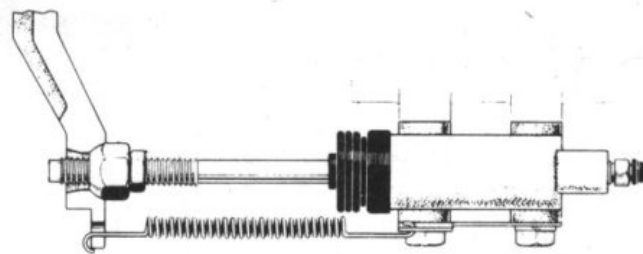
I finally purchased a Haynes manual for the 1968 through 1982 Land Cruiser. The sketches on right and below show the release bearing arrangement. Note that a lever type fork arrangement is used to push the release bearing. The sketch below shows the linkage between the slave cylinder and the fork in more detail. Note that there is a spring that pulls the lever (and bearing) back and an adjustment to push the bearing close to the pressure plate. The specified play at the adjustment nut is 0.12 to .016 inches. This is very similar to the TR3 & TR4 arrangement that is described in more detail later.

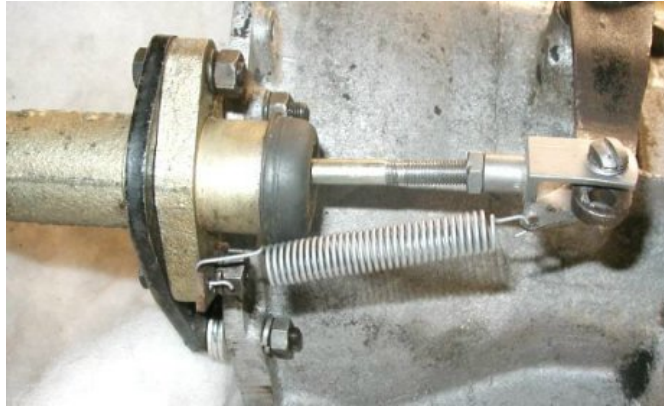
the TR3/TR4. A small flat bracket with a 5/16 inch mounting hole and a 1/8 inch hole to secure the front of the spring as show in the photo was fabricated. The TR3/TR4 slack adjustment is 0.10 inches. One way to achieve this adjustment is to remove the spring, loosen the nut, back the rod out of the end to the point where the slack disappears, then screw the rod back into the end 2.4 turns. The slack can be adjusted to less, such as 0.040 inches (one turn) and readjust it more frequently. In this case, the need for adjustment will be noted when the release bearing develops a constant squeal. Of course, if you wait long enough the squeal will stop as the clutch wears enough to give a constant preload -- just like using the clutch pedal for a foot rest.

Koyo -- Alternative #1 -- Pull the bearing away from the pressure plate: One alternative that many have used is to pull the release bearing away from the pressure plate as is done in the TR3/TR4 and the Land Cruiser. The TR3/TR4 linkage hardware can be used except for the pushrod that is too short. The configuration is shown in the next photo (note the use of washers between the gearbox and slave cylinder in place of the engine rear plate). The push rod is 5.5 inches long and made from 5/16 steel rod threaded 24 TPI. Threaded rod can also be used. The push rod end is I think from a TR4. The push rod that came with the end was 4.75 inches, too short for the TR250/TR6 application. The spring is the same as used on the TR6 accelerator, somewhat weaker than the spring used on
