## Reupholstering TR6 Seats

Winter is a good time to work on inside projects such as seats. I'm in the process of prepping my '76 TR6 for repainting. I plan to have it done in white again and have obtained a new red interior. The seats were so bad that I replaced them with a set from a '73 that I junked; thus the seats from the '76 were in storage ready for reupholstering.

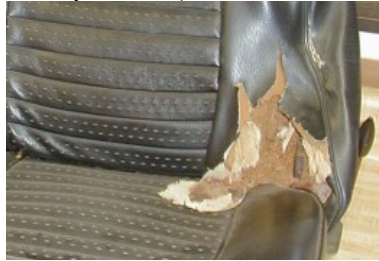
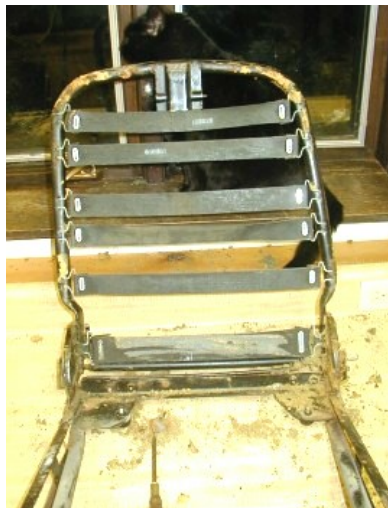
I decided to do one seat at a time so that I could refer to an assembled seat if required during the reassembly. The following photos show the driver's side seat as it was disassembled. The padding had disintegrated in many places and made a real mess in the workshop. Note that the diaphragm was broken, which probably is responsible for the low ride. The workshop is also the residence of two cats. One is checking out the seat frame while meowing about the mess (obviously a female).

There was a rubber type cement on much of the frame and the under side had quite a bit of surface rust. I cleaned much of the cement off using lacquer thinner and an old wood chisel. I then took it outside and sandblasted it. Sandblasting doesn't have much effect on the soft cement residue. I attacked the cement residue again and got the rest of it off. Another bout with the sandblaster cleaned it up quite nicely. I then painted it with a spray can of Rustoleum Gloss Black. The next photo shows the (LH) frame in a reclined position. Note that the back is asymmetric; the inside of the back is vertical (when the back is upright) and the outside slopes inward. The seat bottom appears to be symmetric.

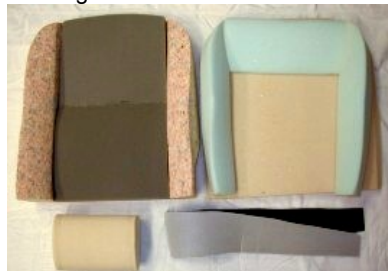
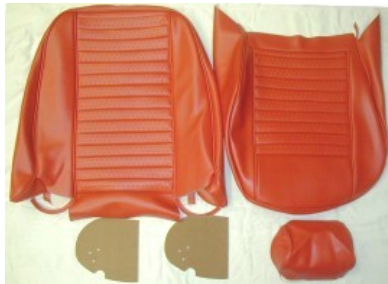
I had purchased a Seat Foam Kit, Seat Reupholstery Kit and a pair of diaphragms from TRF during one of their sales. The foam came in two packages taped together; one package had a sticker labeling it RH and the other had a similar sticker marked LH with the LH crossed out with a pen. There was also a sticker indicating that there was a pair of foam kits in the package. I'm going to assume one is RH and the other is LH even though the LH was crossed out. The upholstery kit had all the parts in one package. Upon close examination I found that the backs were marked LH & RH on the inside. There were no markings on the other parts indicating that both sides are the same (I hope). The kits (for one seat) are shown in the following photos.

Those of you that download this from the website will see the pictures in color and notice that the red is the orange red of the earlier TRs ---- not the darker red of the TR6 interior. You may also note the shade differs some from photo to photo. That is due to my messing with the photos on the computer to try to make them clearer. The orange red was my choice; I think it goes well with the white exterior. I was able to obtain the entire interior in this shade of red excepting the fuzzy door seals. These seals really clash with the rest of the interior when viewed under florescent lighting but don't look so bad when in sunlight.

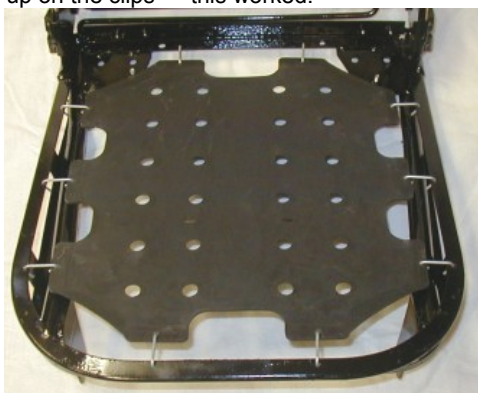
The next step was to install the diaphragm (smooth side up) using the new hooks provided. I started with the back followed by the front. I used a pair of pliers on the front clips to stretch the diaphragm so that the clips can be slipped into the holes. One side was fastened with no trouble but the last side was more difficult since I couldn't hold the frame and pull on the clips on the same time. I finally set the frame on one side on the floor, sat on the top edge and pulled up on the clips --- this worked.

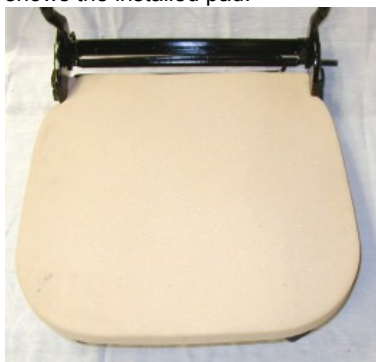
The seat bottom foam pad was installed next. I sprayed the top of the frame around the outer edge and a half inch strip around the outer edge of the under side of the foam. The sides of the pad are beveled resulting in the top surface being bigger than the bottom surface (that's how you tell which side is top & bottom). The next photo shows the installed pad.

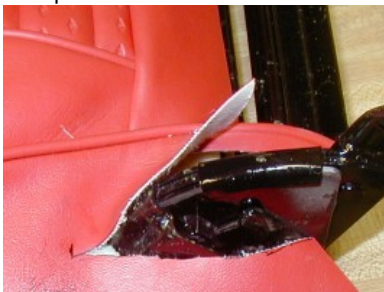
The next step was to cut a slit in each side of the seat bottom upholstery so that it will fit around the area where the back and bottom parts of the frame connect. The slit should be parallel to and about 2 inches below the bead. The slit should extend to a point opposite the middle of the first full stripe in the seat bottom as shown in the next photo.

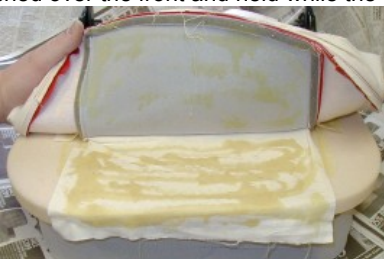
Next, the cloth strips on the under side of the seat upholstery (one at front and one on each side) were cemented to the seat bottom foam – see next photo. The long strip at the front was stretched over the front and held while the adhesive set.

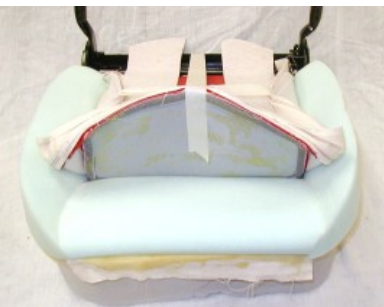
Next, the U shaped edge roll was cemented into place on the bottom foam over the cloth strips attached in the previous step as shown in next photo.

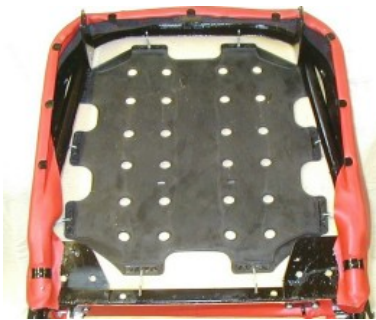
The final step on the bottom was to trim the upholstery in the area where the tubular clips go in the rear and then cement the upholstery in place. The tubular clips were then installed to hold it in place while the adhesive dried. The under side with clips installed is shown in next photo.

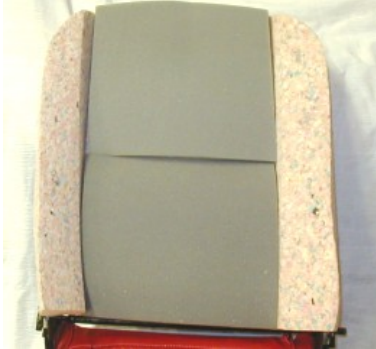
The back was next. (Those of you with sharp eyes will note that we're back working on the LH seat --- the first one.) I reinstalled the straps first and then sprayed adhesive on the areas of the back frame that contact the back foam and also on the matching areas of the foam. The bottom strap was also coated with adhesive. I then pressed the foam against the frame back --- see next photo.

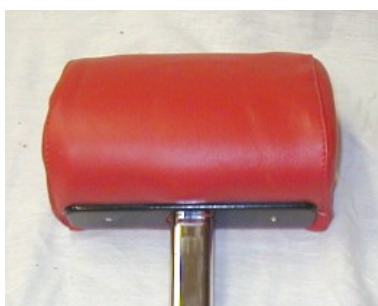
The headrest was easily to assemble. First, adhesive was sprayed on the headrest frame and the mating surface of the headrest foam and the foam was then slid on the frame, making sure the thick side was to the front. Next, the upholstery was slid over the foam, making sure that it is positioned correctly. The seam at the bottom was then tacked shut and the trimmed finisher screwed into place. The following photos show this process. Note that I decided to paint the trimmed finisher black. The finisher was painted to match the upholstery on the original equipment. If I can find red paint that matches the upholstery I might repaint them.

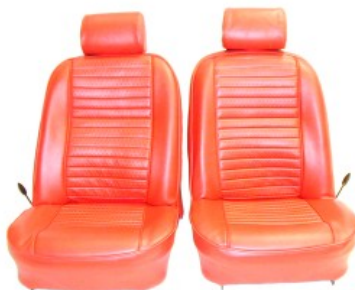
The angle control arm was polished and installed together with the headrest to complete the job. The finished product is shown in the last photo.

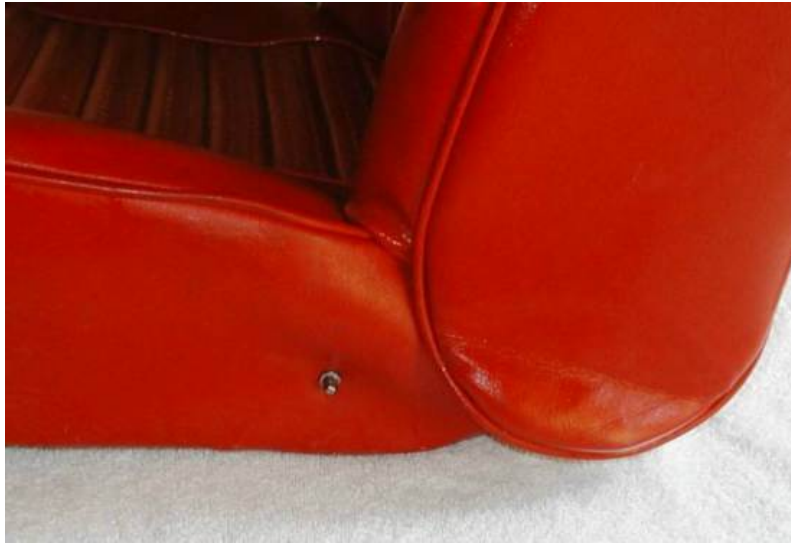
**Update, July 2002:** I finally got around to installing that tonneau strap peg in the right seat. The stud listed in the TRF TR250 and TR6 catalogs seems to be NA, but a replacement, part number 552669 shown on the right is available. The stud is installed in the left side of the right seat as shown below. There is a hole in the steel frame for the stud so it was a simple matter to shove a pointed object through the hole from the inside to pierce the vinyl in the correct spot. .
