## A Type Overdrive, Part III - Reassembly

### A Type OD Part III

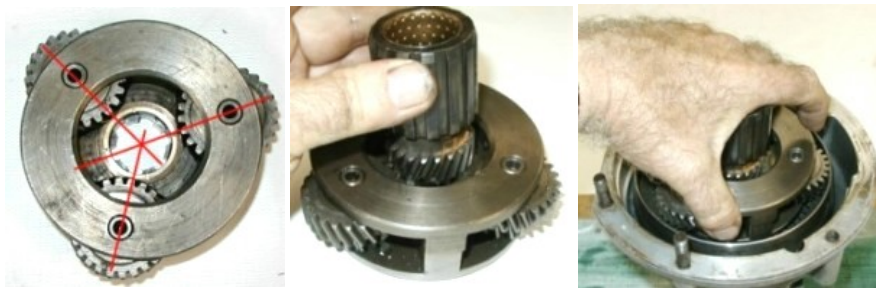
**Installing Epicyclic Gear:** The sun gear can be installed in the planet carrier with the planet gears in various positions. If the gears are not in the correct position, the sun gear shaft will be off center. This would be recognized when it was impossible to pass the mainshaft through the sun gear, the planet carrier and the unidirectional clutch. There are indexing dots stamped into the top of each of the planet gears. Each gear was turned so that the dot is on the outside and a line through the dot and the center of the planet gear shaft also passed through the center of the planet carrier as show in the left photo below. The sun gear was inserted with the planet gears aligned as indicated. The dot alignment was verified after the sun gear

was in position. The three dots didn't line up as indicated, so I did it over and got it right. The planet carrier with sun gear was then inserted into the annulus. The sun gear was rotated back and forth slightly to get the gears to mesh properly so that the planet carrier would drop into the annulus..

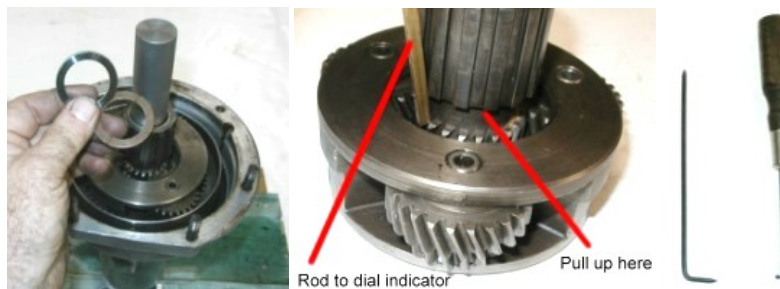
**Measuring Sun Gear End Float:** A thrust washer and adjustment washer fit between the sun gear and the bushing in the rear of the main casting (left photo below). When everything is put together, the sun gear must have an end float of between .014 and .020 inches. The books tell you to put an extra washer (thickness over .025 inches) on the mainshaft, pound the brake ring in the main casting and slide the main casting into position. Because of the extra washer, there will be a gap between the brake ring and the rear casting. Measure that gap with feeler gauges and subtract the measured value from the size of the extra washer to determine the end float. For example if the gap is .025 inch and the washer is .040, the end float is .015 inch. I was unable to get a repeatable measurement using this method --- the brake ring was on crooked, slid down from the main casting, or main casting tilted, etc.
