## A Type Overdrive, Part IV Final Assembly & Testing

Part III ended with a nearly assembled OD. We pick up here with attaching the OD to the gearbox and finishing the OD assembly. The OD was then tested and several problems were uncovered and solved.

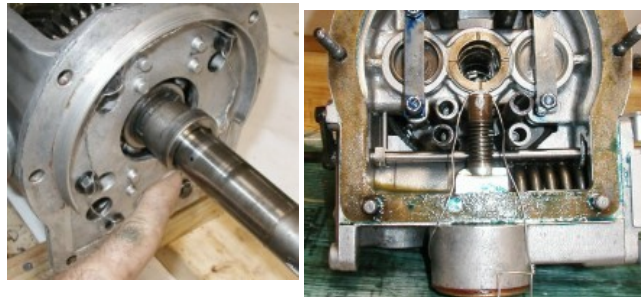
The dummy mainshaft was then rotated so that the spline was at the top and this position marked by putting a dab of Whiteout on the rear flange opposite the parting line at the top of the rear casting. The dummy main shaft was removed and a small amount of oil was poured into the main shaft hole.

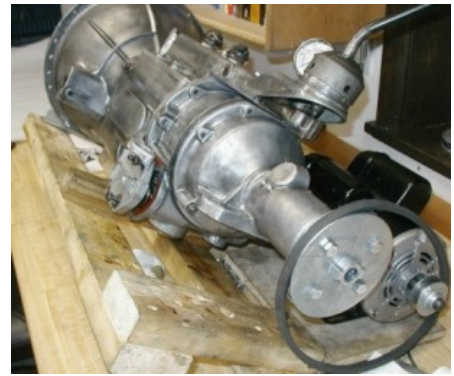
springs, I first tried that new outer spring with the original inner spring and found the pressure to be 360 psi. That was still a little low, but 450 psi looked reachable with a couple packing washers. I had a bunch of questions about what if "this spring" was used or "that spring combination" so I made out a list of things to test and set about the task. I got pretty efficient changing the springs ---- about three minutes by tilting the unit up part way on it's side so the oil wouldn't leak out as shown in photo on right. The dust shield and the nut on the top stud were left off. The solenoid and actuating lever were not used during these tests.

Rather than adding the packing washers immediately, the old outer spring and then that spring with the two available late OD springs used as the inner spring were measured first. Part of the reason to do this was to get good comparisons with a gauge that is easy to read and thought to be relatively precise. These are the first three measurements listed below. (The reading with the new gauge were 20 to 40 pounds lower than with the old gauge.) Note that the used late spring adds 205 psi and the new one adds 265 psi (I calculated earlier that this one would add 300 --- close). Also, the decision to not buy a late spring to be used as a replacement for the original inner spring looks good since this combinations gave 515 psi (test 3), a little high.

The new outer spring was then tried with and without the original inner spring, tests 4 & 5. That inner spring seemed to have very little effect on the pressure ---- it was worthless!. In hindsight, a new one of those should have been purchased too. The 0.9 inch plug spacer was then added to give a total 65 psi contribution from the inner spring (test 6 vs. test 4).

At this point the setup of test 9, the 0.9 inch plug and the 3 washers looked like the best choice. It did seem a shame to have this thing all fixed up like new and use that many washers. An attempt was made to secure a replacement inner spring. Called Moss UK, they didn't have any and none were on order. Then called Overdrive Repair Services (011 114 248 2632) to see if they had one. The guy who answered the phone asked "why do you want one of those?" I explained that I had low pressure and since I had a new outer spring, figured we should get a new inner spring to increase the pressure. He said that the inner spring has little effect on the pressure (I noticed that), it is there to support the outer spring --- help keep it straight. I said that the pressure was only about 350 psi. He said that was what it's supposed to be, 350 to 370 psi. He then explained the 350 psi and the big accumulator provided near instant engagement that tore up the axels in the later IRS cars so easily that the design was changed to the smaller accumulator on the later units to make the OD engagement softer. That made sense since Ronnie Babbitt's data showed that the pressure drops when engaged much more in the later units, and then built up in a second or so. Further, the later J type has no accumulator and has a much softer engagement. After the call I got to thinking ---- what pressure should the later A type unit be? Called the guy back and he said about 450 psi for the later units with the smaller accumulator pistons. The smaller accumulator makes for slower engagement but the higher pressure holds it in OD harder and should allow for higher torque without slipping. The later engines were 6 cylinders that had greater power and torque so it all fits together.

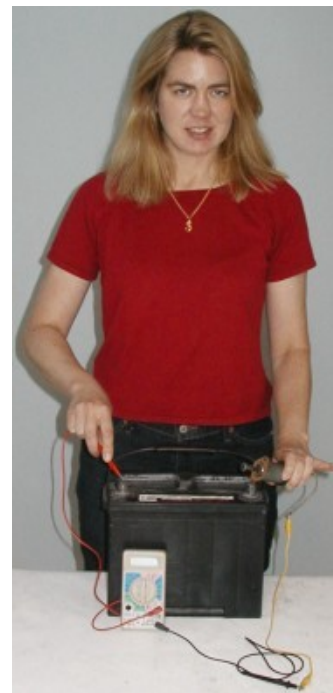
The engineer set the multimeter to the 20 ampere current range and connected the negative (black) probe to the solenoid lead using the yellow clip lead. The positive (red) probe was held against positive battery terminal and the solenoid case was touched against the negative battery terminal. The first test was made with the plunger removed. We read 16 amperes on one and 17 amperes on a second solenoid. Next, she measured the current with a plunger in the solenoid. When the current was applied this time, the plunger snapped into the solenoid and the current read about one ampere, just as it should. She explained that with the plunger in the solenoid, the initial current is about 17 amperes until the plunger reaches the back of the recess and operates a switch to remove the high current pull-in coil and leave only the low current holding coil in the circuit. She must have checked out the schematic at the end of Part I.
