Gearbox Overhaul - Part 1

We describe the disassembly of a TR250-TR6 gearbox in another technical note. The following describes how an amateur mechanic can successfully (we hope) overhaul a gearbox and put it back together. The same parts nomenclature as The Roadster Factory TR6 and TR250 Catalogues is used. These catalogues have excellent diagrams showing how the parts are assembled on the shafts and should be used in conjunction with the following description.

You might recall from the previous article that the object was to overhaul a TR250 gearbox with A Type overdrive. When the gearbox was examined the **constant gear** (the big gear on the front of the countershaft that mates with the gear on the input shaft) was found to have some broken teeth. A spare early TR6 non-overdrive gearbox was also available. It was that spare gearbox that was disassembled in the previous article to get good gears for the overdrive gearbox. The only difference between an overdrive and a non-over drive gearbox is the mainshaft; the overdrive gearbox uses a shorter mainshaft that mates with the overdrive unit that is installed in place of the gearbox rear extension. The plan had been to use all th

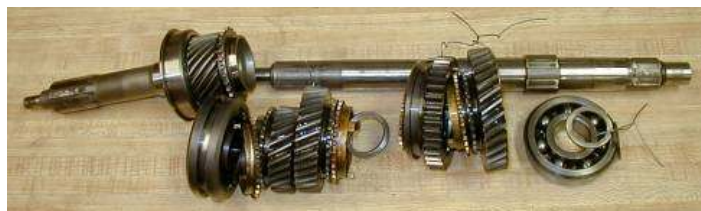
Second and third speed gears together with washers and bushings are held in the front of the main shaft by a heavy clip. To remove the clip, place the mainshaft in the vise (wrapped in a rag) and pry out the clip with a couple old screwdrivers. With perseverance, the clip will finally give up and come off. If you're lucky, you can get part of the clip out and break it in half which then eases removal. (There is a new clip in the overhaul kit.) Wire this set of parts together to ease reassembly. The gears together with the input shaft, mainshaft, and bearings are shown in the next photo.

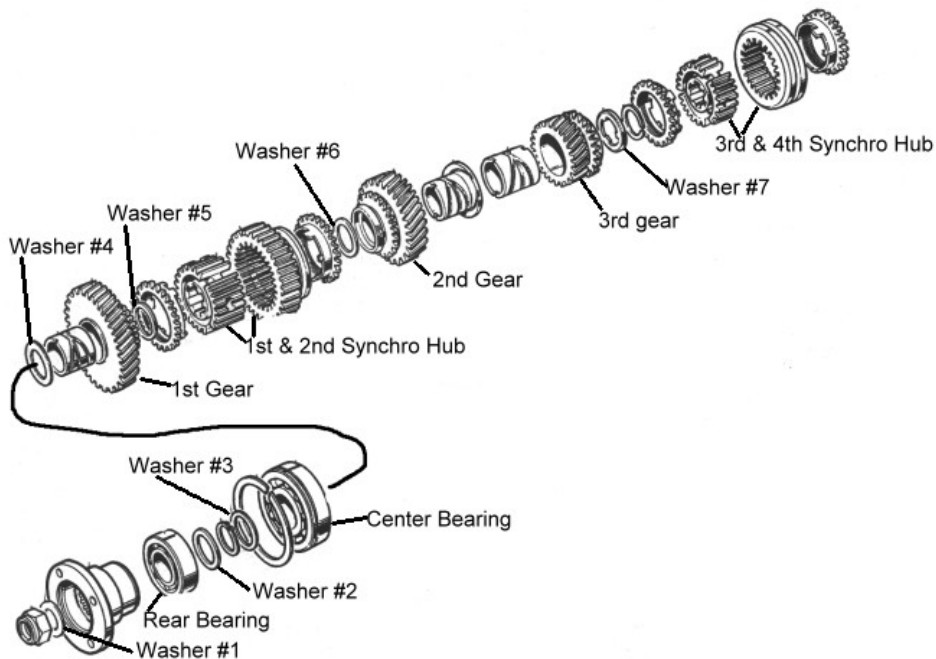
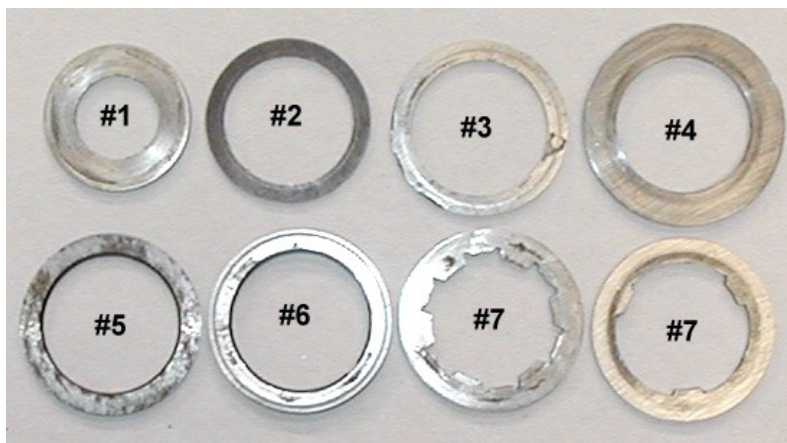
Description	ID (in)	OD (in)	Thickness (in)
#1	Between nut and rear flange	0.763-0.778	1.374	0.117
#2	Between rear bearing and shoulder on mainshaft	1.192	1.517-1.525	0.095
#3	Between circlip and center bearing	1.256-1.264	1.642	0.94
#4	Between center bearing and 1st gear	1.256	1.887	0.141
#5	Adjustment washer between 1st gear and mainshaft shoulder	1.257	1.673	See Text
#6	Adjustment washer between 2nd gear and mainshaft shoulder	1.257	1.688	See Text
#7	Splined, between circlip and 3rd gear	1.122	1.684	0.120

The photo above shows two versions of washer #7, the splined washer between the circlip and 3rd gear. These I believe can be used interchangeably.

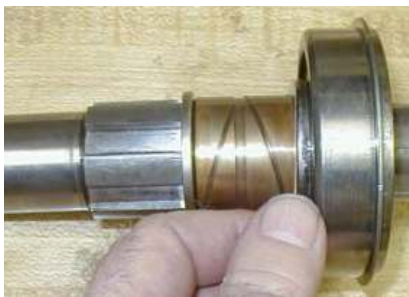
To measure the end float on the rear (first gear) bush it is necessary to assemble the parts and then press on the center bearing --- see next photo. After this is done and the clip installed, the bearing should be pressed back so that it is snug against the retaining clip. The end float specs are the same as for the front bushes. In this case the end float was .003 inches --- at the minimum. The rear set uses the same type adjustment washer as the front set. Each washer was measured and the front one was found to be thinner than the rear one. Reversing the washers yielded an end float was about .007 inch on both. Note: the two adjustment washers, #5 and #6 above can be reverse only on pre commission number CF12,500 gearboxes.

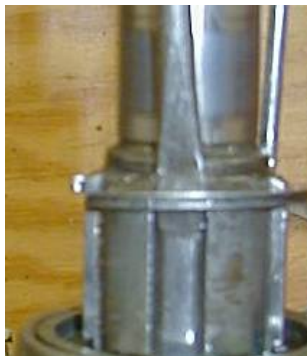
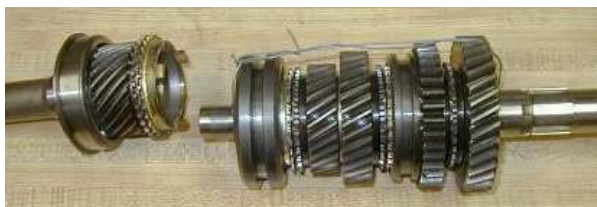
The next step is to assemble all the gears on the main shaft. The mainshaft is mounted in the vise and the front set of gears is slipped on together with washers, bushes, synchro cup, etc. The bushes should be lubricated with gear oil before installation. Next, that nasty clip is installed. (Three old screwdrivers were driven into the mainshaft groves to expand the clip and then the clip was driven on using a punch --- see photo.) Next, the shaft is set on the bench and the rear set of gears, synchro hub, bushes, washers, etc lubricated and slid in place followed by the front synchro hub and synchro cups. The rear set of gears and the front synchro hub are not held in place until the mainshaft is installed in the gearbox. Everything is wired together to ease the later installation into the gearbox as shown in photo.
