Sticky Clutch

I had a sticky clutch in my TR250 and after I mentioned it to some of the Buckeye Triumphs members I found Murry Mercier had a similar problem. I've also seen a number of references to the problem on the Triumph and 6-PACK email lists.

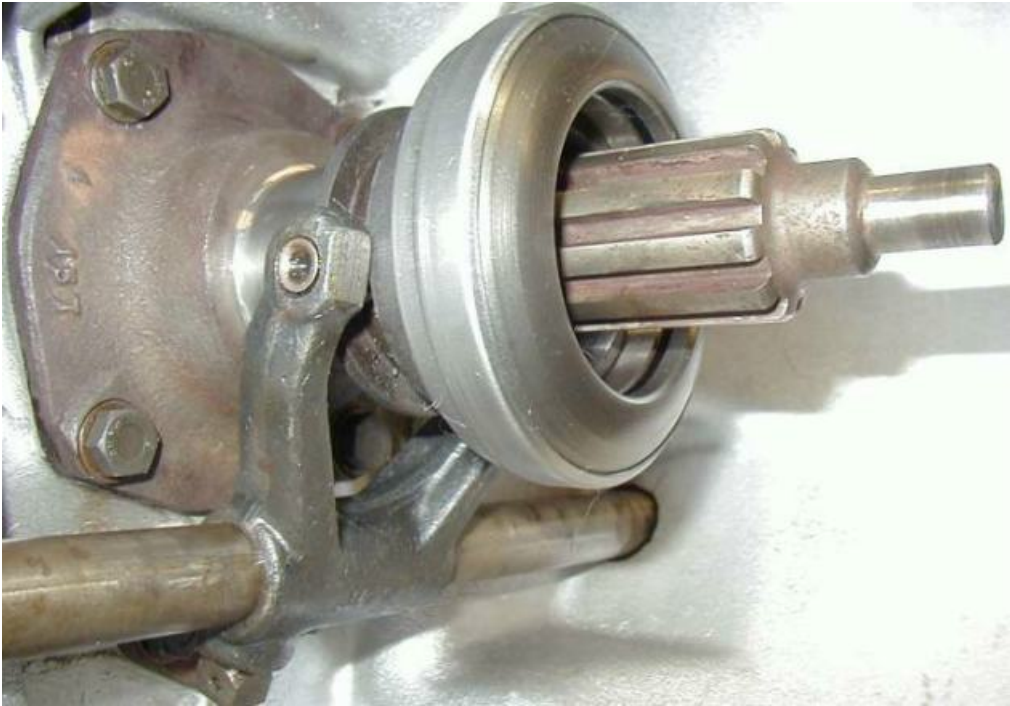
The following photo shows the front of the gearbox with the release bearing, sleeve, gearbox front end cover and the operating shaft with clutch fork attached to refresh your memory. When the clutch pedal is pressed, the operating shaft rotates such that the top of the fork moves toward the front (right) and pushes the sleeve and release bearing against the clutch pressure plate (that is not shown).
