TR250 & TR6 Brakes Overhauling Master Cylinder & PDWA

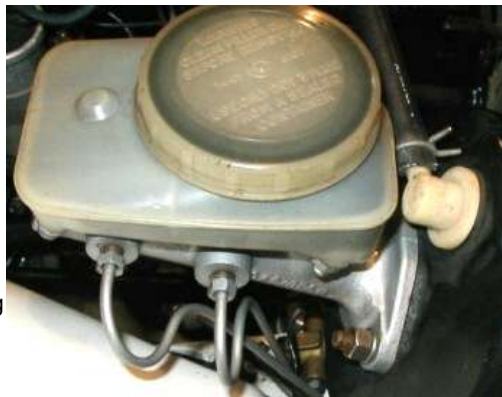
Removing the MC: The photo on right is of my '76 TR6. To remove the MC, I first disconnect the two brake lines from the side of the cylinder. Fluid will likely drip from the pipes so it's a good idea to wrap the pipes with a large rag or towel. The two nuts and lock washers are then removed from the studs that secure the MC to the servo and the MC can be lifted off. If I plan to remove the PDWA and/or plan to drain the entire system, I open one wheel caliper/cylinder bleed nipple at a time, drape a large rag or towel over the nipple and then use an air gun to apply ~10 psi air to the associated brake line fitting previously disconnected from the MC. If I'm not removing the PDWA, I cover the end of the brake lines with tape and then scrub both the engine compartment and the area around the wheels to remove any fluid.

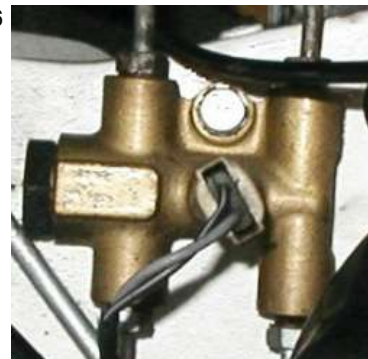
Removing the PDWA: The photo on right shows the PDWA on my '76 TR6. Before removing the PDWA I blow the fluid out of the system as described above. Next, I disconnect the electrical connector to the switch on the top and then disconnect the two pipes from the engine side of the PDWA and then remove the bolt securing the PDWA to the body. The PDWA will then lift off with the pipes that connect between the MC and PDWA still attached to the PDWA. I then seal the ends of the two pipes still attached to the frame with tape and scrub everything down with soapy water and hose it off.

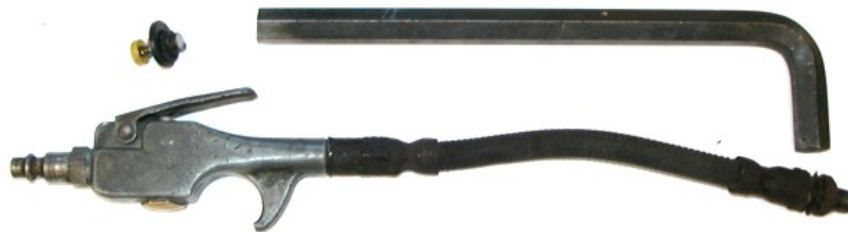
Disassembling the MC: As with any TR project, a couple special tools will come in handy here. The 1/2 inch hex wrench shown in photo below is to remove the nut that retains the tip over valve in the MC. The little part to the left of the wrench is an old tip over valve with the end cut off so it won't tip over. The lower tool is a bow gun with an old rear brake hose screwed into it. The blowgun has 1/8 inch pipe threads and the hose is 3/8-24, which is the right TPI, but a little loose. A few wraps of Teflon makes it nearly air tight.

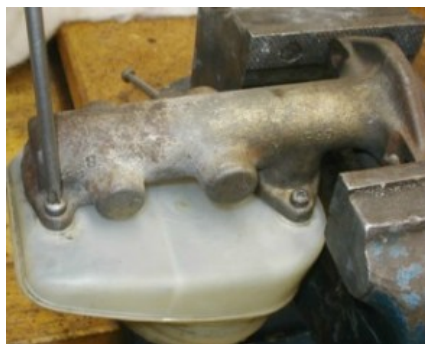
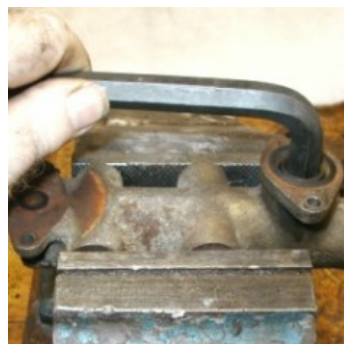
The photos below show disassembling the MC. The reservoir is being removed on the left and the nut (hollow plug) that holds the tip over valve in place is being removed in the center photo. The tip over valve with nut is shown in the right photo. The first time I disassembled one of these I discovered I didn't have the correct hex wrench at like 3 AM. I shoved the hex head of an old 5/16-inch bolt into the retaining nut and used a small pipe wrench on the shaft of the bolt. (Pipe wrenches are really handy ---- one step above vise grips.)

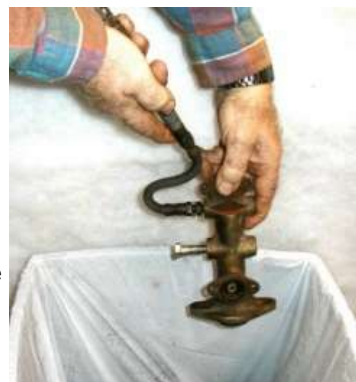
The next task is to remove the two pistons. With a little luck they'll come out when the cylinder is shook. However, we have other methods for the difficult ones. The scheme is to blow out the pistons with compressed air. However, for this to work all the openings except the end must be sealed. The tip over valve with the end cut off mentioned earlier can be installed to seal that opening. The tip over valve just removed can be used (with end sawed off) since there is a new one in the rebuild kit. The front brake port is plugged with a 7/16 -20 bolt and the air connection hose & gun pictured above is attached to the rear brake line port. The port to the rear brake reservoir can be covered with a finger. I pointed the end in a trashcan with some impact absorbing material (loose trash) in the bottom. I was really careful here because the pistons usually leave the cylinder with some dispatch. If the pistons don't come out I disconnect the air and then use a hammer and punch to drive the pistons into the cylinder a little to break them free --- then the air again. The pistons and springs are shown below. This stuff was set aside till later.

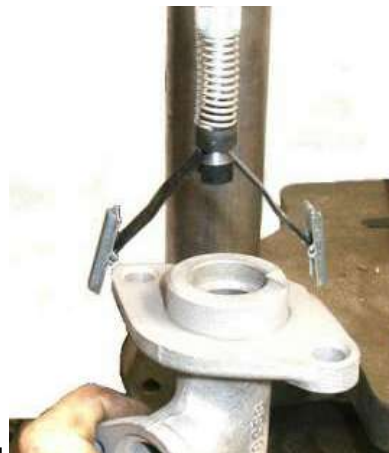
ran a spring-loaded hone with a little brake fluid for lubricant down the cylinder to clean up any imperfections. See adjacent photo. The inside of the cylinder should be smooth and free of all pits. Sometimes there are pits very near the open end of the cylinder that can be ignored because they are beyond the travel of the primary piston seal. It is very important to get then back end of the cylinder clean to insure that the secondary supply valve seals properly. That end is more prone to having built up residue from old seals than corrosion so it isn't too hard to cleanup with a little effort.

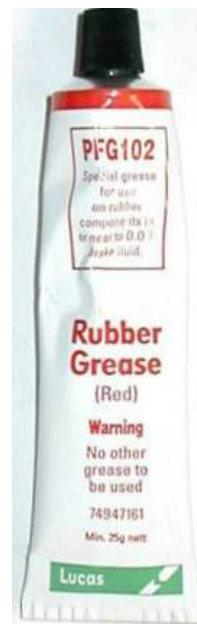
Rubber Grease: I think one of the keys to a lasting brake job is the use of grease on all threads, rubber seals and exposed unfinished metal such as the exposed ends of the cylinders. Greasing the pipe and bleed nipple threads often eliminates problems 10 to 20 years hence at the next rebuild. Greasing the exposed metal prevents the corrosion and pitting that sometimes destroys the components. Girling and Lockheed sell red rubber grease that is compatible with the rubber seals and brake fluid for just this purpose. Unfortunately, I had a hard time securing the grease recently. None of the local parts stores (Auto Zone, NAPA, etc.) carry it or are interested in getting any for me. The clutch MC rebuild kit comes with a small packet, not so the brake rebuild kits. TRF lists a Girling tube but has had it backordered for a year. Moss sells the small Lockheed packets called sachets, but was out when I tried to order some recently, and didn't expect to have any for six weeks. Victoria British said it was no longer manufactured. I inquired on the email lists was given three sources:

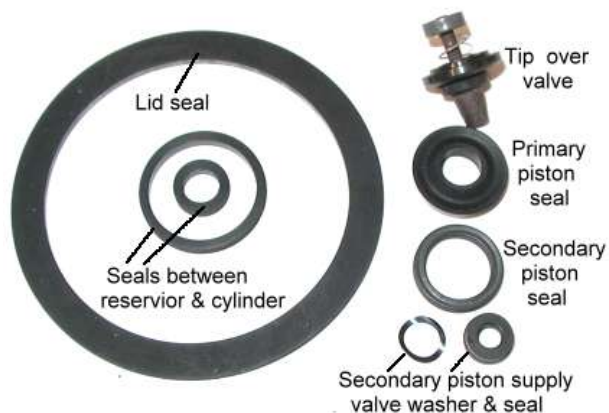
Replacing the MC Seals: The parts of the rebuild kit are shown on the right. The tip over valve seal is easy to deal with --- you get a new valve in the rebuild kit.

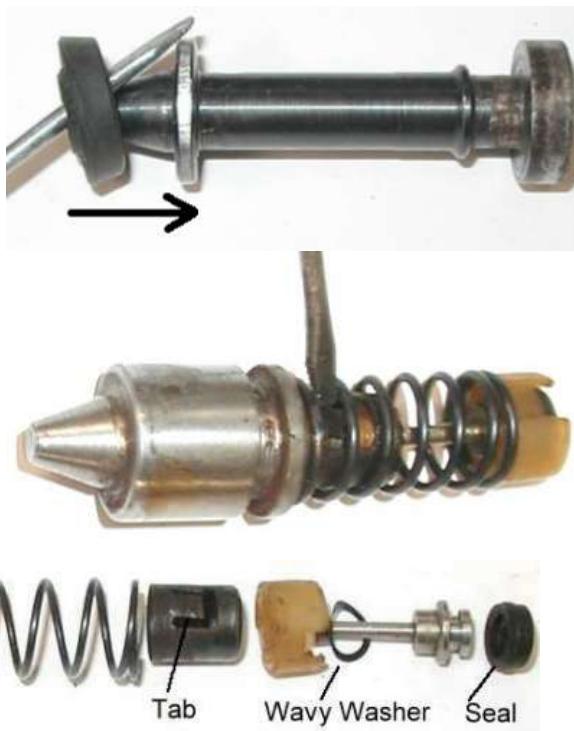
The seal on the primary piston is sometimes difficult to install. I coated the seal with grease and slipped it on over the pointed end. The correct orientation is with the largest part of the seal to the inside of the cylinder (the pointed end of the piston) as shown being installed in the top photo on the right. As you see, a small screwdriver helps. Caution, the seal will tear if

stretched only slightly more than necessary to get it over the disk on the end of the piston.

The secondary piston must be disassembled to get at the supply valve seal and wavy washer. I **wore eye protection for this procedure.** I used a small screwdriver to lift the thimble tab over the lip on the piston. The spring usually propels the pieces in all directions if they are not secured --- a rag over the whole mess sometimes helps. Once apart, the old wavy washer and seal were removed and discarded and new parts installed. The lip on the outside of the seal is positioned toward the end of the cylinder. It looks like it may be position in the other direction in the photo below.

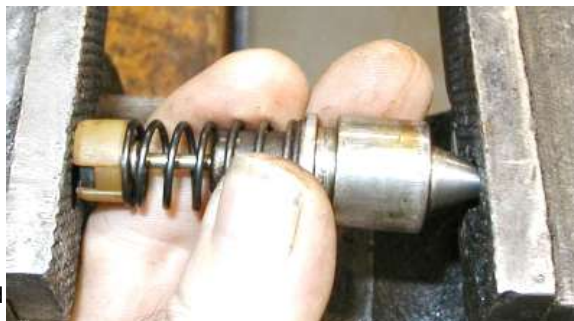
The next step is to put the secondary piston back together. I used the vise to squeeze the spring (I held the parts with one hand as shown in photo) and then used a small screwdriver in the other hand to push the thimble over the end of the piston and pressed the tab down behind the lip.

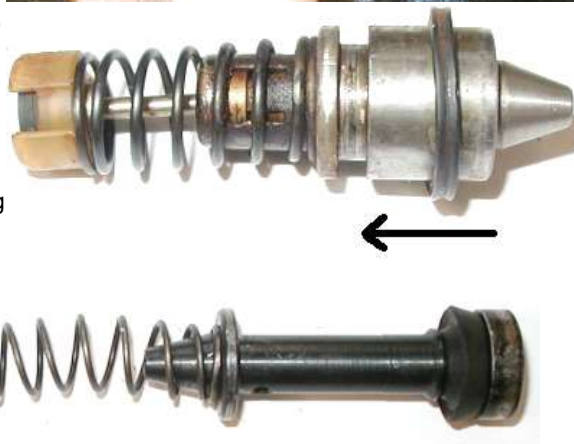
The pistons with new seals are shown below. I applied a little more grease to the seals and then slid the secondary piston, then spring and then primary piston into the cylinder. I held the primary piston in with a finger and then dropped the tipping valve into position and secured with the nut and tightened with the hex wrench.

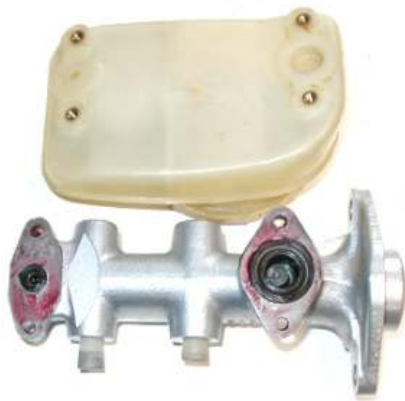
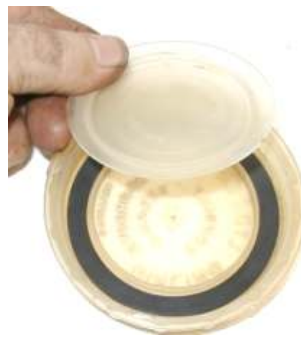
The final assembly steps were to replace the two seals between the cylinder and reservoir, attach the reservoir and replace the seal in the reservoir lid see photos below. I cleaned the reservoir as much as possible with hot soapy water and then dried with air before attaching it to the casting. Red rubber grease was spread over the joint areas (left photo below) and the original screws were replaced with hex head stainless steel screws with stainless lock washers. The seal retainer on the underside of the reservoir lid was prided off, the old seal replaced (right photo below) and the retainer pushed into place to hold the new seal.

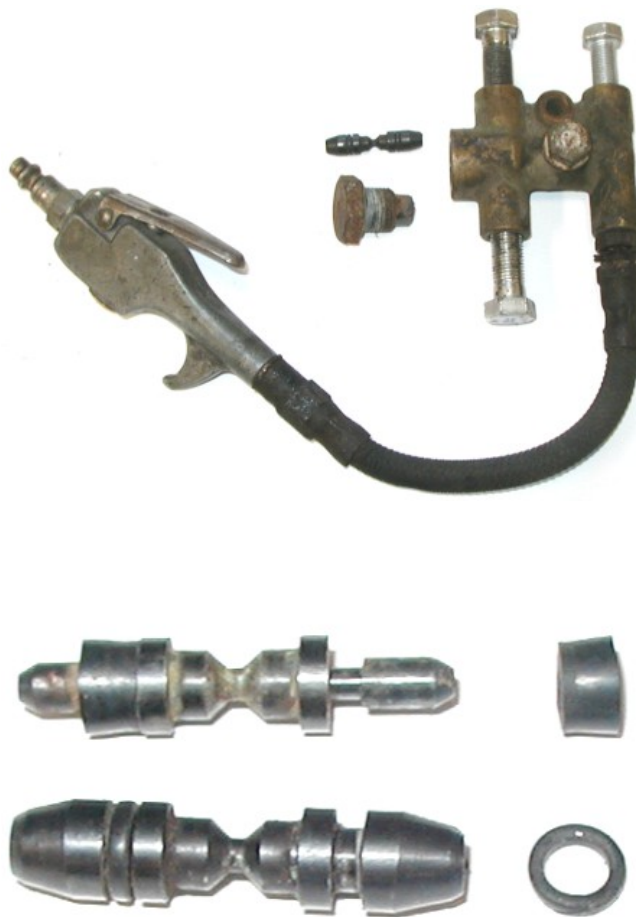
PWDA Disassembly: The major task with the PDWA was to get the piston out so that I could replace the seals. I used compressed air as shown in the photo on the right. I removed the switch and end plug and then plugged the ports for the front brakes with 7/16" bolts and the switch hole and one of the ports for the rear brakes with 3/8 bolts. The airline connects to the last rear brake port. I pointed it in the trashcan and fired. (If the local dogooders saw me doing this, they'd make me get a permit and register this thing.) If it doesn't let go, I disconnect the air, use a punch drive the piston in to break it free and then hook up the air and fire again.

I've been told there were PDWAs made with different size cylinders. I have PDWAs from years '68,'70, '73 & '76 and all have 5/16" cylinders. Three use O-Ring seals as the lower piston in the photo and one uses the more substantial seal as the upper piston in the photo. I haven't been able to find a source for the upper piston seals. The O-Rings for the lower piston are 3/16" ID & 5/16" OD with 1/16" cross section --- O-Ring size # 008.; See <http://www.marcorubber.com/>. Ethylene Propylene (EP/EPR/EPDM) is the correct material. I understand they are available from American Packing and Gasket Co, www.apandg.com (713) 675-5271 or (800) 888-5223. I bought 100 from McMaster - Carr for a little over \$8.

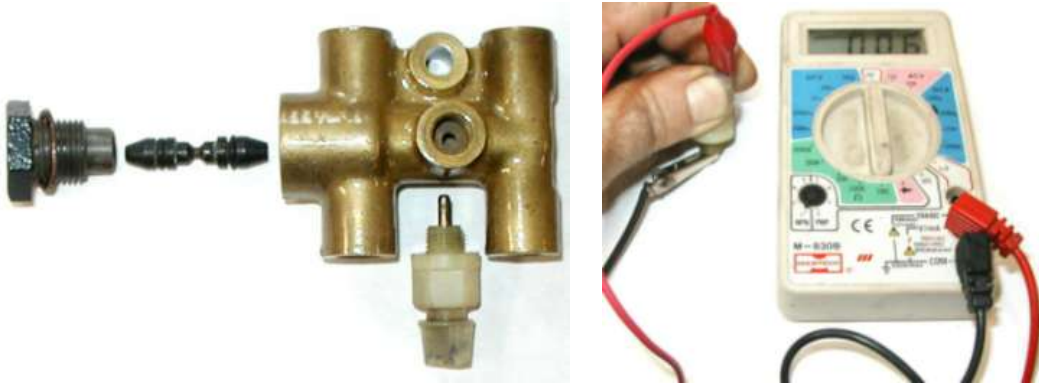
PDWA Reassembly: I coated the piston with rubber grease and slid two new O-Rings into position on the piston. I then poured a little silicone fluid into the PDWA bore and then slid the piston into position. I looked down into the hole for the switch and positioned the piston such that the narrow part is exactly under the middle of the hole. I used the sharp end of a scribe (a nail would work as well) through the switch hole to work the piston into the exact middle. I then installed and tightened the plug, making sure that there was a copper washer under the head of the plug. The ready to assemble parts are shown in the next photo.

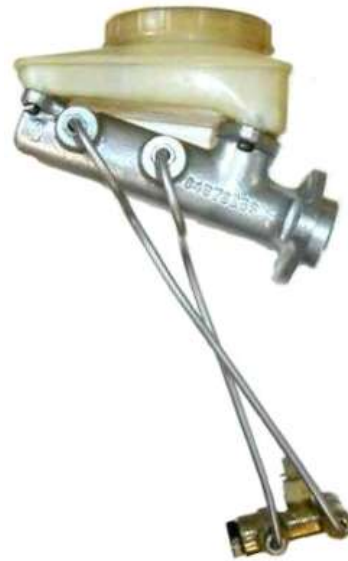
The assembled master cylinder with PDWA and connecting pipes are shown on the right.
